# Independent Tree Surveys Ltd

## Tree Survey Report Dodder Rapid Deployment Scheme Milltown Road Dublin

July 2023

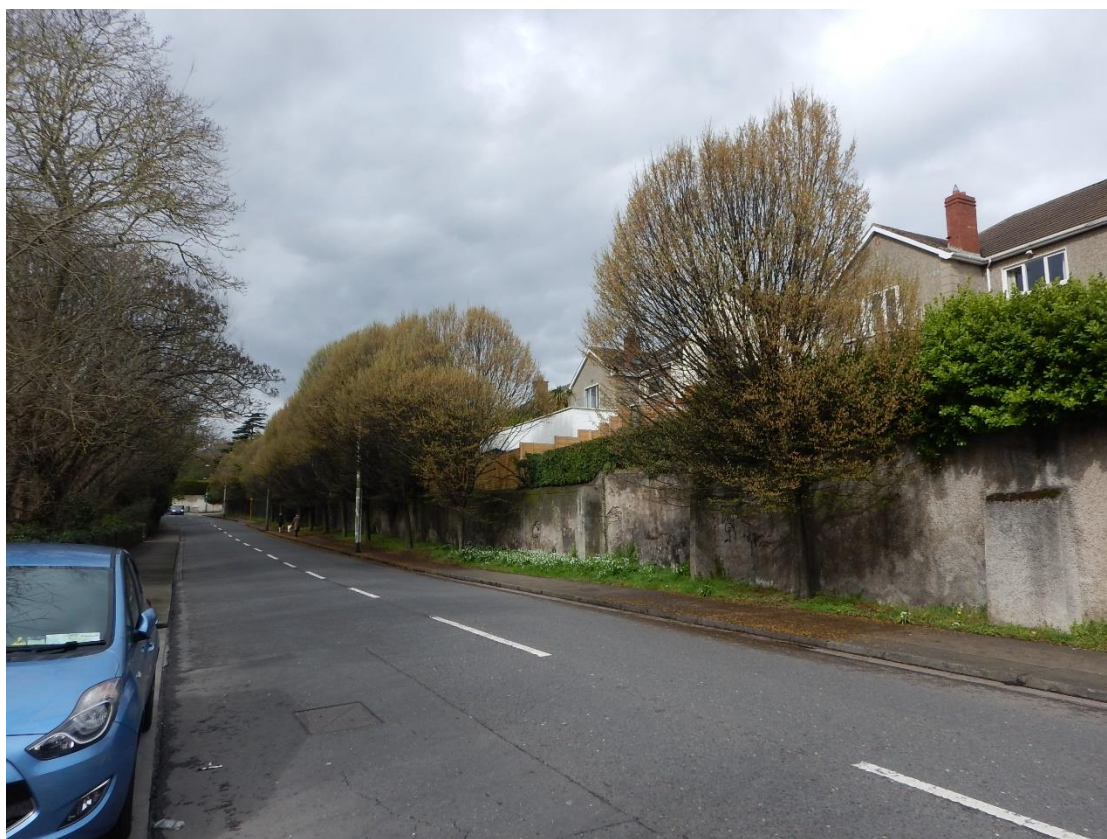
This section included a linear group of 12 Hornbeam trees that have been established in the narrow verge along the north side of Milltown Road. The trees are now in early maturity and have grown to mostly occupy the available space between the road carriageway to the south and private houses to the north. The Hornbeam trees are in apparently good health and condition and were graded category B using the BS5837 categorisation. Some of the branching from the trees is now restricting the street lighting and associated overhead powerlines. There is likely to be some root spread from the trees under the footpath to the south, and this may extend further under the road surface. Any works within the nominal root zones of the trees should expect to encounter roots and should be undertaken with care and in line with BS5837 (2012); where existing surfacing is being lifted, the sub-base should be left in place where practicable.

1. Group G1 along Milltown Road, viewed from the east

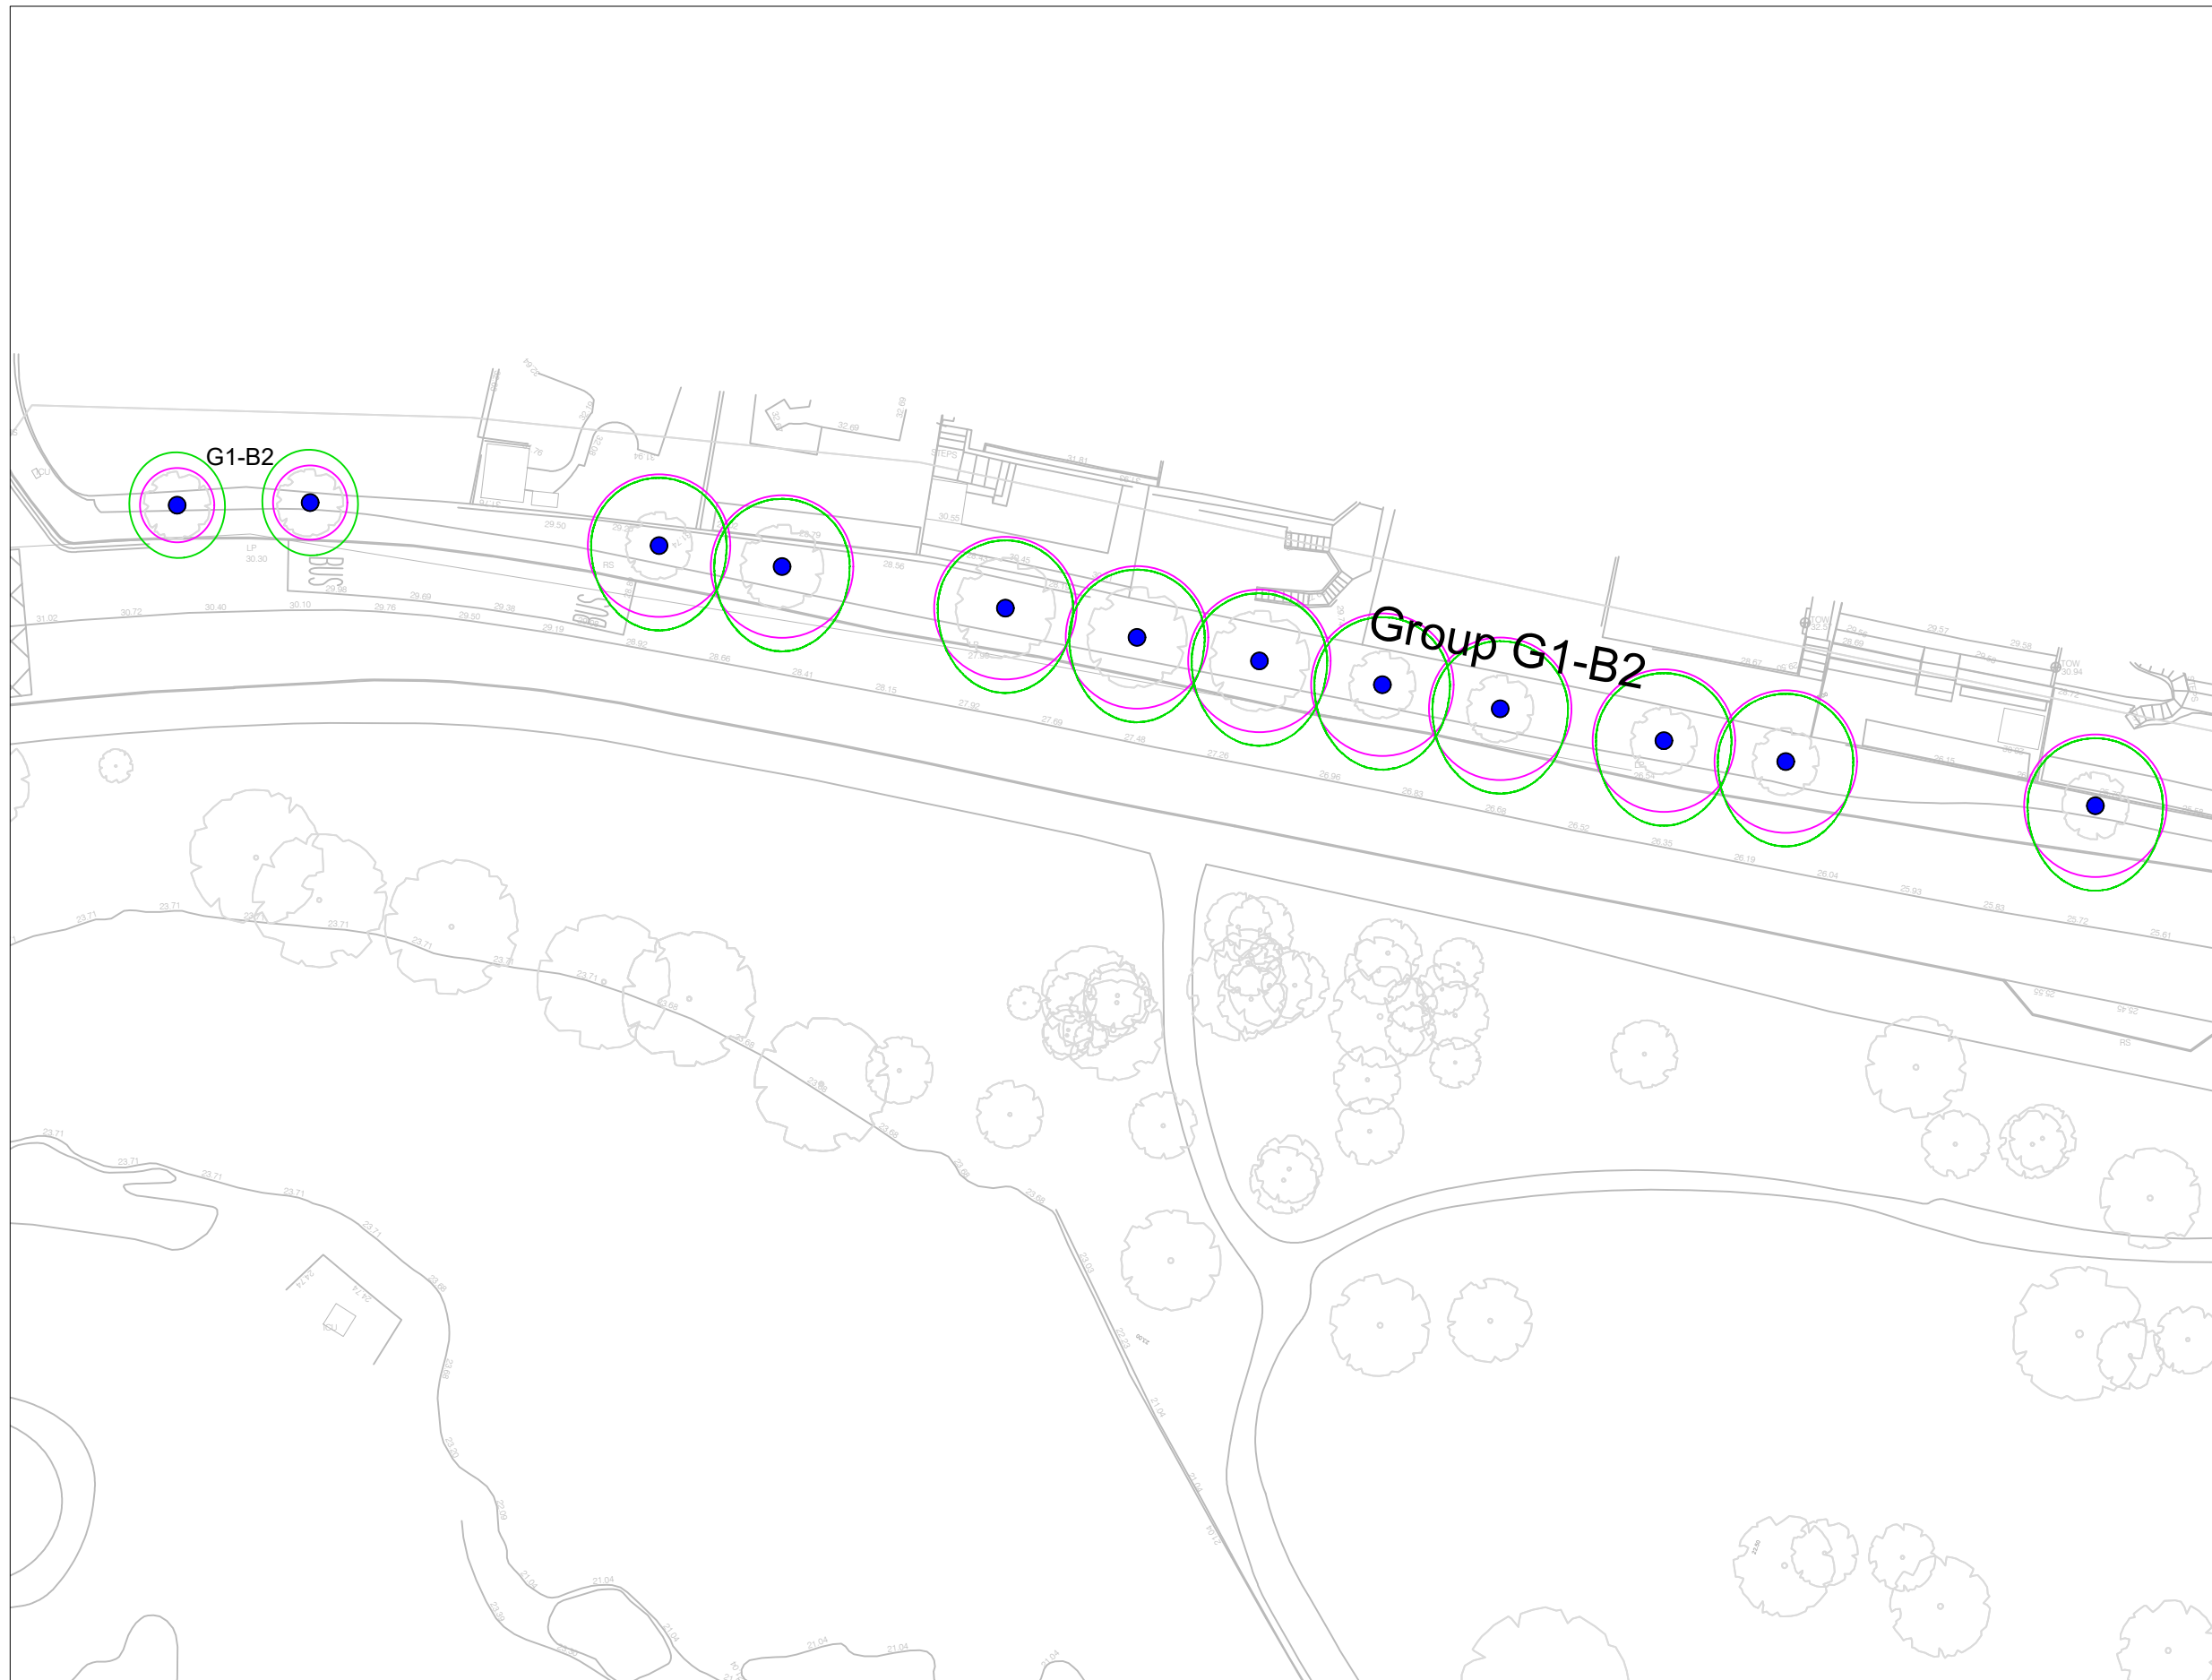
**Drawing Number:** 23007\_TS\_Site 8 Milltown Road

The trees were assessed during site visits in February and March 2023; the field data for the trees is contained in the accompanying Tree Survey Schedule in the appendices. Indicative tree location, BS5837 category, RPA and approximate crown shape are shown on the Tree Survey/Constraints Drawings 23007\_TS sheet 8.

Type	No.	Species	Age	Ht m	Dbh mm	St	Cr	N	S	E	W	ERC	Phys Cond	Structural Condition/Comments	Preliminary Recommendations	RPA m	Cat
<b>Site 8. Milltown Road</b>																	
G	1	Carpinus betulus (Hornbeam)	EM	10	350	1	2.4	4	4	5	4	20+	Good	Good/Fair. Linear group of 12 small/medium sized trees in grass verge. Varying stem diameter. with most 300 to 350mm dbh and 2x smaller trees to west 180mm dbh. 8 to 12m tall. Some branches restricting street light and interfering with overhead powerlines.	Prune tree clear of overhead ESB wires.	4.2	B2
