Proposed Tree works Brickfield Park, 2021

14th January 2021

In 2020, the Council's Tree Officer carried out a survey of trees in Brickfield Park. This is the first such survey of trees in this park. It is an action of the Dublin City Council Tree Strategy 2016-2020 to survey and create a baseline inventory of urban trees in public ownership with the goal of ensuring the City has a good and healthy urban forest which includes woodlands, copses and individual trees whether in open spaces or streets. A healthy tree population is important both for public safety and the multiple benefits for people and the environment that trees provide.

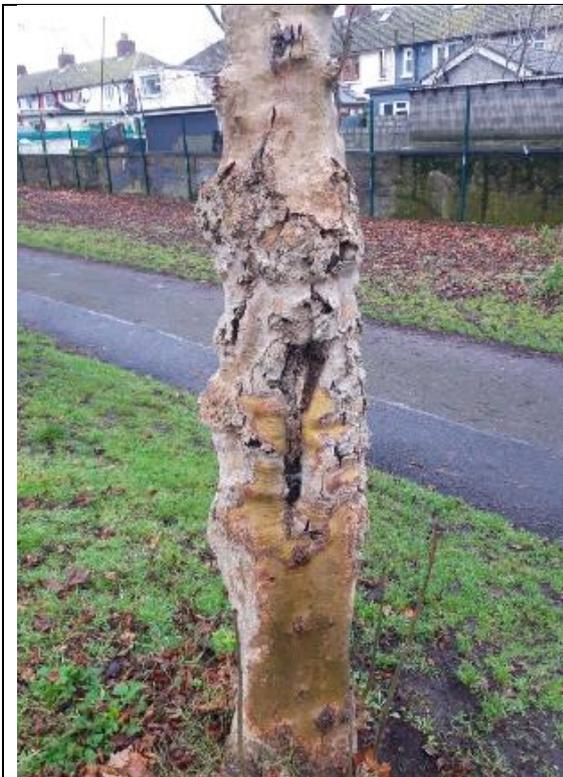
Ash Tree. Number: 01KP

3 *Fraxinus excelsior* (Ash Trees) will be removed due to a disease called Bacterial Canker of Ash. It is caused by the bacteria *Pseudomonas syringae ssp. savastanoi pv. Fraxini* and it is not related to Ash Dieback disease. Previous wounds are invaded by the pathogen which develops into lesions that may exude a sticky fluid. Over time the bark dies and peels back. In some cases, trees with Bacterial Canker live for many years and be hardly affected; others develop large lesions and fail especially if the lesions ring the trunk or branch.

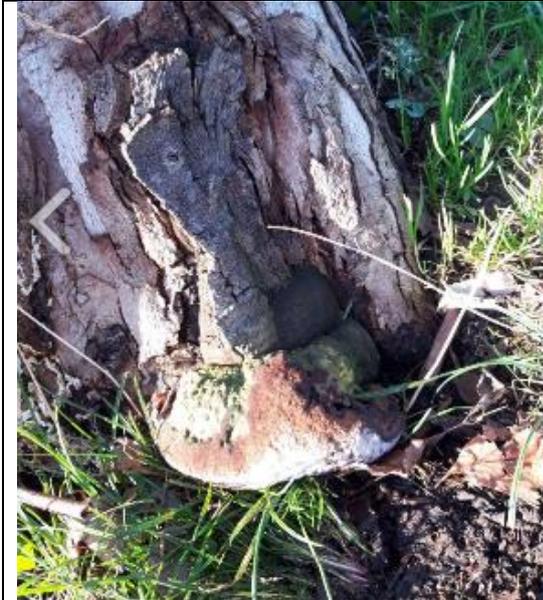
2) Tree with fungal infection: Eucalyptus (tree 01AM) with Ganoderma australe fungi.

Ganoderma australe is a perennial woody fungus bracket. It can extend from damaged wood to previously sound sapwood. When advanced and extensive, the decay can result in failure of the stem, base and rootplate. The presence of 2 brackets shows that the fungi have started to successfully colonise the base of the tree. As the tree is located beside a playground, as the Eucalyptus is a brittle species in Ireland, and due to the fact that the tree has basal wound and codominant stems, the removal is inevitable.

Ganoderma australe (first bracket)

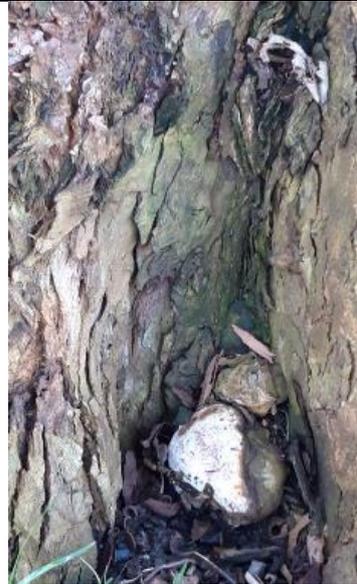
Immature form of *Ganoderma australe* (second bracket)

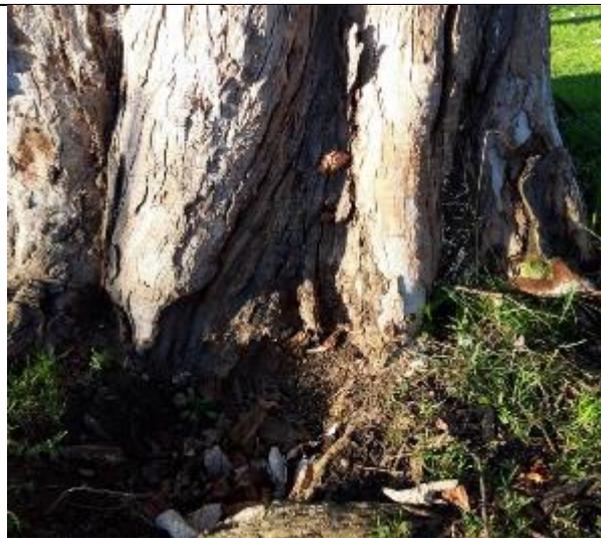
Basal wound and *Ganoderma* brackets

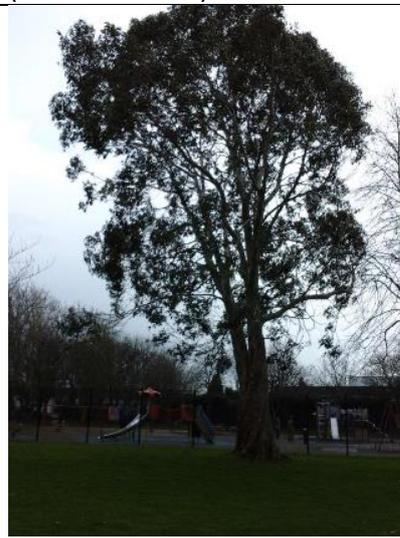
Tree with compression fork, codominant stems, basal wound, and fungi beside playground.

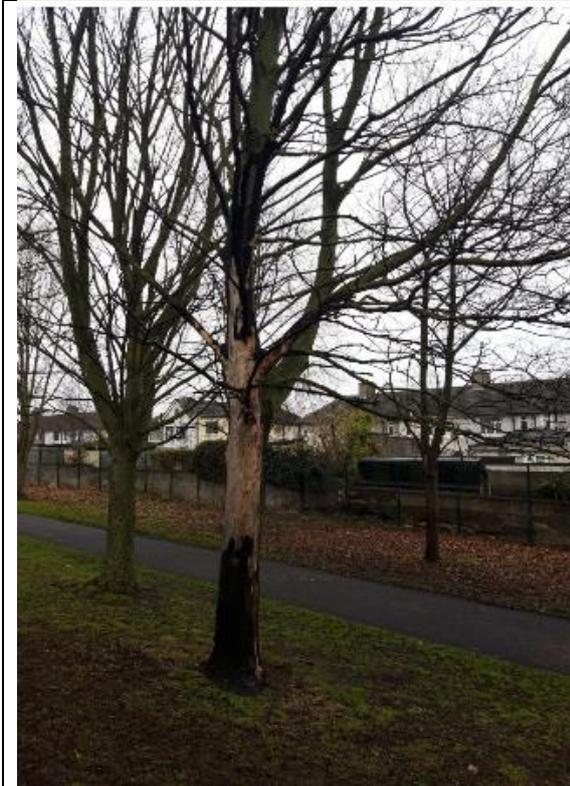
The inventory noted that 11 trees have been severely burnt by fires lit at their bases. The damage done is so extensive that the trees have to be removed.

Norway Maple Extensive damages due to fire.
Tree Number 01KS

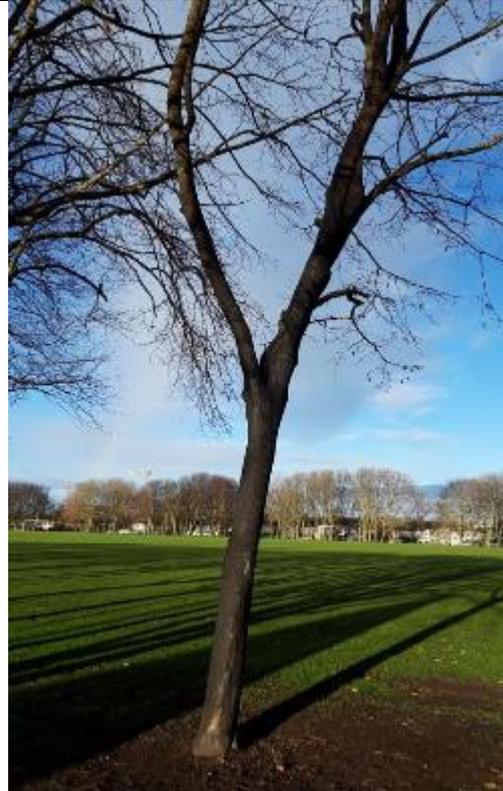
Lime tree, entirely scorched. Tree Number
01KA

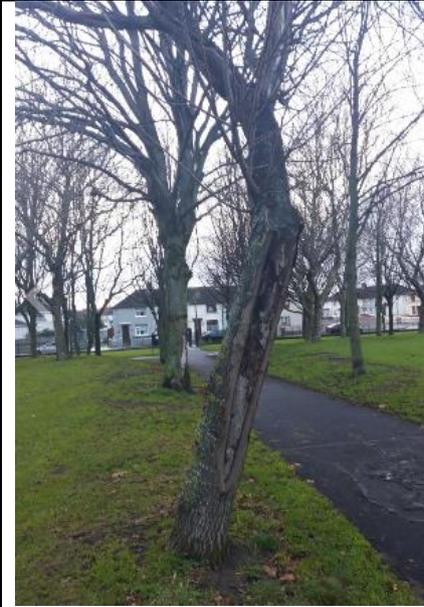
Lime tree. Tree Number 01K8

The inventory has uncovered 36 trees with large cavities associated with extensive decay and leading to dieback and decline. The origins of the wounds are not clear but it is likely that vandalism has been a major issue.

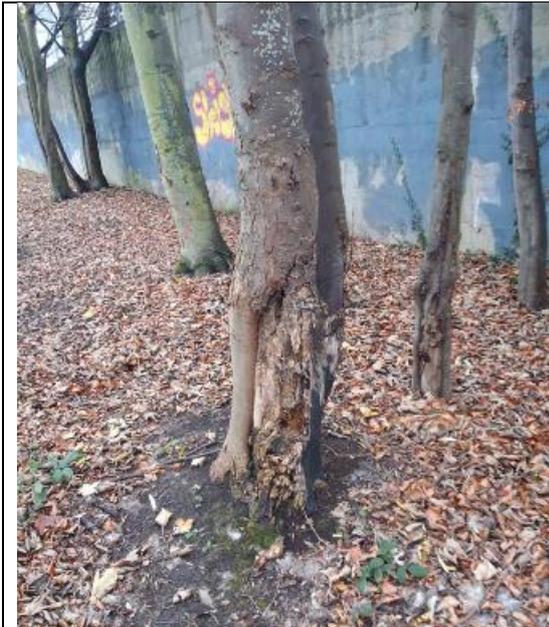
Beech tree. Cavity with extensive decay. Tree number 01J7

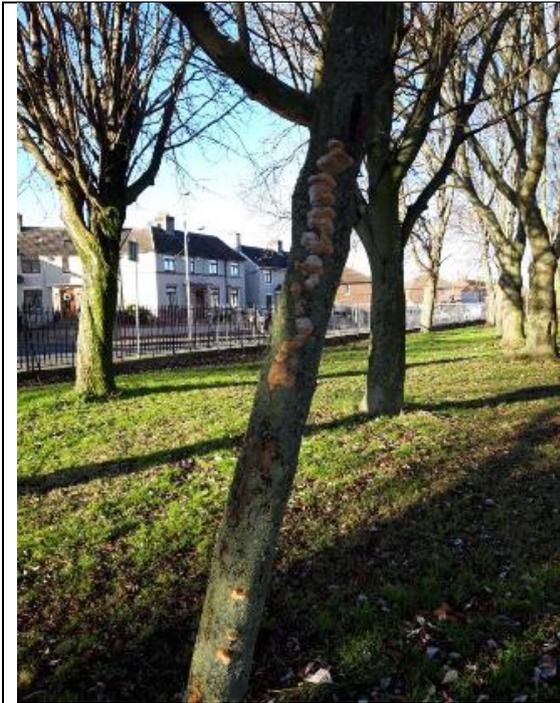
Prunus cerasifera nigra. Tree 01KJ

The inventory found 6 dying trees, notably 2 *Prunus cerasifera nigra* with fungal infection (*Phellinus pomaceus*). The reason for the decline of the other 4 trees is likely to be due to them being on the losing side of competition for light and water.

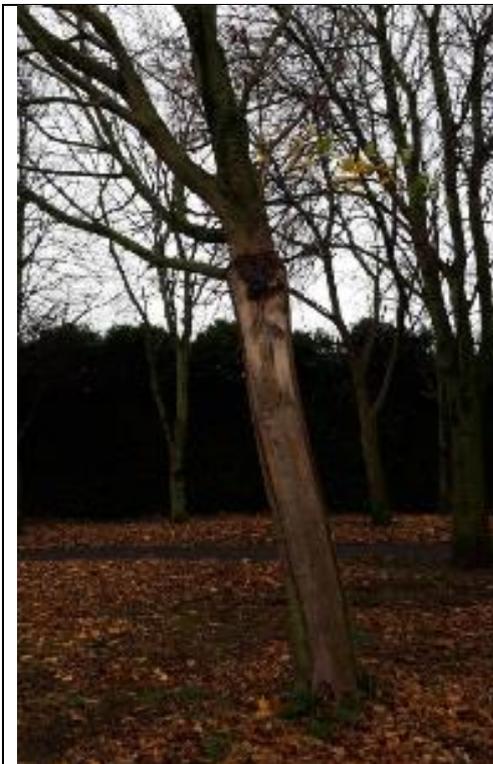
The assessment found 4 trees which suffered catastrophic damages during wind events. All 4 are Norway maples (*Acer platanoides*) which lost major limbs as a compression fork failed.

Norway maple has broken in 2 when compression fork failed during high wind
Tree Number 01HS

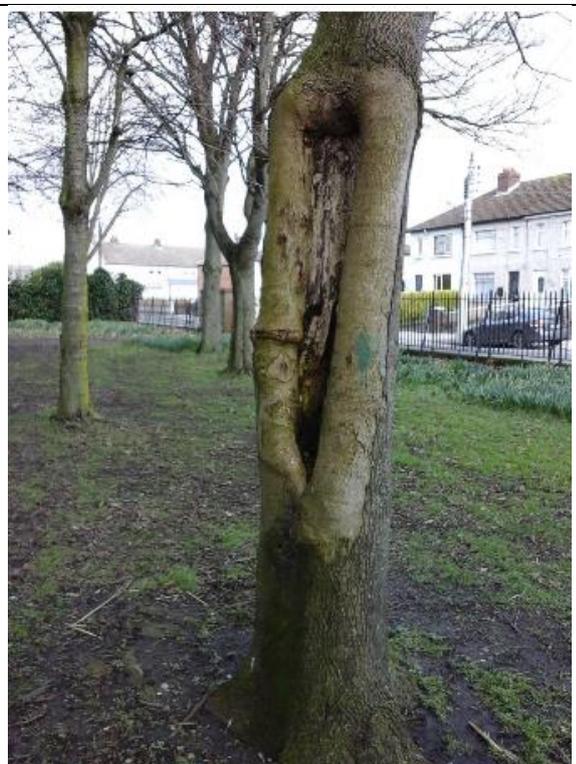
Norway maple with large cavity and decay due to compression fork failure during high wind
Tree Number 01HS

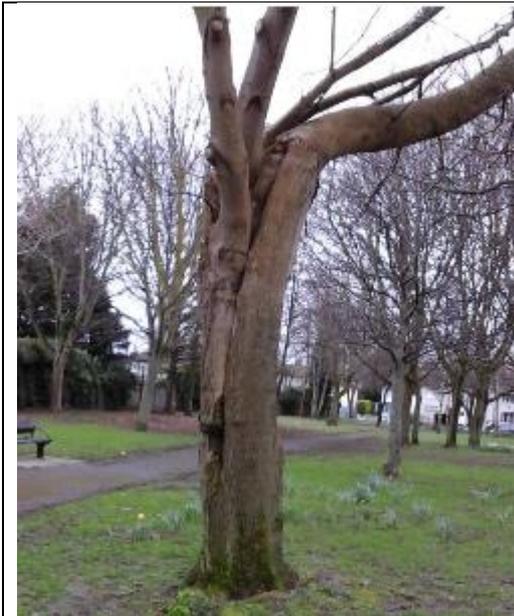
Norway maple compression fork failure.
Tree Number 01Ak

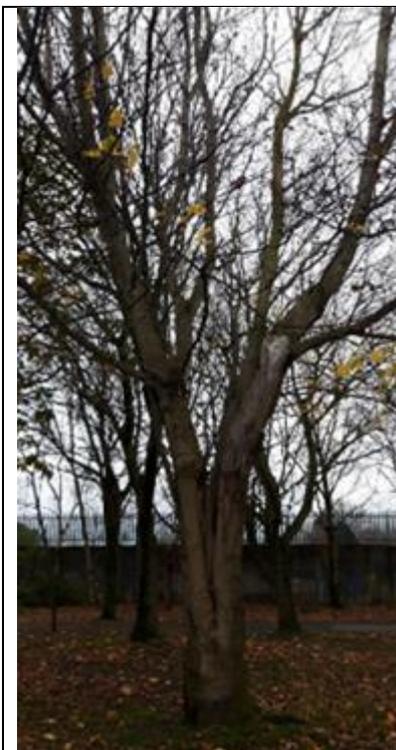
During the assessment, 8 trees were found with advanced stage of compression fork with included bark. Compression fork with included bark is a V-shaped narrow fork in which continued radial growth results in pressure which tends to push the limbs of the fork apart and lead to limb failure. This structural defect is common in Norway maples.

Large Norway maple splitting in 2. Tree Number 01HZ

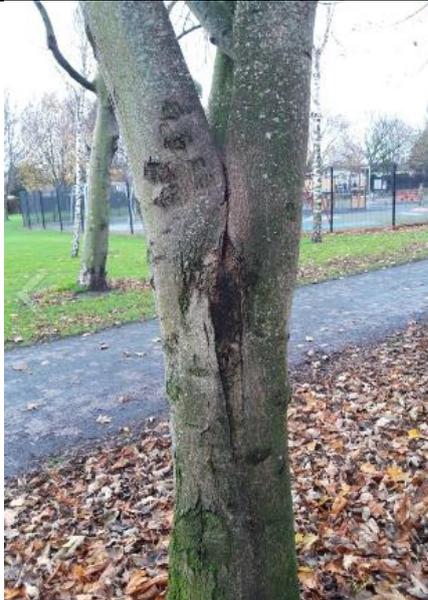
Norway maple with compression fork starting to split. Tree Number 01HP

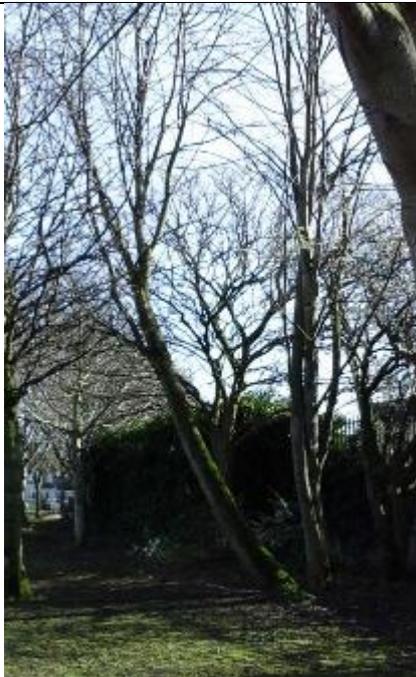
While trees can “correct themselves” by developing a balancing canopy, 2 Trees will have to be removed as the lean is too advanced and due to their locations close to paths and playgrounds.

Beech tree with extensive lean close to footpath. Tree Number: 01B5.

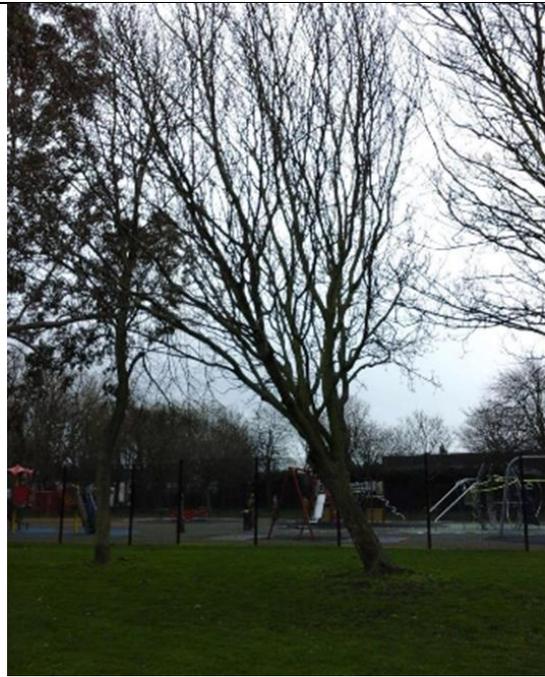
Sorbus aria with severe lean beside playground
Tree Number: 01AL
