Tree Survey & Arboricultural Impact Assessment Report

Sandyford Clonskeagh to Charlemont Street
Pedestrian & Cyclist Scheme
Ranelagh
Dublin

25 January 2023 6955RP01

Tree Survey and Arboricultural Impact Assessment Report

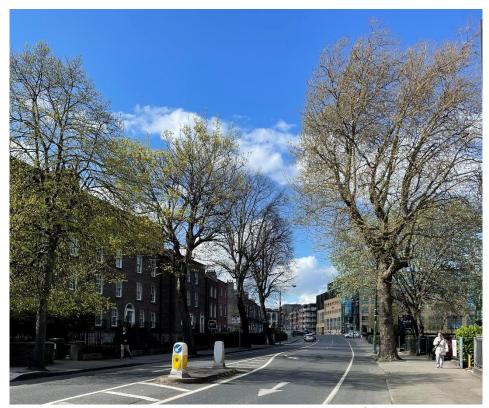
Photo 1. Mature street trees along Ranelagh Road in the northern part of the survey area (London Plane tree T4 is on the right)

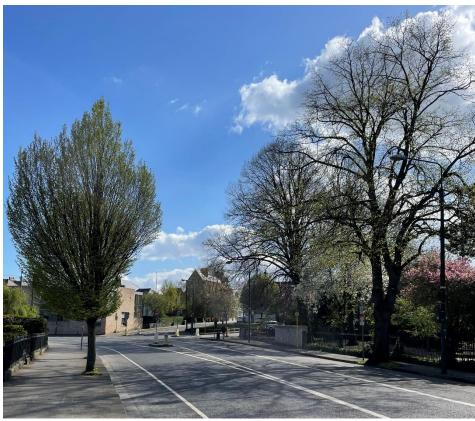
Photo 2 Mature street and parkland trees at Mountpleasant Square Park

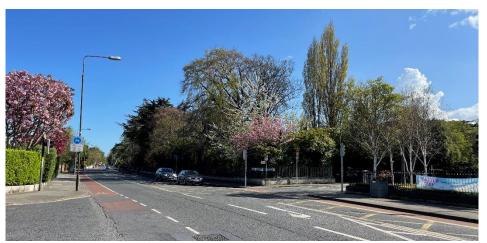
${\it Photo 3. Mature trees making up woodland area W1 on Clonskeagh Road (Sandford Terrace)} \\ {\it seen from the north}$

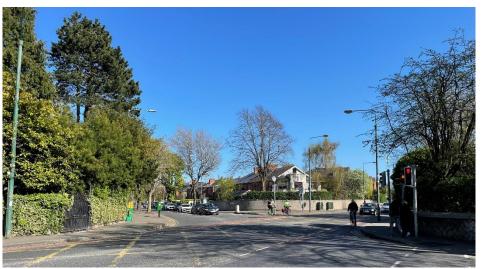
4. Mature trees in group G6 on left, with mature street trees T107-109 in the centre

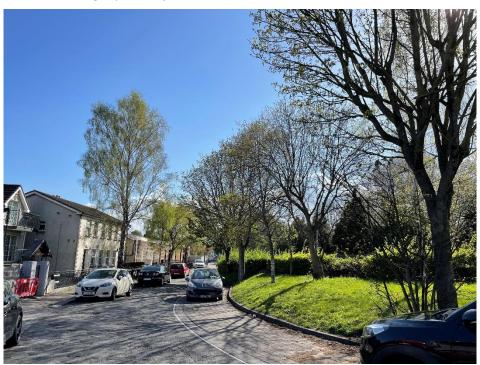
$5.\ Trees\ in\ small\ green\ space\ and\ streets cape\ outside\ Ashton's\ Pub$

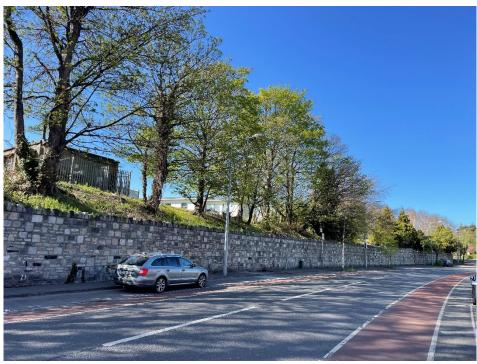
6. Mature Beech and Sycamore trees within the grounds of Clonskeagh Hospital (group G12)
