# **Chestnut Avenue, St Anne's Park: Tree Care Programme**

Ludovic Beaumont

Dublin City Tree Officer

20/02/2023

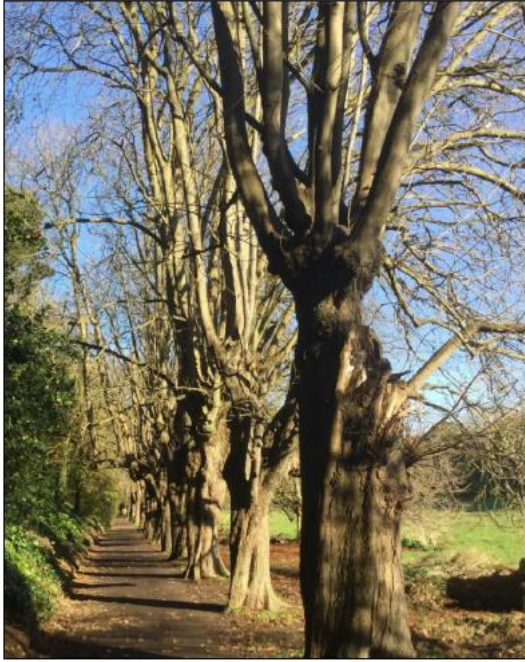
*The majority of the thirty trees are lapsed pollards, having been cut decades ago, and been allowed to grow extended and heavy limbs from the original pruning points. Trees at the north eastern end of the avenue are maiden specimens – trees that have not been pruned or worked in the past. A defining characteristic of the avenue are the hollowing stems, they contribute great character and a sense of antiquity to the avenue as well as numerous opportunities for wildlife.*

**Figure 11.** Avenue of lapsed pollard horse chestnut between park footpath and meadow.

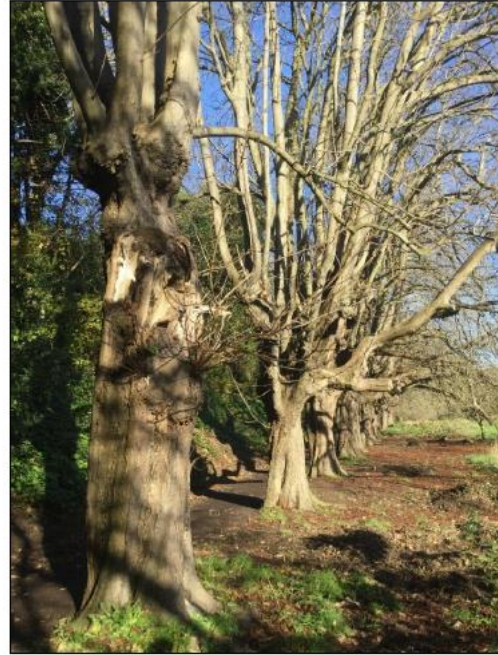
**Figure 12.** Long heavy limbs arising from bolling points of horse chestnut with decay and failures.

*There is evidence of limb failure within the main crown scaffolds and a number of gaps from root plate failure exposing the shallow soils overlaying sand. The stems also show scattered bleeding points, a bacterial infection known as Horse Chestnut Bleeding canker (*Pseudomonas syringae* pv. *aesculi*) which leads to bark death followed by death of the vascular cambium. This can prepare exposed, aerated wood for further decay by secondary decay colonisers such as decay fungi.*

*The main concern is the increasing likelihood of mechanical failure from heavy branches attached to a severely decaying pruning point. Given the high occupancy of the area, there is a need to lower the risk of crown and root plate failure by significantly reducing the height of the canopy. However, a balance needs to be struck between removing enough material to reduce biomechanical stress to prevent failure and limiting the removal of leaf mass to that to which the tree can reasonably tolerate.*

The reduction in crown volume recommended should ideally be staged over a number of years in a process known as retrenchment pruning. However, due to the length of time since they were last pruned, there is an obvious and urgent need to avert continued failures, not just from a tree risk management perspective but to prevent further failures ensure the longevity of this important historic landscape feature. Legacy planting within this area will be important to maintain the cultural continuity of an avenue in some form. Species other than *A. hippocastanum* should be considered such as an Elm cultivars and clones (e.g. *Ulmus lutece*, *Ulmus lobel*). Trees could be replaced in gaps as they arise or better still, a new continuous avenue of trees planted some 10m to the south of the existing line.

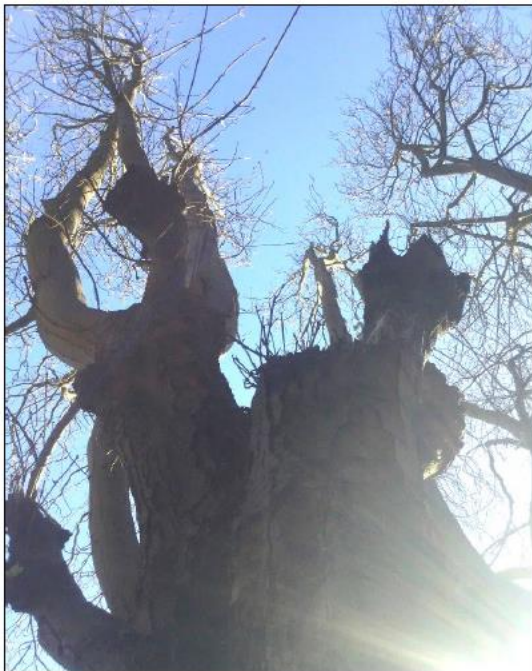
**Figure 13.** Long heavy limbs arising from bolling points of horse chestnut with decay and failures.

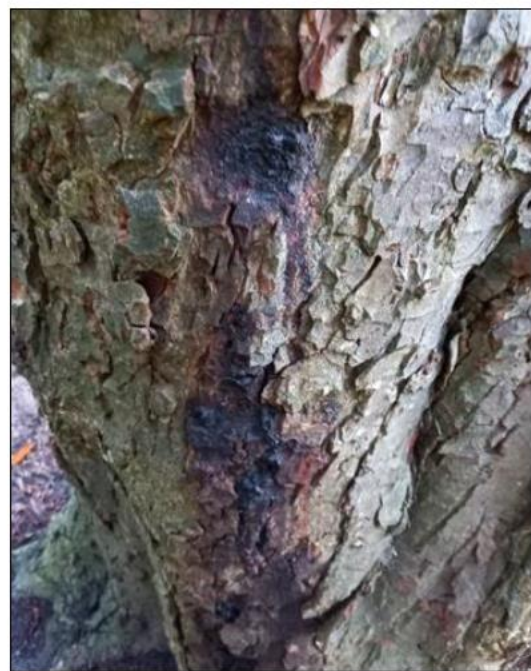
**Figure 14.** Horse chestnut Bleeding canker (*Pseudomonas syringae* pv. *aesculi*) on stems.

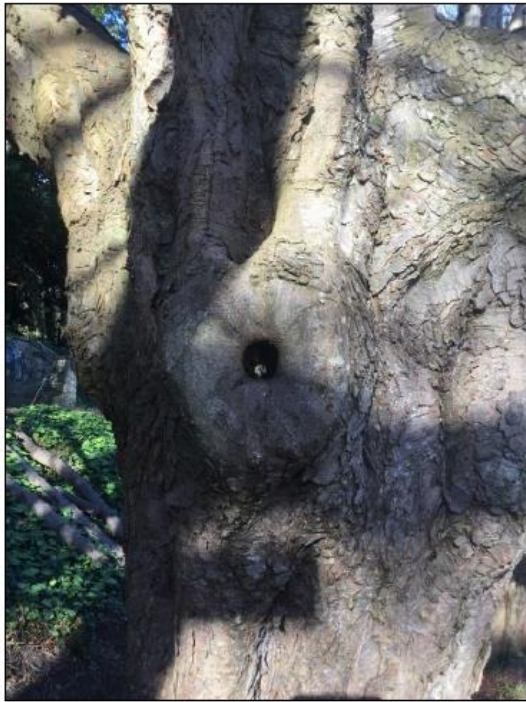
Figure 15. Occluding stem wound offering nesting opportunities for birds and bats.

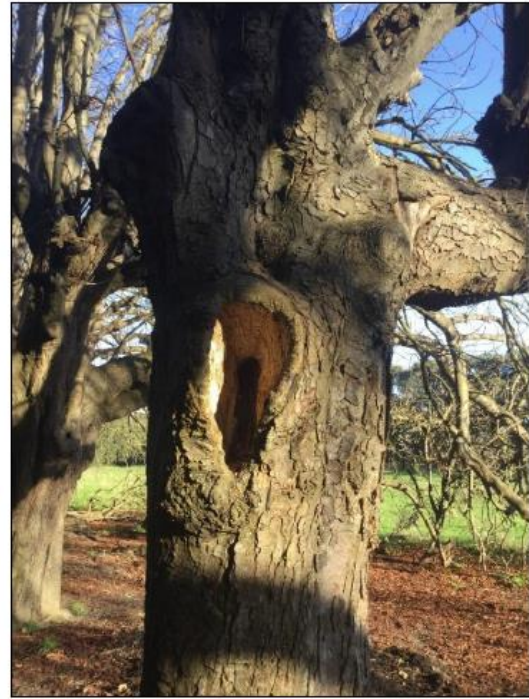
Figure 16. Occluding stem wound offering nesting opportunities for birds and bats.
