Dublin 8: 2023 Tree Care Programme

By Ludovic Beaumont. Dublin City Tree officer.

30/01/2022

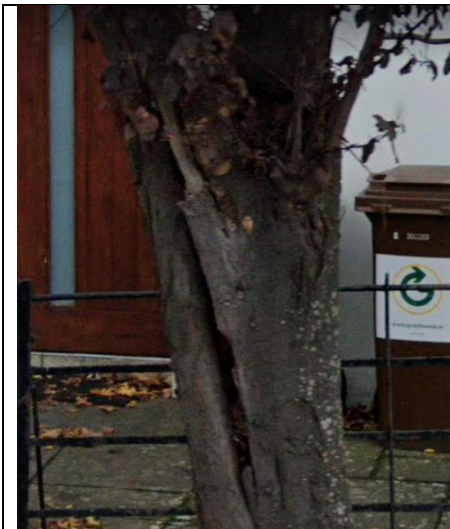
In Clarence mangan Road, the five trees that were recently removed are all *Prunus Cerasifera Nigra*. In all cases, the reason for the removal was an infestation of the decay fungus *Phellinus pomaceus*. *Phellinus pomaceus* is not a particularly aggressive fungus but as it spreads through the heartwood and eventually into the sapwood, extensive sections of the tree canopy become brittle and will snap. The *Prunus Cerasifera Nigra* at number 77 had also another decay fungus growing on it (*Ganoderma spp.*). All the trees were suffering from crown dieback as the consequence of the infestation and were in physiological decline.

Tree at number 77. The amount of decay is clearly visible in the cavity. One of the main limb has already snapped

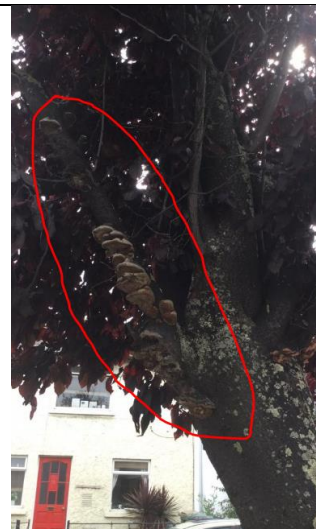
Tree at number 55. *Phellinus pomaceus* infestation.

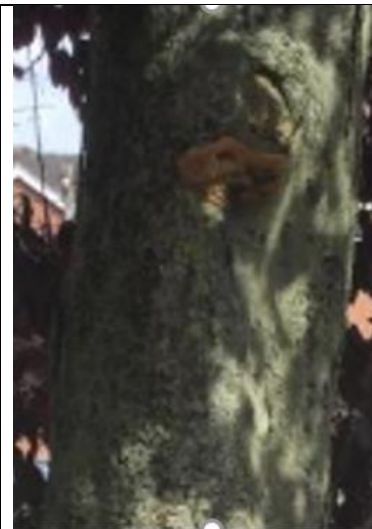
Tree at number 68. *Phellinus pomaceus* infestation.

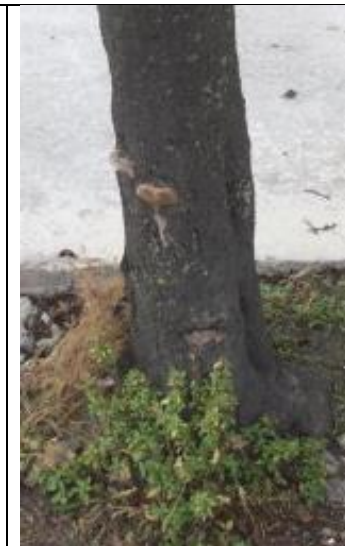
Tree at number 57. *Phellinus pomaceus* infestation.

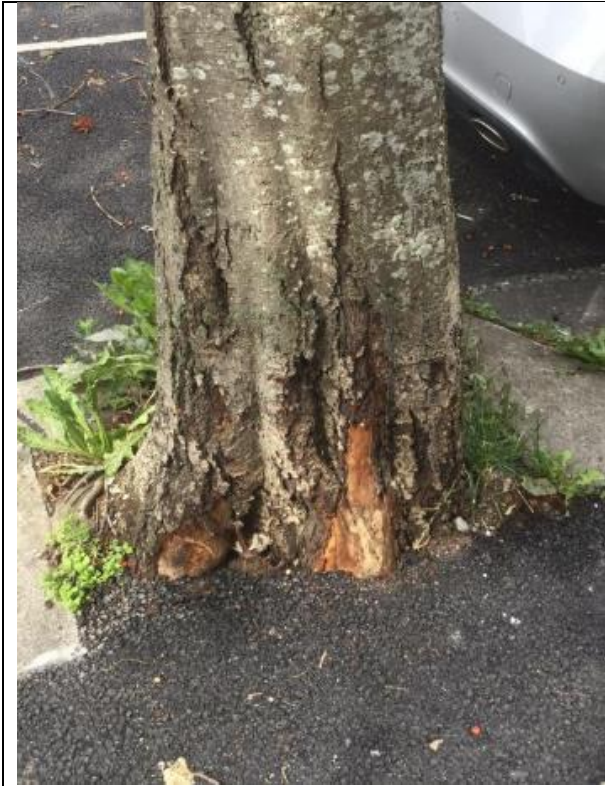
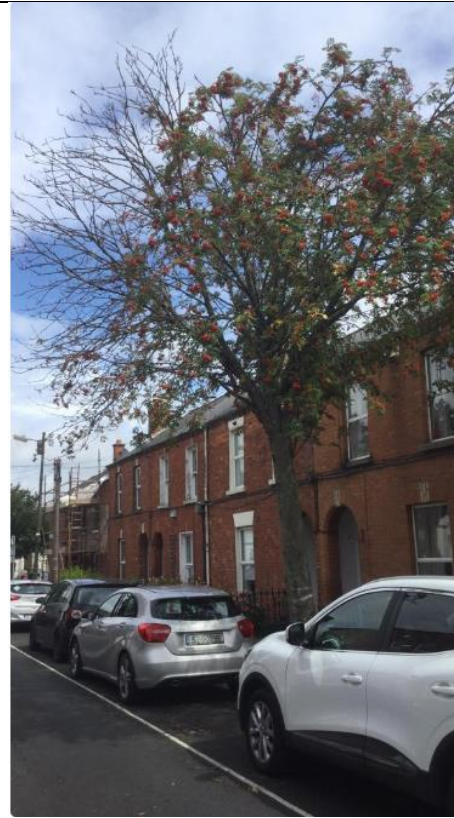
33/34 Greenville Terrace

The tree is a rowan (*Sorbus aucuparia*) in poor condition with basal stem/root decay with cavity. Decay fungus *Ganoderma spp* was also found. There was a codominant limb failure in lower crown and severe crown dieback over road. The tree is in decline.

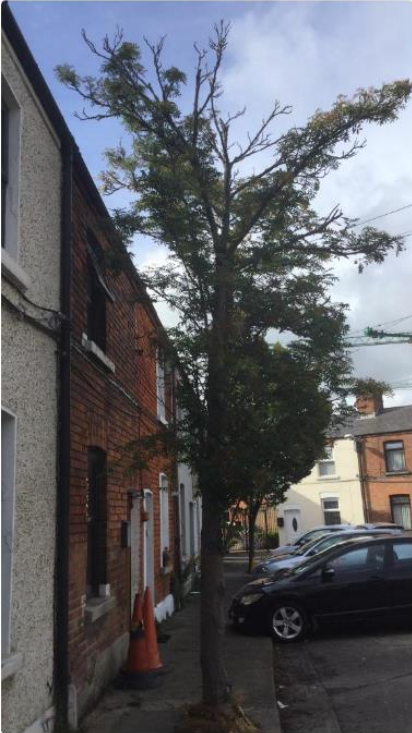
27/28 Hammond Street

The tree is a rowan (*Sorbus aucuparia*) in poor condition , with extensive dieback and in decline.

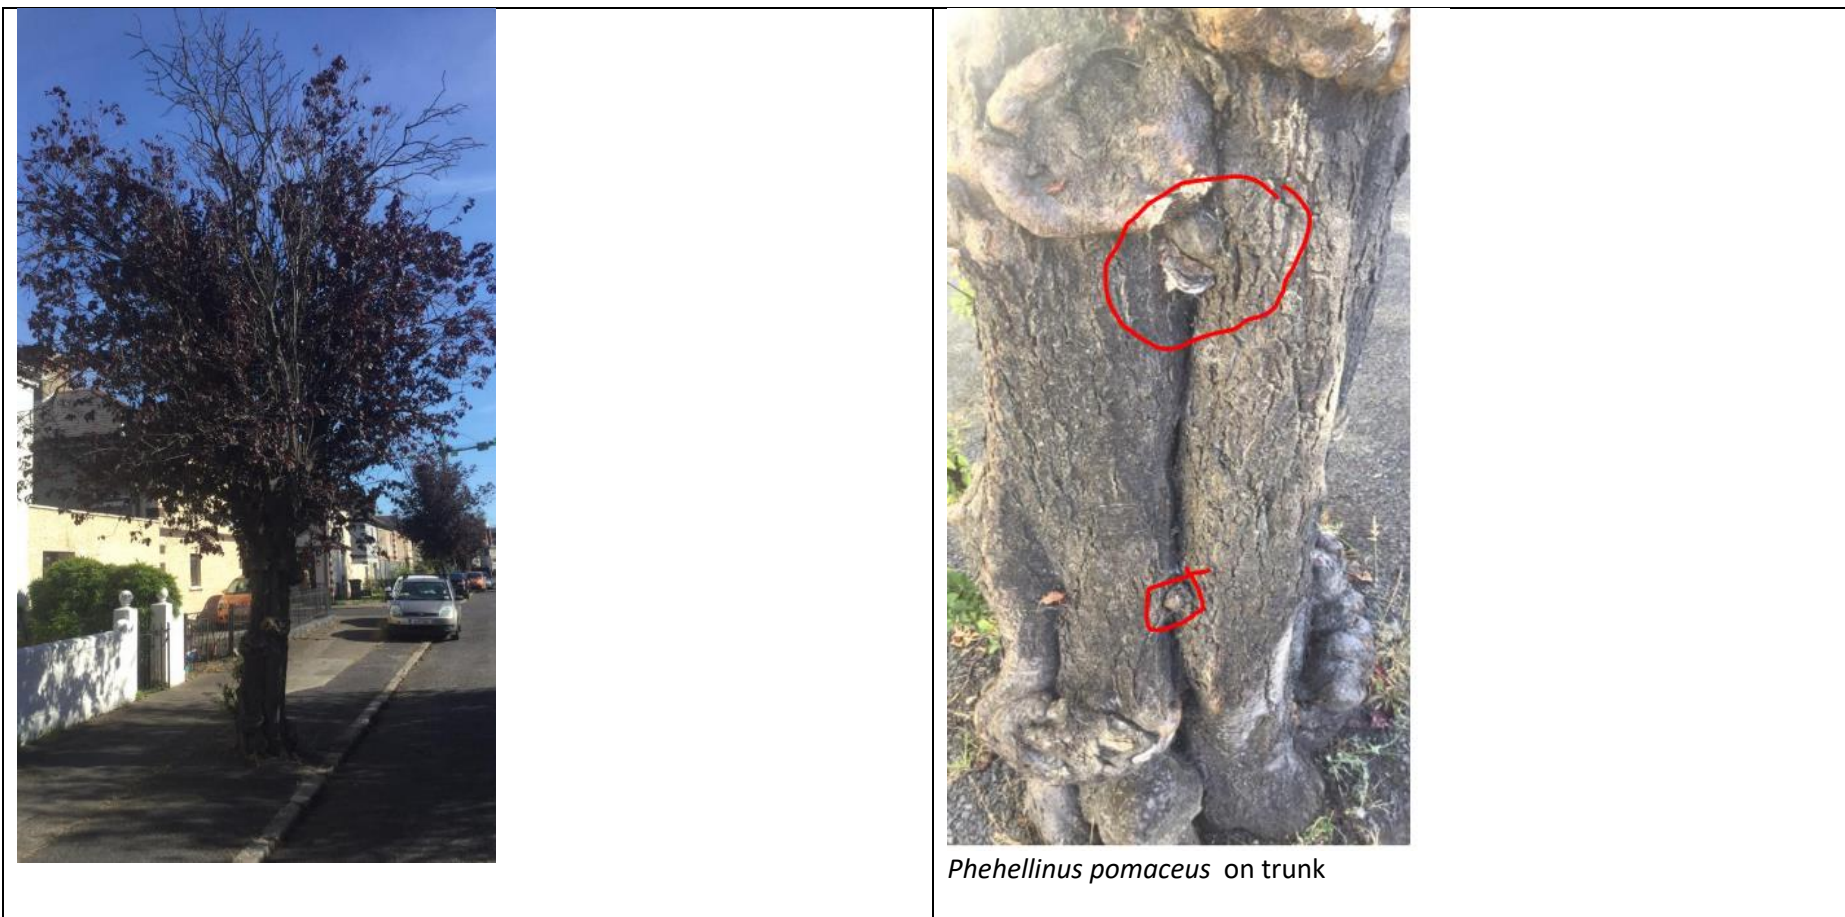
7 O'Carolan Road

This mature Plum Cherry tree (*Prunus cerasifera 'Pissardii'*) is in poor condition and in decline. It has the decay fungus *Phehellinus pomaceus* on stem and crown, as well as hollow and cavities. It is in physiological decline and limited life expectancy.

Phehellinus pomaceus on trunk

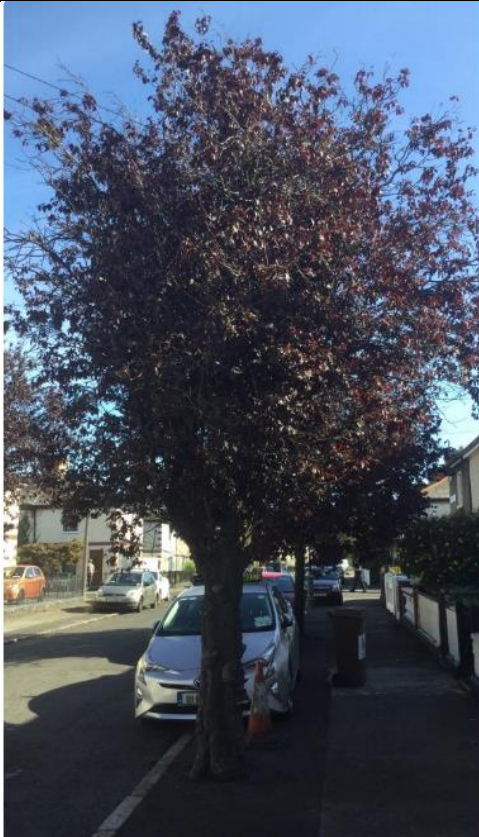
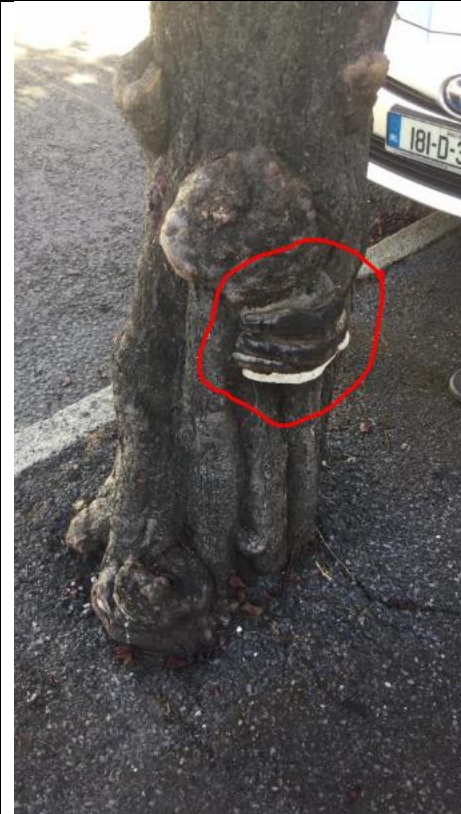
11/12 Carolan Road

This is another mature Plum Cherry tree (*Prunus cerasifera* 'Pissardii') in poor condition and decline. It has the decay fungus *Phehellinus pomaceus* as well as *Ganoderma* spp. on stem and crown. It is in physiological decline and limited life expectancy.

Ganoderma spp on trunk.
