# **Bushy Park Tree Care Programme Report (2023-2025)**

**Ludovic Beaumont**

**Dublin City Tree Officer**

**February 2023**

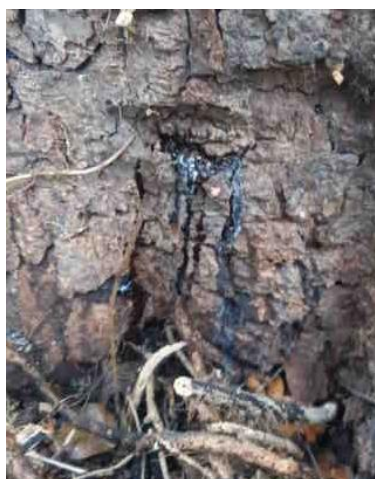
Following this report and in relation to the poor condition of the oak trees, the Horticulture & Plant Health Division of the Department of Agriculture, Food, and the Marine conducted a plant health inspection of the oak trees in Bushy Park. Inspectors found bleedings and cankers on the trunks towards ground level that could be considered disease symptom (see pictures below).

*'Bleeding' on oak tree trunk*

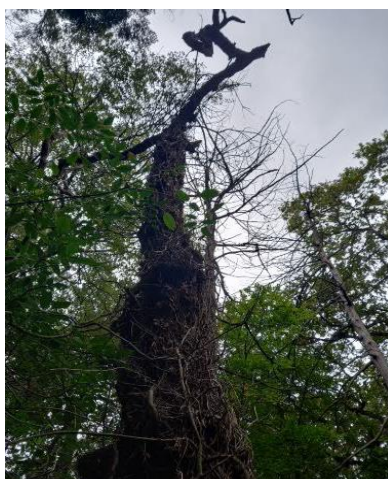
*Dead Oak Tree*

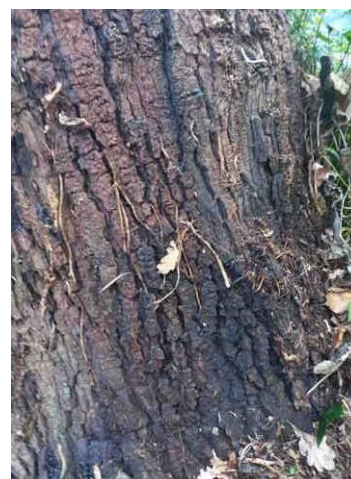
*'Bleeding' on oak tree trunk*

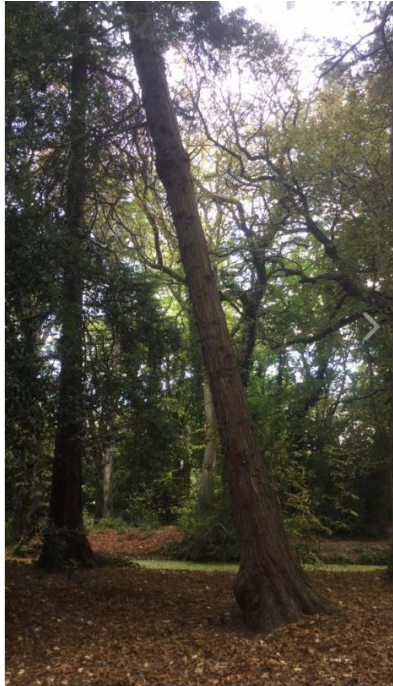
Tree 05LG: *Thuja plicata*. Removal.

Single stem, historic root plate failure with some correction but still excessive lean, basal/stem decay/cavity/hollow, previous crown failure.

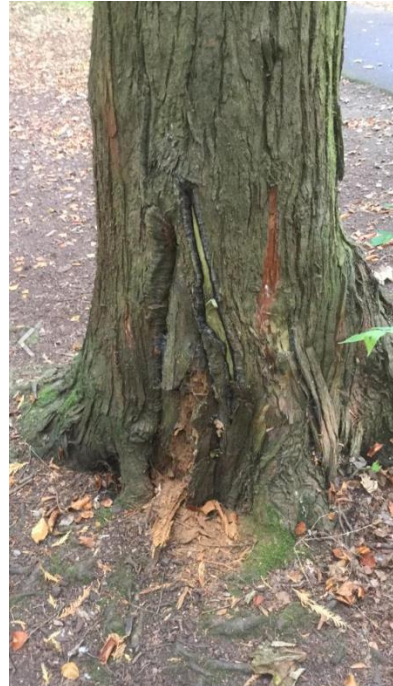
Tree 05LL: *Thuja plicata*. Removal.

Single stem, asymmetric crown, basal/stem decay/cavity/hollow with signs of cubical brown rot.

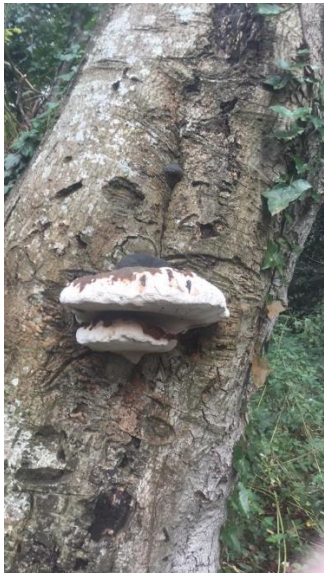
Tree 05NX: *Fagus sylvatica*. Monolith.

Dead tree located near informal footpaths, fungus *kretzchmaria* present at base, fungus *Ganoderma australe* present on stem, porcelain fungus present on stem suggesting all of tree is dead.

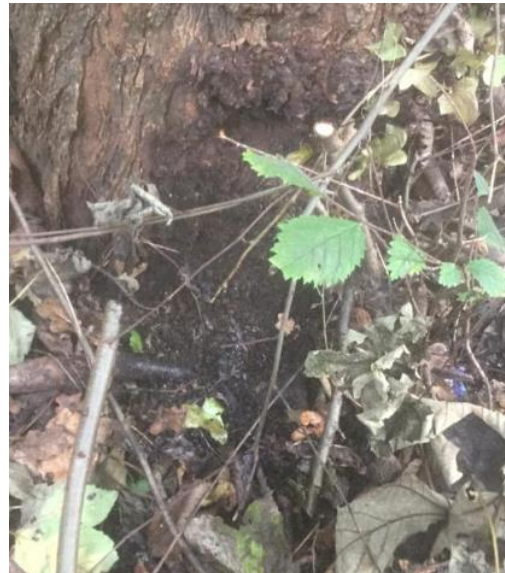
Tree 05PP: *Whych Elm*. Removal.

Dangerous decay fungus *kretzchmaria deusta* at base, tree heavily in decline.

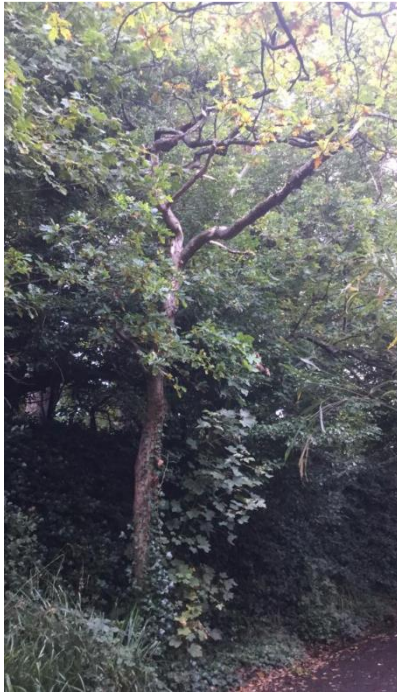
Tree 05QQ: *Quercus robur*. Removal.

Single dead stem by path.

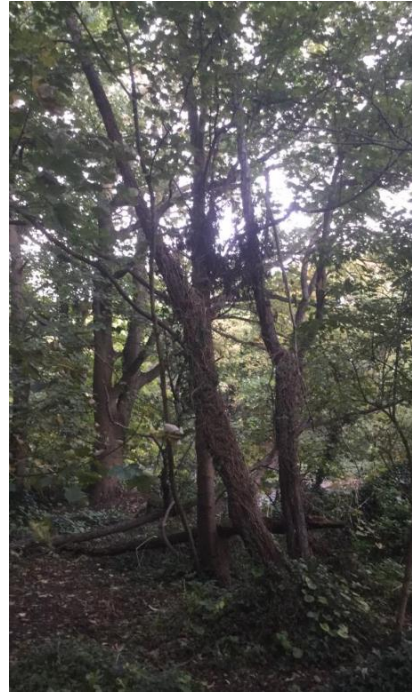
Tree 05R5: *Alnus glutinosa*. Removal.

Two stems, third has failed, cavity/decay/hollow stems with cracks.

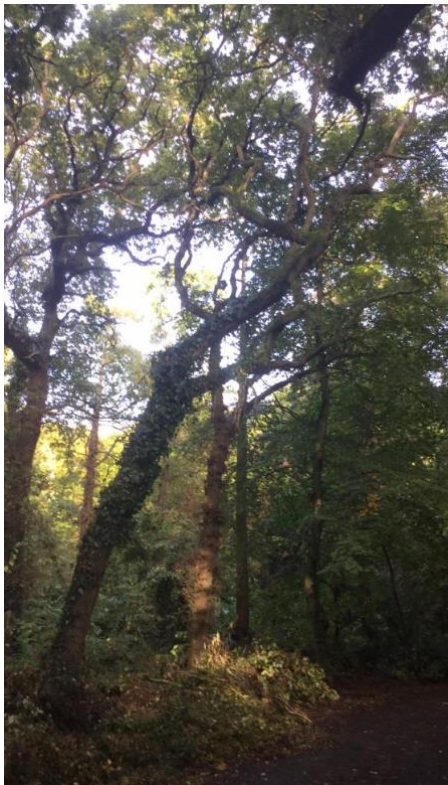
Tree 05V0: *Quercus robur*. Removal.

Single dead tree.

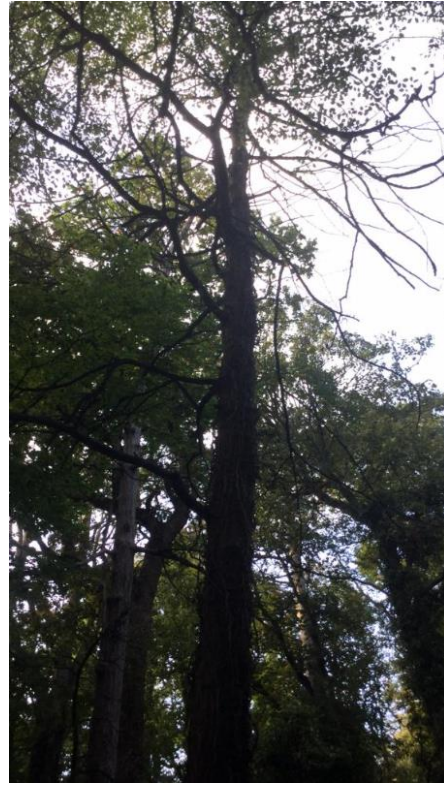
Tree 05V1: *Larix*. Removal.

Dead Larch tree.

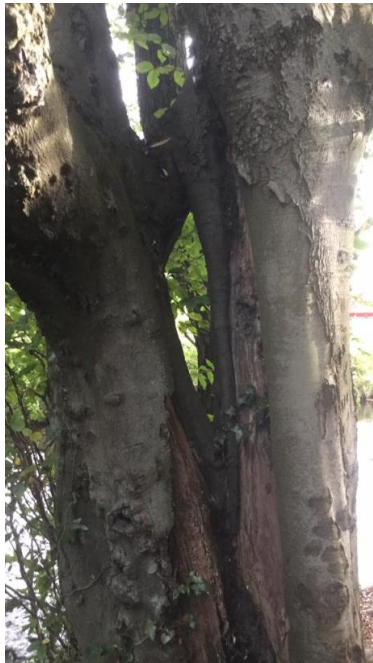
Tree 05QG: *Fagus sylvatica*. Monolith.

Three stems from 1m, basal/stem wound likely caused by loss of fourth stem, extensive decay and fungi.

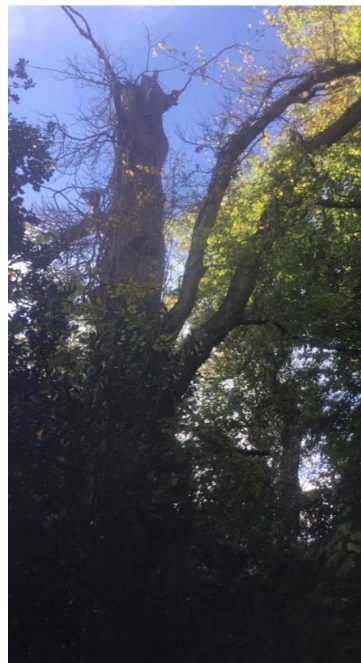
Tree 05N4: *Fagus sylvatica*. Monolith.

Tree has lost main leader resulting in heavily asymmetric crown, extensive decay on main stem from base to approx. 1.5m, decay can be seen in stump from lost leader.

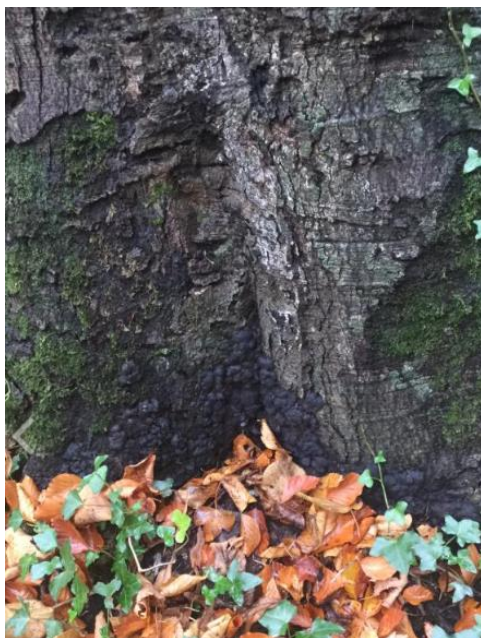
Tree 05NN: *Fagus sylvatica*. Monolith.

Two stems, broad spreading crown, dangerous decay fungi *kretschmaria deusta* at base, severe dieback and deadwood.

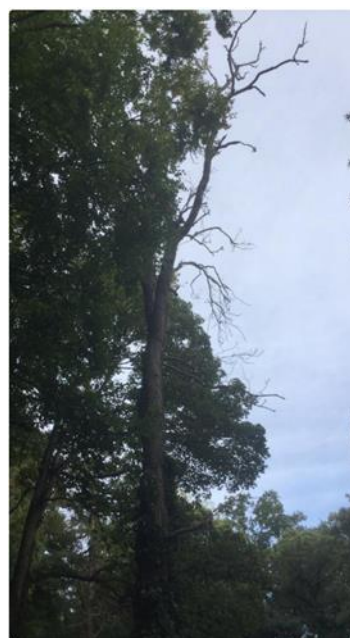
Tree 05LN: *Fraxinus excelsior*. Monolith.

Single stem dead tree with broad spreading crown by lake bank.
