CRUMLIN VILLAGE

Architectural Conservation Area Report

Character Appraisal And Policy Framework

This assessment of the special character of Crumlin Village Architectural Conservation Area was prepared in 2013 by Lotts Architecture and Urbanism. The study was commissioned by Dublin City Council.

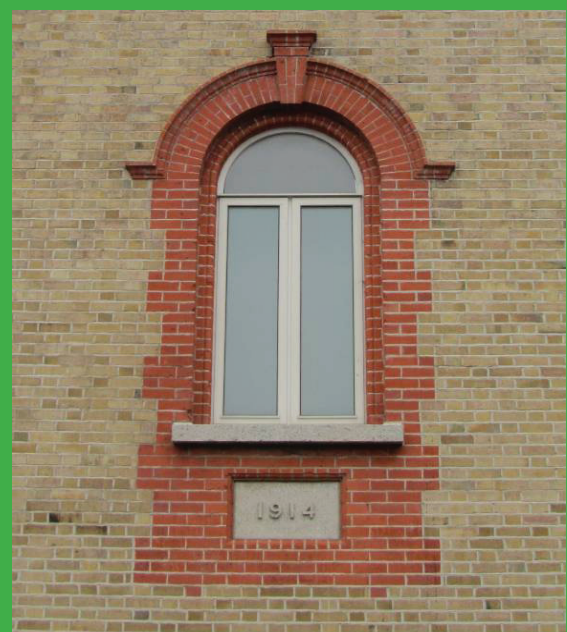
Fig. 22: Brick façade of former national school

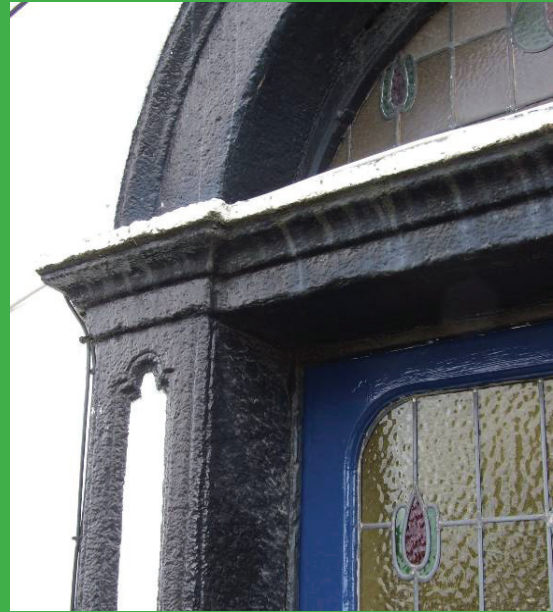
Fig. 25: Decorative stonework to the entrance of the former Glebe House

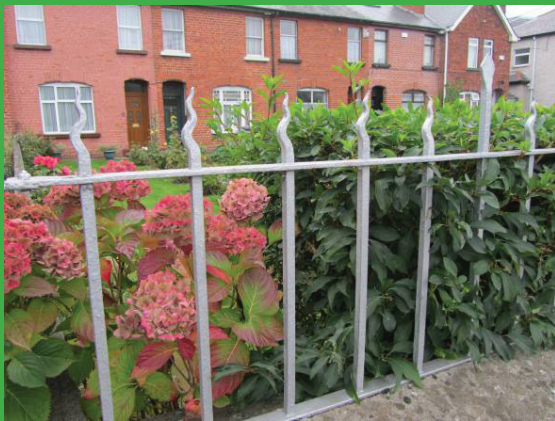
Fig. 29: Metal railings on plinth walls to row houses

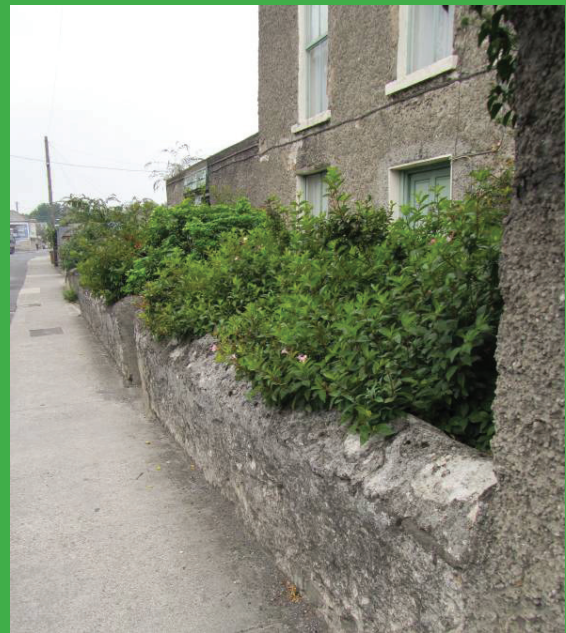
Fig. 31: Rendered rubble stone wall and piers

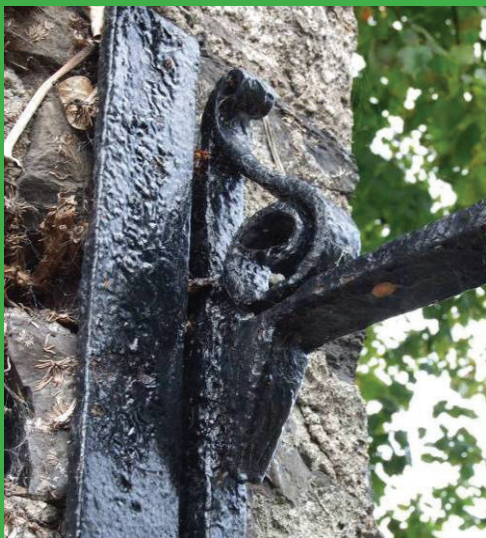
Fig. 34: Detail of metal gates to grounds of former St. Mary's church

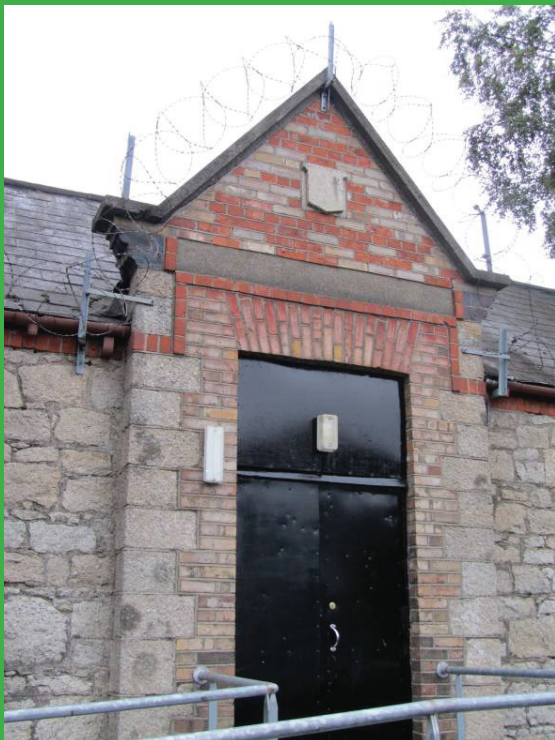
Fig. 46: Detail of main entrance of former parochial school

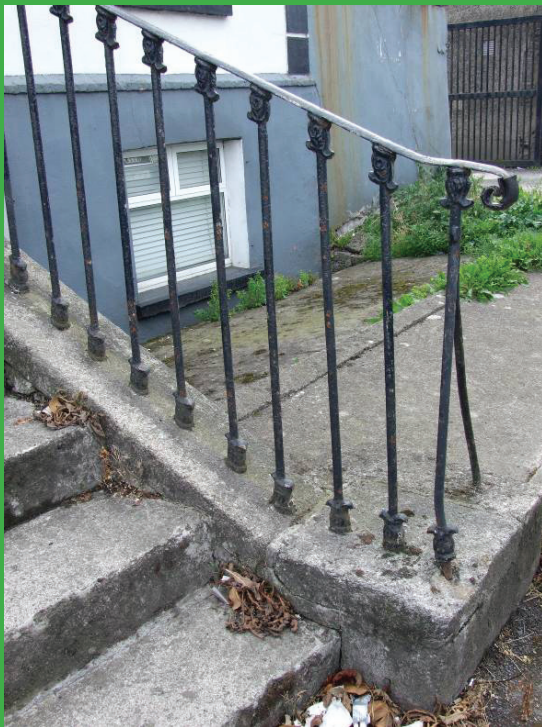
Fig. 53: Detail of steps to former Glebe House

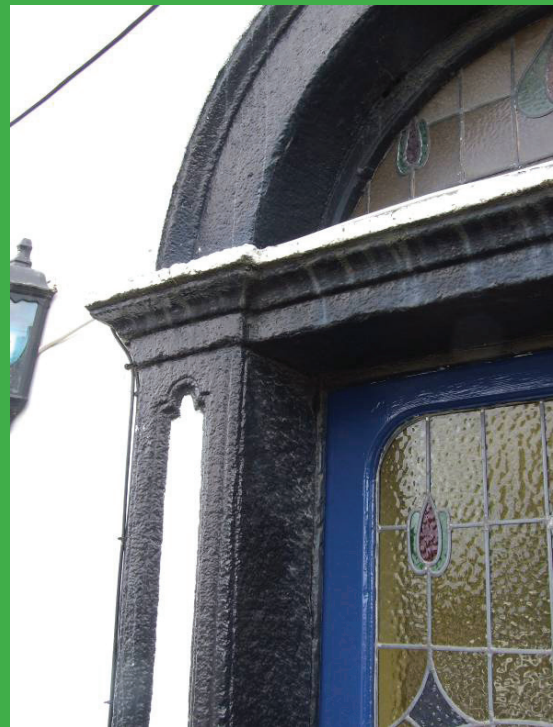
Fig. 54: Detail of main entrance of former Glebe House

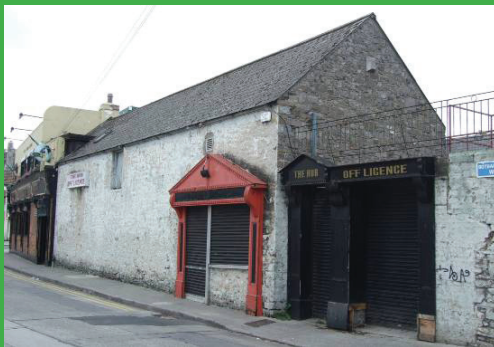
a pitched roof with replacement slates and has rubble-stone walls. This structure gives good character definition to the Windmill Road.

Fig. 58: Building to rear of public house on Windmill Road

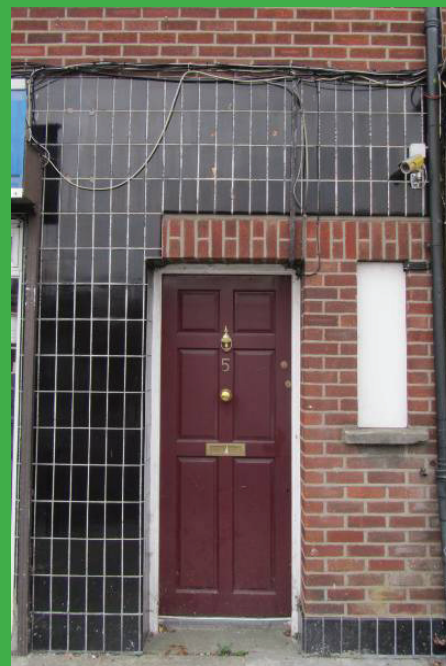
Fig. 61: Detail of entrance in terrace to upper floor

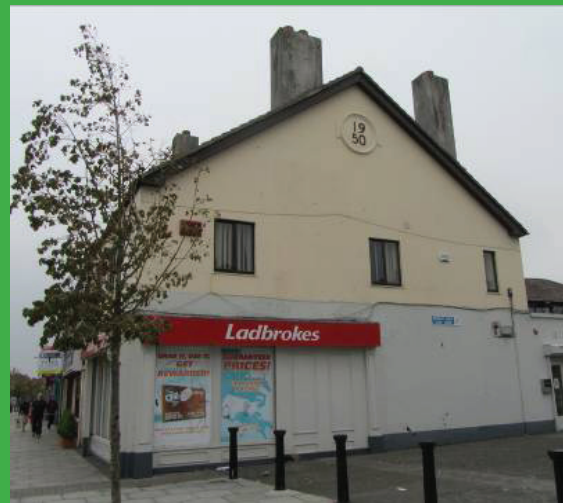
The second terrace marks the corner between St. Agnes Road and Lisle Road. It narrows the street space on St. Agnes Road by drawing the building line forward with respect to the terrace to the west. It splays at the corner with two units facing into the junction and a further row of four units lead into Lisle Road. The units have simple expression with unifying red brick elevations and red concrete tile roofs. The commercial premises at ground floor have tall rendered elevations reaching to sill height of the first floor windows. One unit retains its original metal windows with small scale divisions, the general horizontal format of the openings give a modern-style expression.

Fig. 63: Gable of terrace with '1950' date plaque

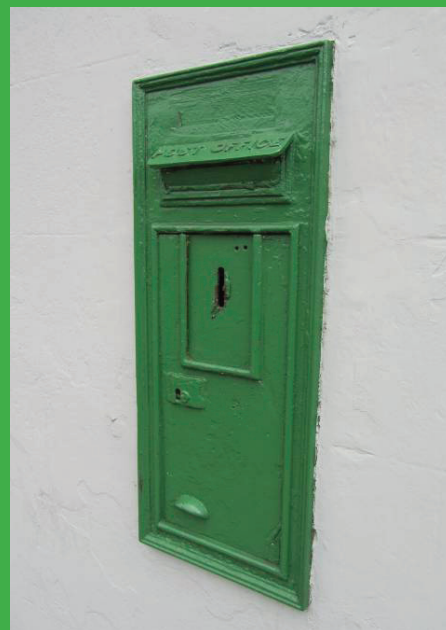
Fig. 69: Post box of former post office in elevation of present day shop

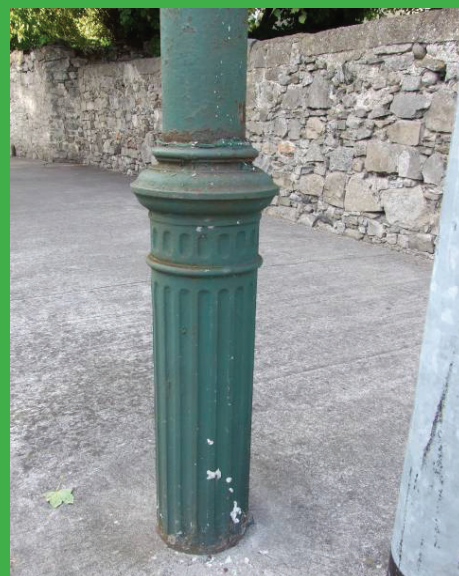
Fig. 70: Detail of historic lighting mast
