Dublin Bay Bathing Waters

Report by the Bathing Water Task Force

June 2023

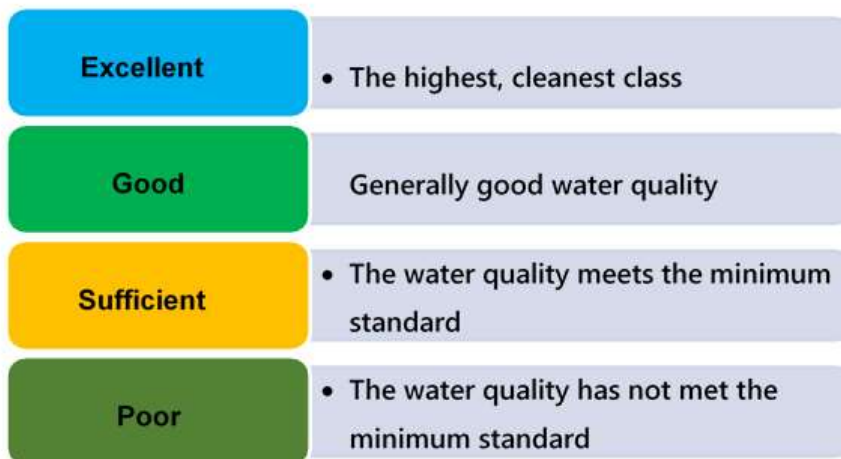
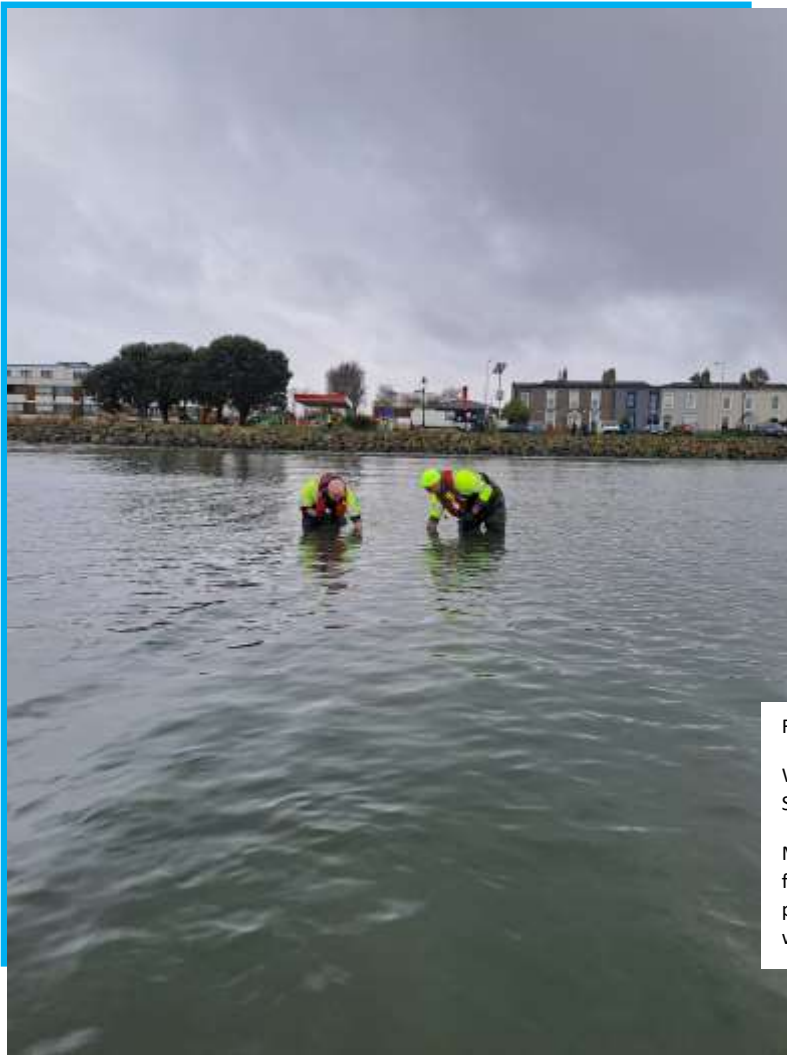
Figure 2: Source - EPA & (www.beaches.ie)

Samplers must adhere to certain requirements when taking water quality samples at bathing sites. For instance, water samples are required to be taken in waters that are 1 meter in depth, approximately 300 millimetres under the waters' surface.

Sampling is typically undertaken at high tide on the pre-scheduled sampling date at a distance of approximately 100 – 150 meters from the shoreline (see Figure 3 above).

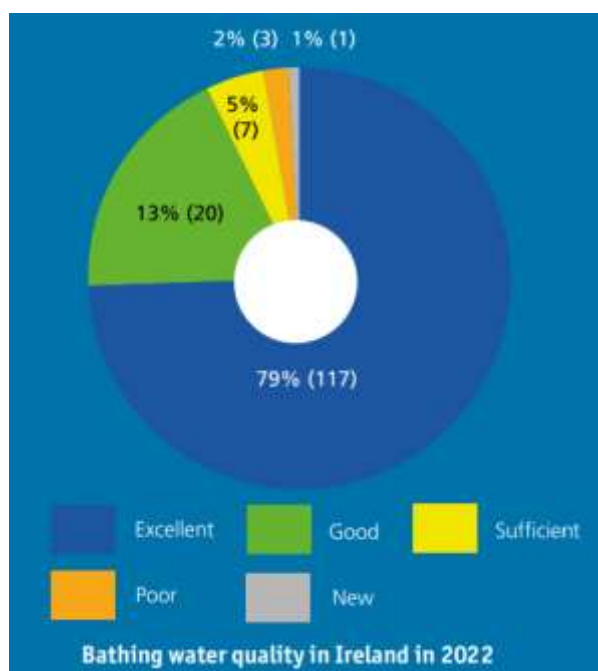
Classification	Number of bathing waters in 2021	Number of bathing waters in 2022
Excellent	115	117
Good	19	20
Sufficient	10	7
Poor	2	3
New/Changes	2	1
Total	148	148

Figure 4: Source: EPA ‘Water Quality in Ireland: 2022 Report’ – Changes in bathing water classifications between 2021 and 2022

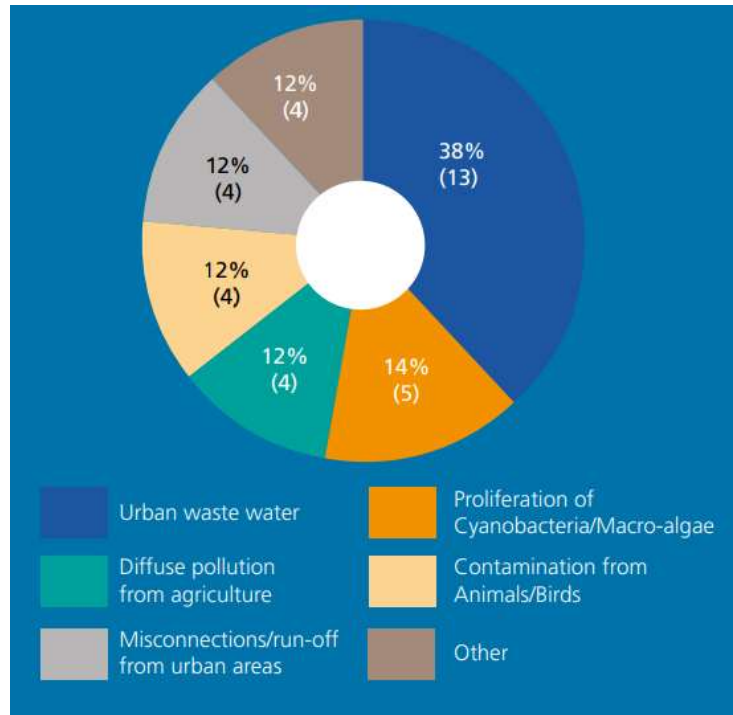
Figure 5 Source: EPA ‘Water Quality in Ireland: 2022 Report’ – Likely causes of reported incidents in 2022

The EPA has also reported that in 2022 ‘urban waste water incidents impacted bathing waters most frequently. Agricultural run-off, fouling from dogs on beaches and algal blooms were also reported. Heavy rainfall can lead to run-off from agricultural lands, urban areas and from wastewater overflows, all of which can impact on bathing water quality temporarily’. Additional information is further presented in the Bathing Water in Ireland Report for 2022 (excerpts in Appendix B). The pertinent pressures on bathing waters are identified as being;

- Urban Waste Water;
- Proliferation of Cyanobacteria/Macro-algae;
- Diffuse pollution from agriculture;
- Contamination from animals/birds;
- Misconnections/run-off from urban areas, and;
- Other.

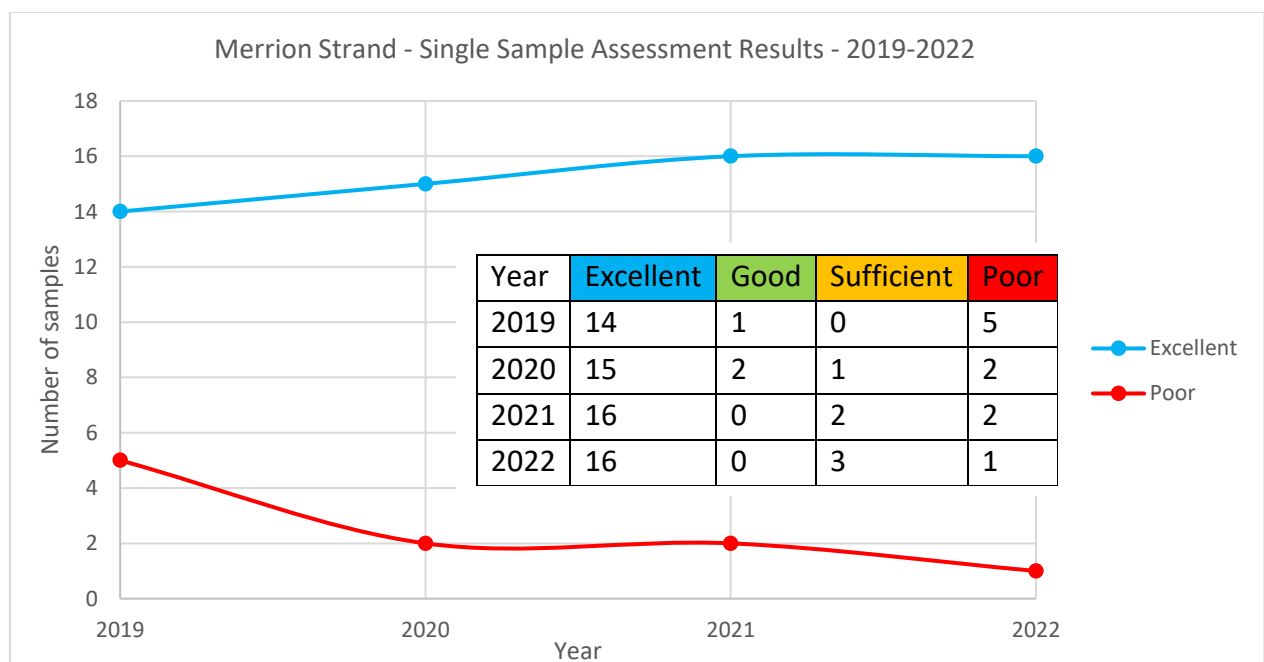
The specific water quality profile at Merrion Strand since 2019 is shown in Figure 8 below. This graph displays a slow but steady improvement in water quality over the last four years. Ceasing the decline in water quality in a relatively short time frame is a significant achievement and indicates that the BWTF activities, as set out in Chapter 7, are having a positive impact.

Figure 8 – Source EPA – designated bathing area classification bands.

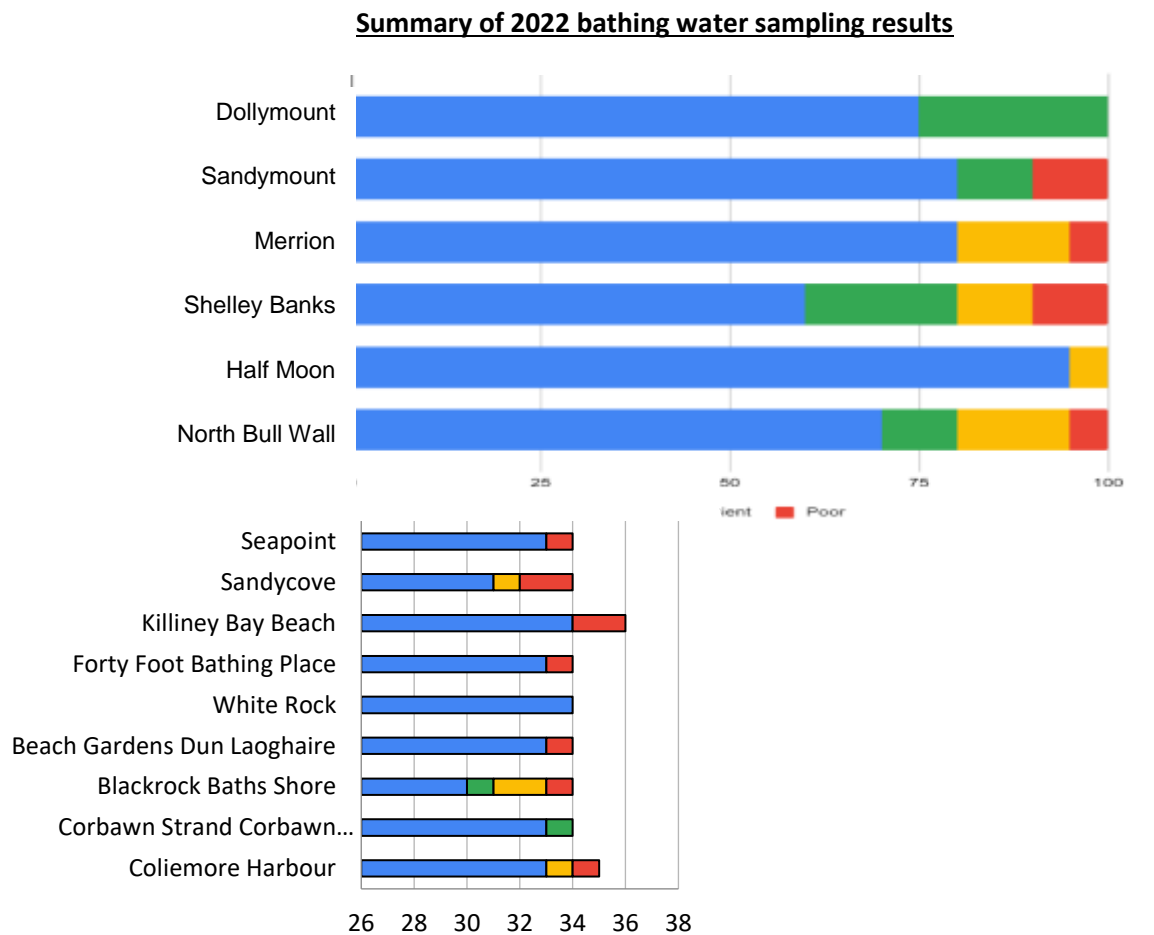
The following graphs show the Dublin Bay sampling undertaken at the various bathing areas along Dublin Bay and the apportionment of water quality classifications as determined by the Central Laboratory.

Figure 9 – Source: DLR & DCC

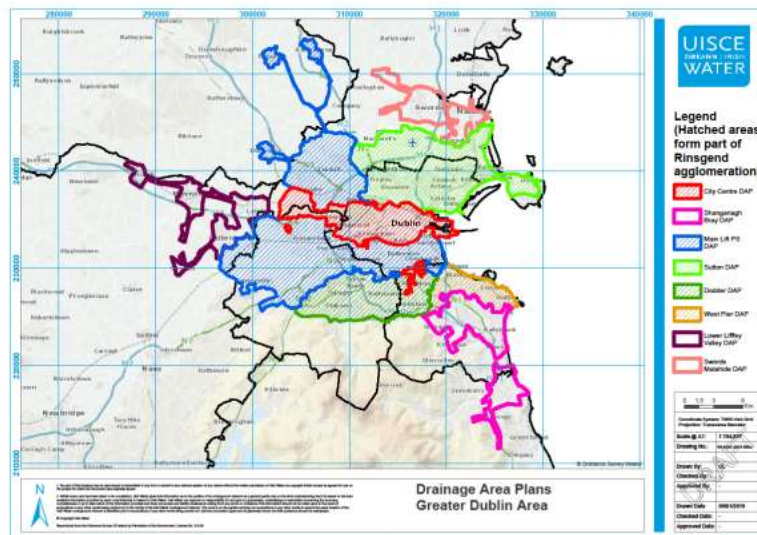
Within the wider Dublin Region, there are seven Drainage Area Plans. These plans will help to improve the performance of the wastewater networks, protect the environment and facilitate social and economic development over the coming years.

- City Centre DAP is complete.
- Shanganagh-Bray DAP is at stage 4
- West Pier DAP is at Stage 3
- Main Lift DAP is entering Stage 2
- Dodder DAP is at stage 3
- Sutton DAP is in stage 2
- Balbriggan DAP stage 1

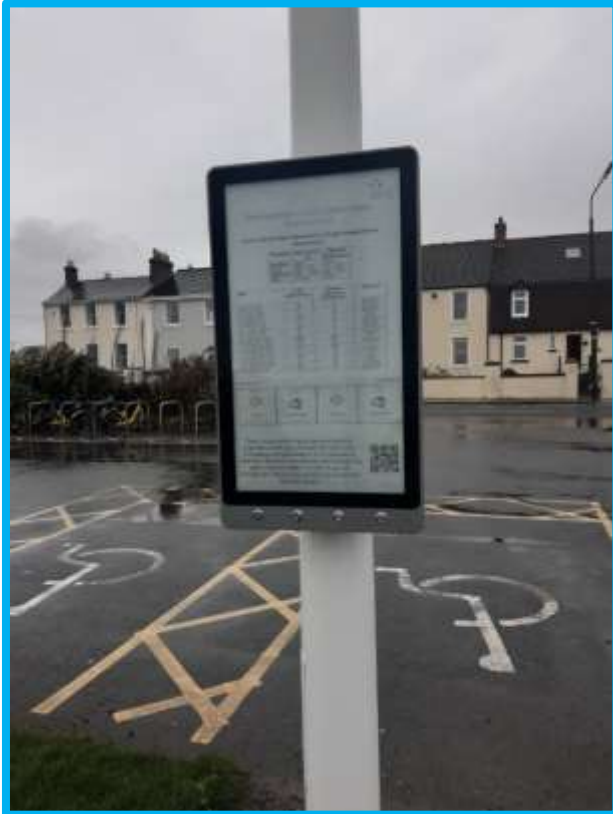
Image: Sustainable self-powered information signage trial ongoing at Sandymount Beach

7.12.3.	<p>On-site communications:</p> <p>To further improve the dissemination of information to the public, DCC initiated a pilot during the bathing season, trialling two self-powering digital screens at Sandymount and Dollymount Strands. The screens are self-sustainable and powered by renewable energy generated by a turbine and solar panel fitted on the installation. They utilise e-ink technology (similar to a kindle) and are updated remotely by DCC staff (see photograph 1 below). Statutory information including bathing water results and warnings are published on the screens and supplemented by water safety campaigns, weather forecasts and tides. The pilot has been extended for a further 6 months with minor adjustments to establish the feasibility of their operation during winter months.</p> <p>Further digital screens have been installed at busy bathing locations in the DLR area, including at Seapoint, DLR Baths, Sandycove and Killiney Beach. Those particular screens are mains powered and can be updated remotely with new data making them an ideal communication tool to inform the public about recent bathing water results, weather forecasts, tide times or important safety tips for swimmers.</p>	Trail commenced in Q1 2022 and remains under trial status.

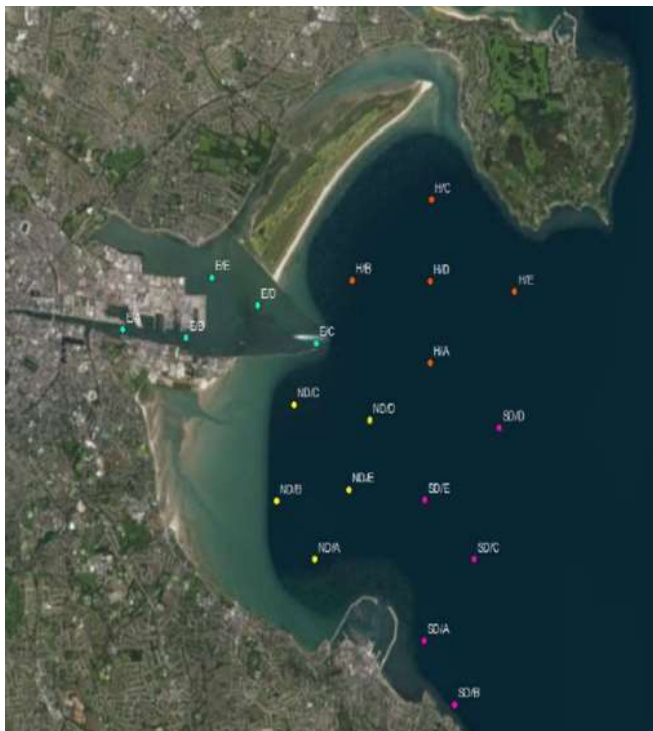
Dublin Bay sampling locations:

4 clusters containing 5 sampling sites each

Dry & wet conditions: neap & spring

- The project also undertook a comprehensive water quality assessment across twenty locations across Dublin bay to determine the likely overall classification of the water quality in accordance with the EPA criterion. The image below conveys the locations from where water samples were taken in Dublin Bay. The outcome of this assessment concluded that the water quality in Dublin Bay has ‘good’ status, consistent with the EPA 2022 classification. This assessment predominantly assesses the chemical and ecological status of the water samples taken.

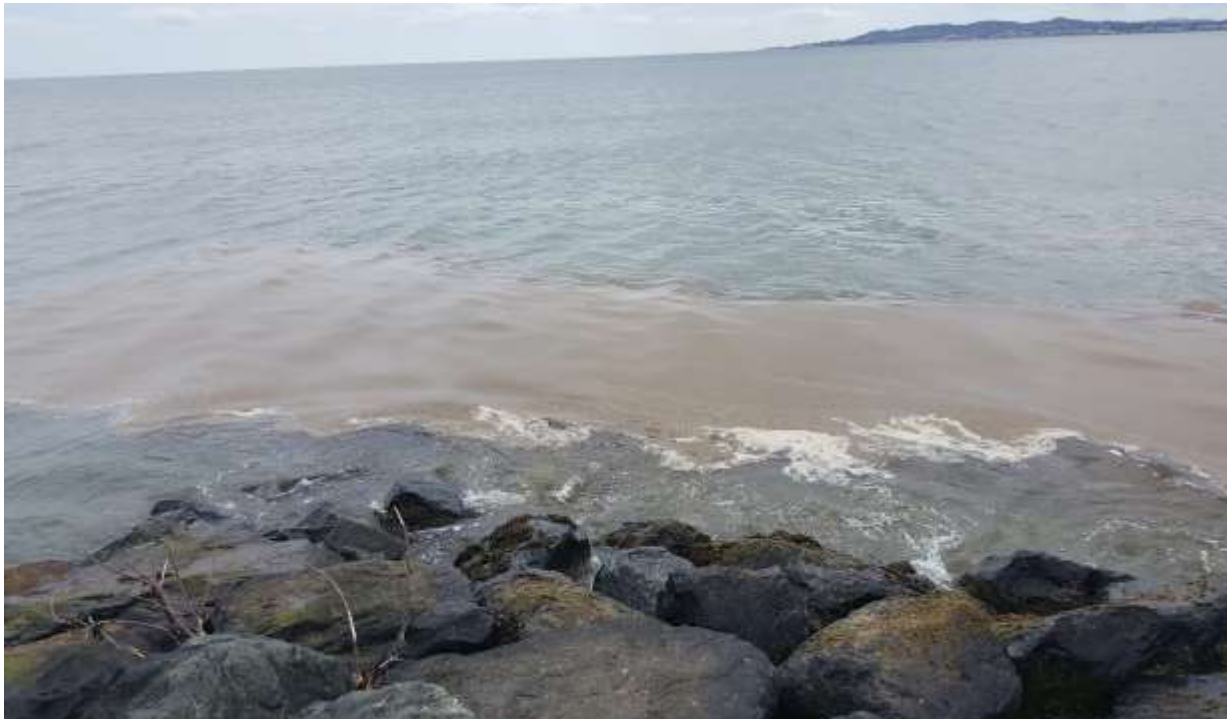
Shelly Banks – Brown ectocarpus washing ashore in the seawater, (Sept. 2019)

Dublin Bay biosphere has a various vegetation types growing on its sea bed, much of which is within a Special Area of Conservation. This particular material is currently both floating in the sea water and washing up onto coastal marshes and beaches during high tides. It is a naturally occurring seaweed or macro algae called Ectocarpus. Toward the end of its lifecycle Ectocarpus quickly progresses through various stages of decay and it is at this time of year the decaying ectocarpus presents itself with characteristics not too dissimilar to foul effluent or sewage.

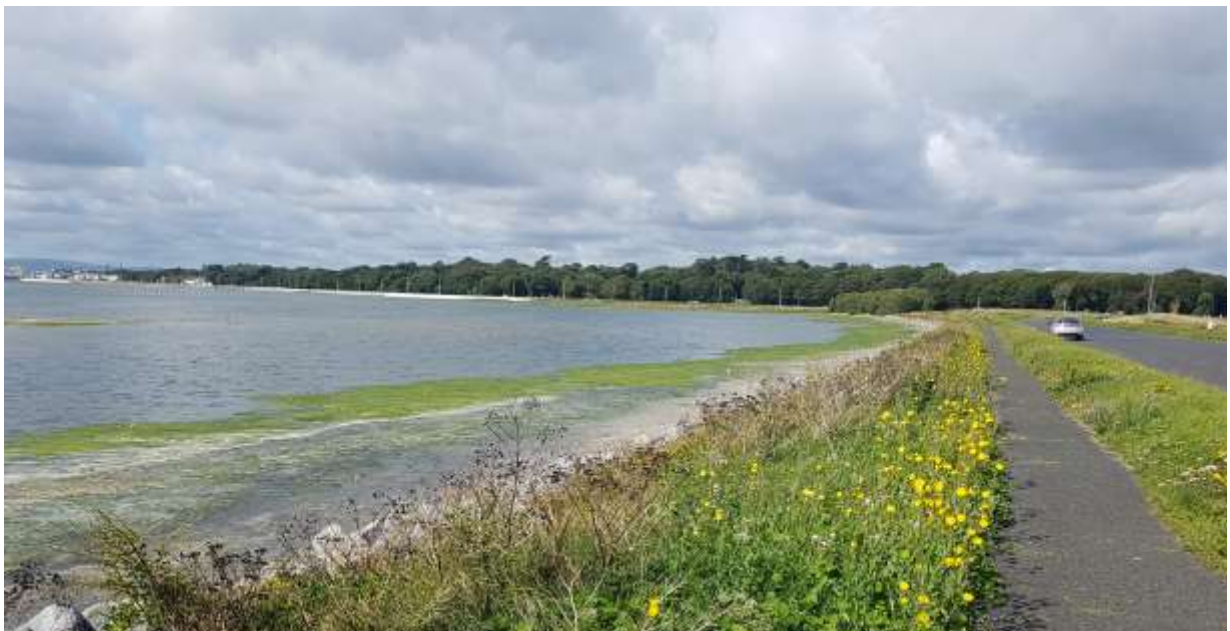
Causeway Road, Bull Island – Green ectocarpus floating on high tide waters, (Sept. 2019)

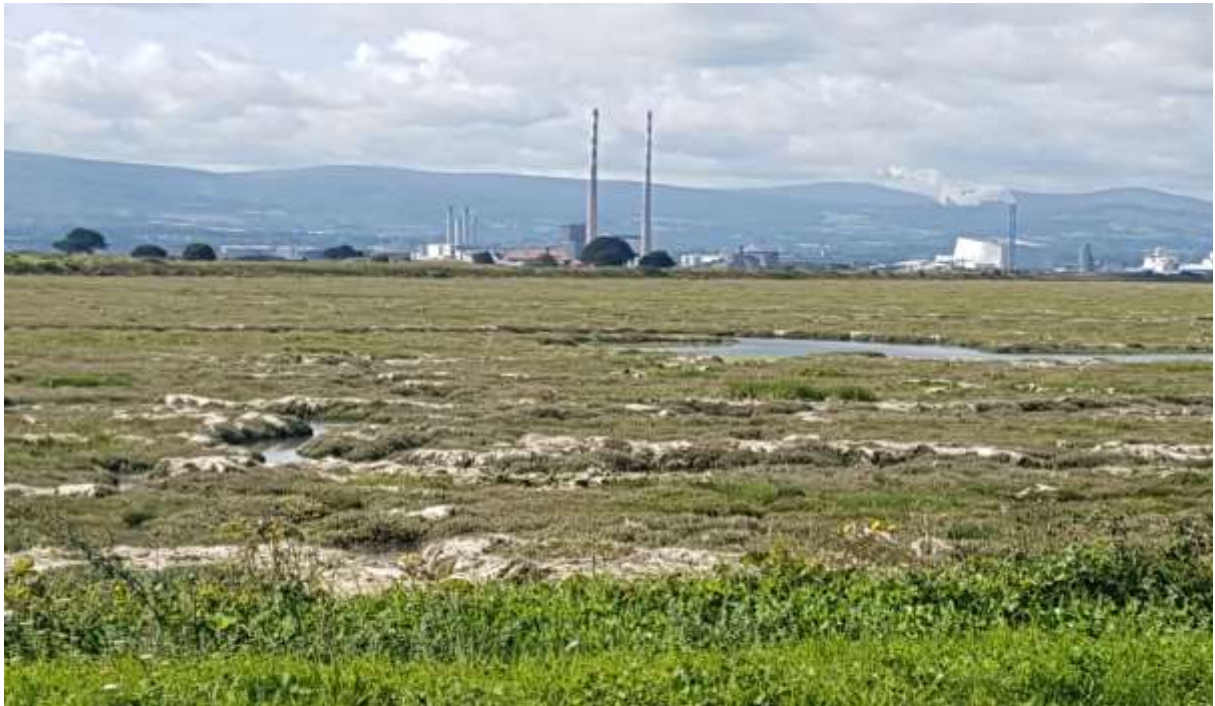
Bull Island – (Light brown) Dried ectocarpus resting on top of the marshes once high tide waters recede, (Sept. 2019).

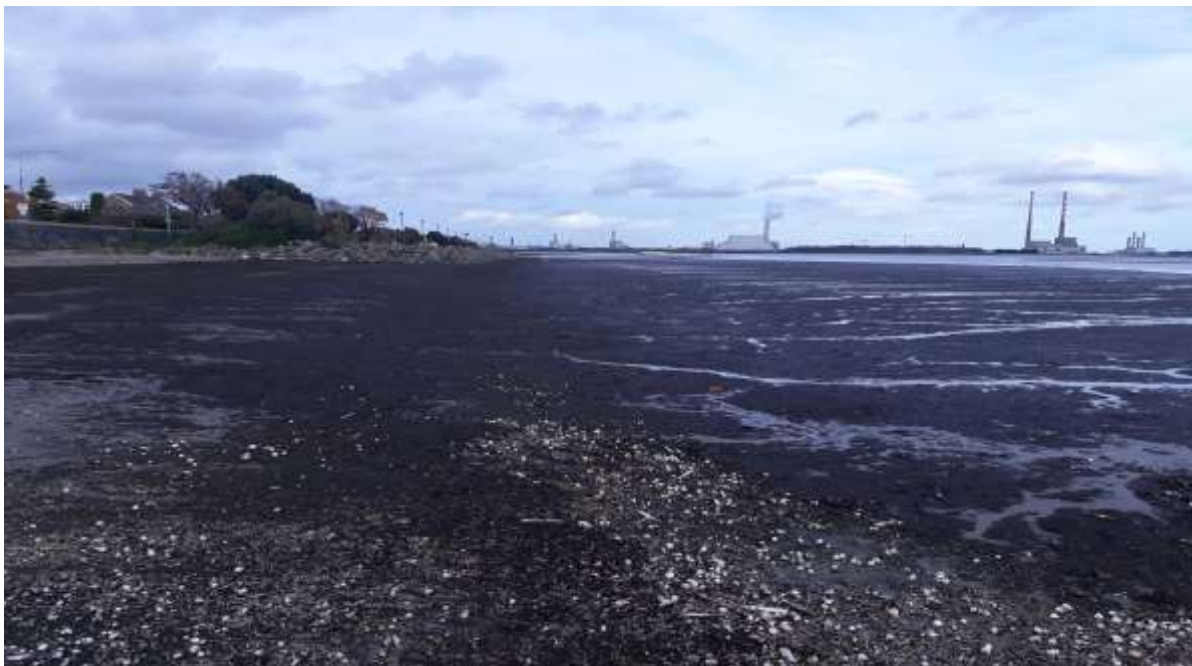
Merrion Strand – (Dark brown) recently washed up ectocarpus on the beach once tidal waters recede, (Sept. 2018).

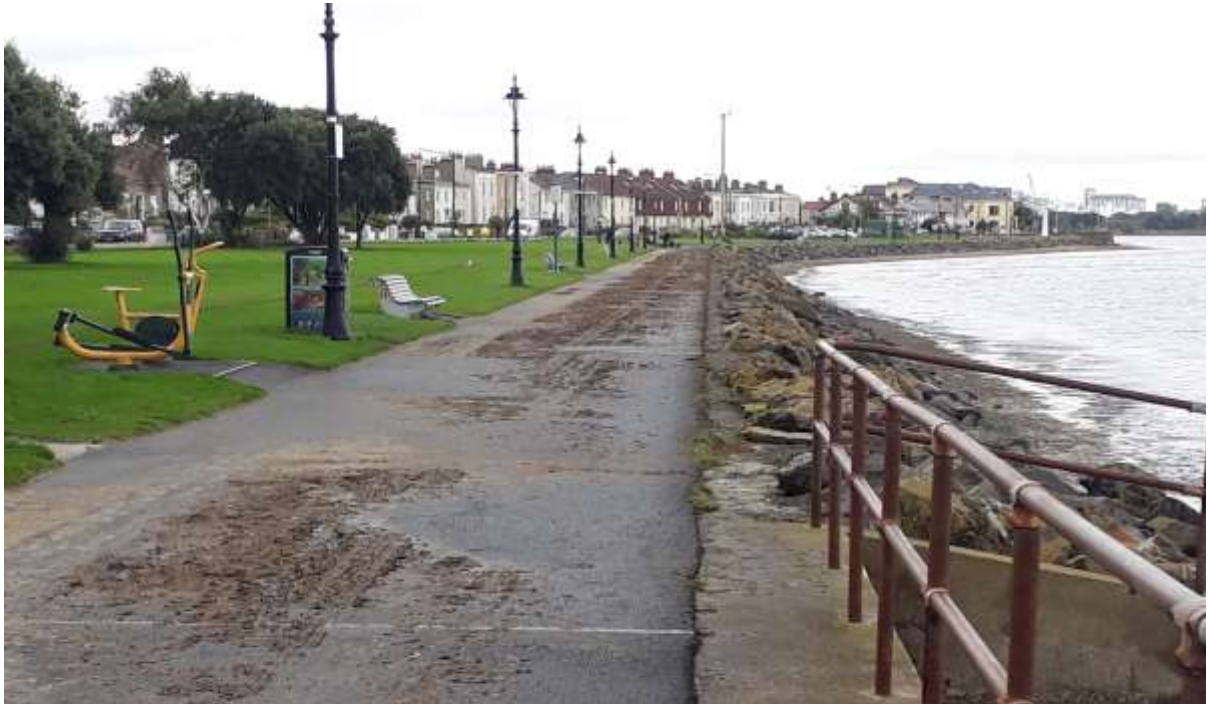
Sandymount Promenade – Ectocarpus washed onto the rocks footpaths during a combination of heavy rainfall and high tides, (Oct. 2019).

Furthermore, we are aware that after the recent heavy rainfall, combined with high tides, decaying ectocarpus can be washed up on the various footpaths or promenades adjacent to the coastline. Our Waste Management Department does tend to these incidents so as to make pedestrian footways safe and ensuring minimal relocation of this natural material from its environment.

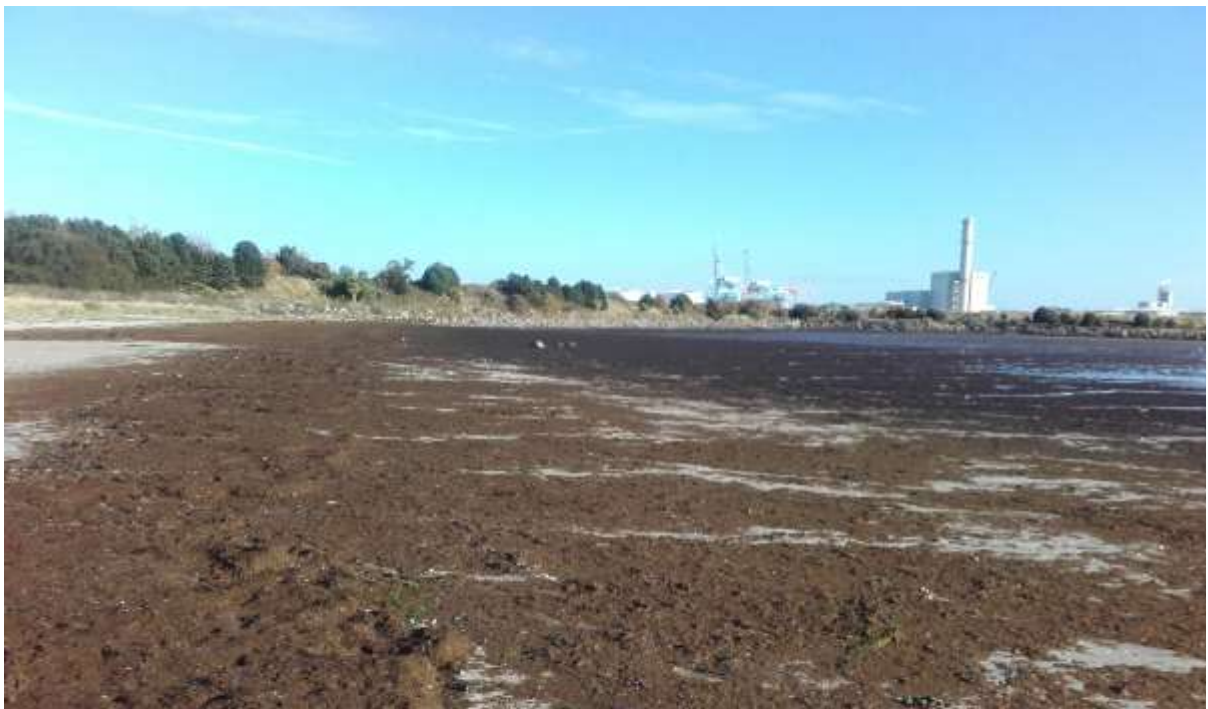
Sandymount Beach – Ectocarpus at various stages of decay, (Oct. 2016).
