ST CANICE'S ECCLESIASTICAL SITE

FINGLAS, DUBLIN 11

CONSERVATION & MANAGEMENT PLAN

APRIL 2022

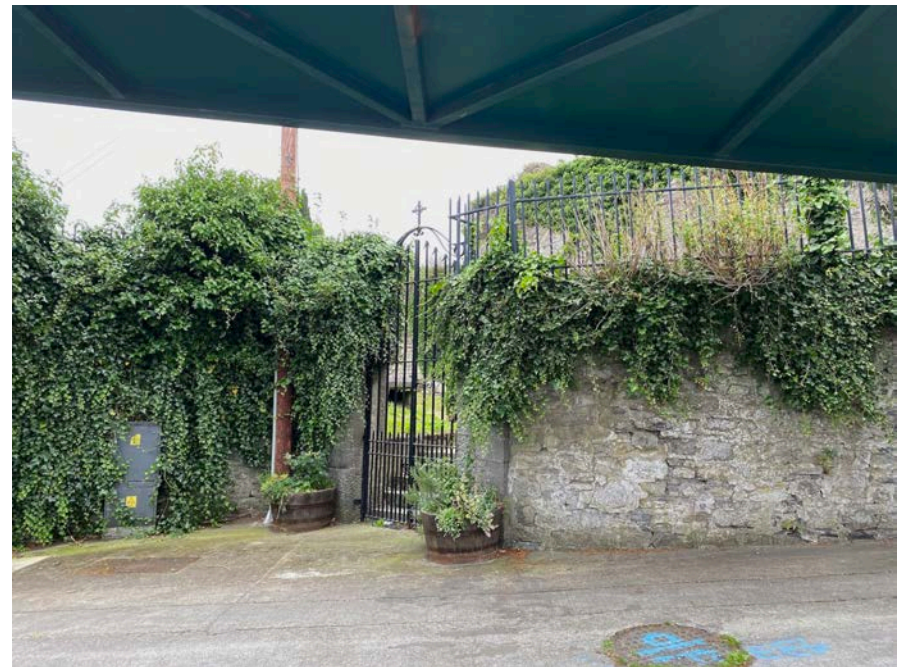
14. View of entrance gate from underneath bridge showing extent of ivy.

Ivy has colonised the wall to varying degrees; in some areas, the ivy is confined to the surface, and poses little threat to the condition of the wall. In other areas, the ivy is more extensive, and has likely rooted into the wall tops and centre of the wall, while adding additional weight and 'windage' to the wall making it more prone to collapse. It is heaviest on the north and south walls to the extent that it poses risk of falling stone along the footpath on Church Street. While it is patchy along the west wall and a long stretch of the eastern wall is completely clear, this is due to rebuilding in recent decades. Along the east side, the collapse was caused by construction on

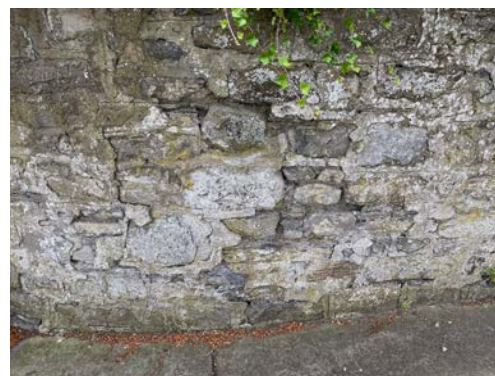
- Of most concern to these walls is the damage caused by tree roots and ivy, some historic, where cracks and bulging can be seen, putting the surviving medieval fabric at risk.

18. Large cracks and bulging to boundary wall along footpath.

- Stabilisation of the boundary walls and removal of damaging trees using best conservation practice should be a priority. This would remove a risk to public safety along the footpaths.
- Several of the monuments have been disturbed so that they are at risk of collapse. Urgent action is required to the monuments close to the stone porch, among the most visible to visitors.
- In 2022, an application should be made for the repair of the chancel and boundary walls under the Community Monuments Fund, Stream 1; these areas are under the most threat.
- In future years, repairs to the nave, side chapel and entrance porch should also be advanced.

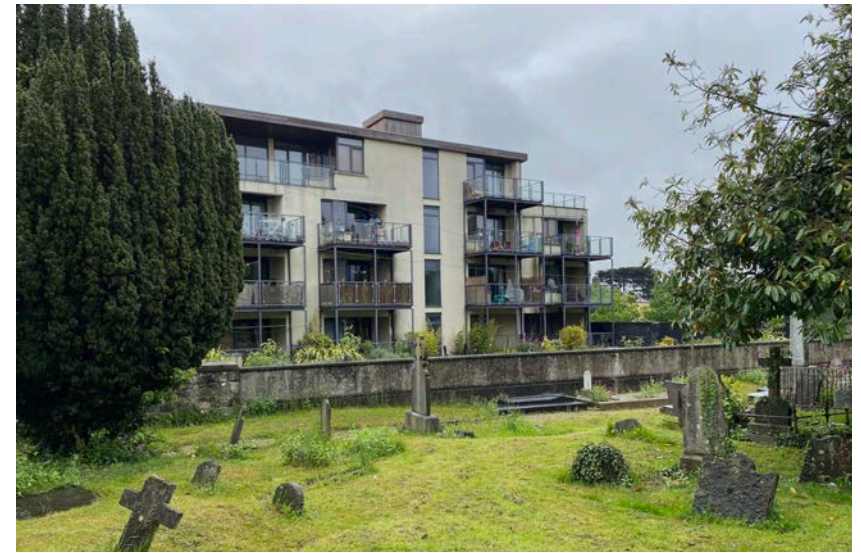
the adjacent Fuel Yard site which caused the exposure of human burials and its reconstruction. Historic sections of this wall have been buttressed, and the internal faces rendered with cement and given a concrete capping.

19. View of Fuel Yard Apartments and rebuilt wall section.

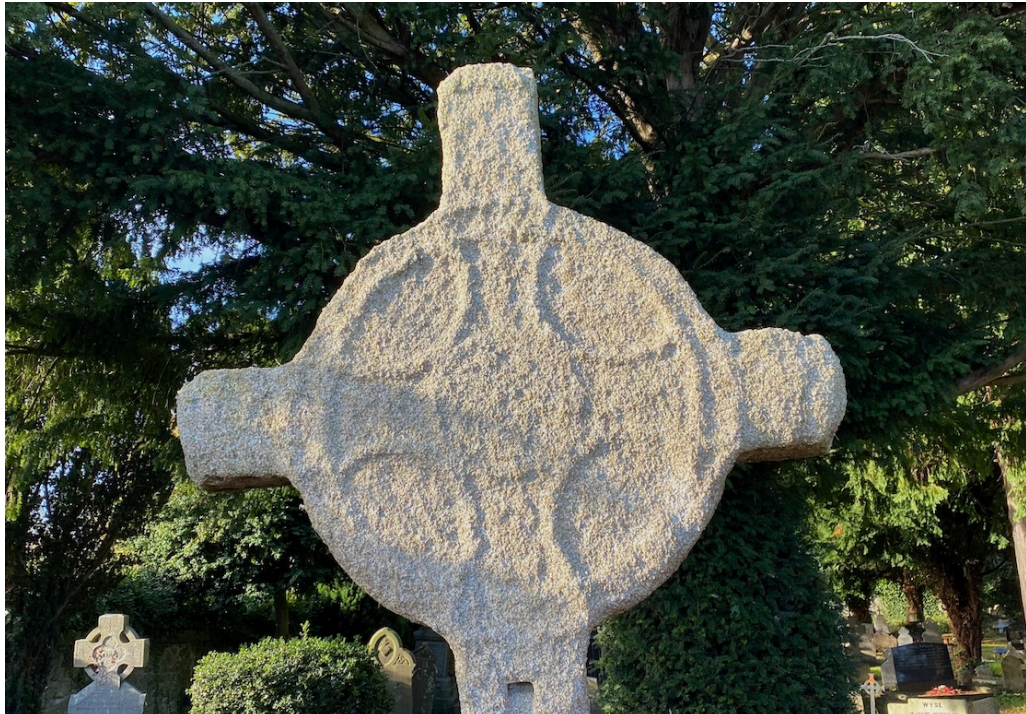
28. View of east face in raking light showing ringed cross design.

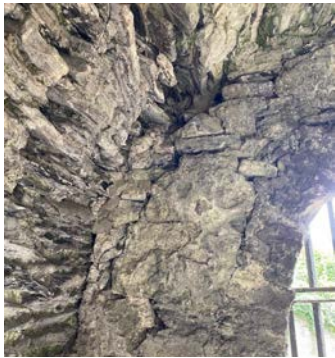
40. Voids and cracks to stone vault to entrance porch

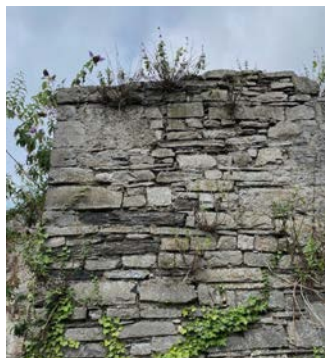
41. Loose stone at high level to nave.

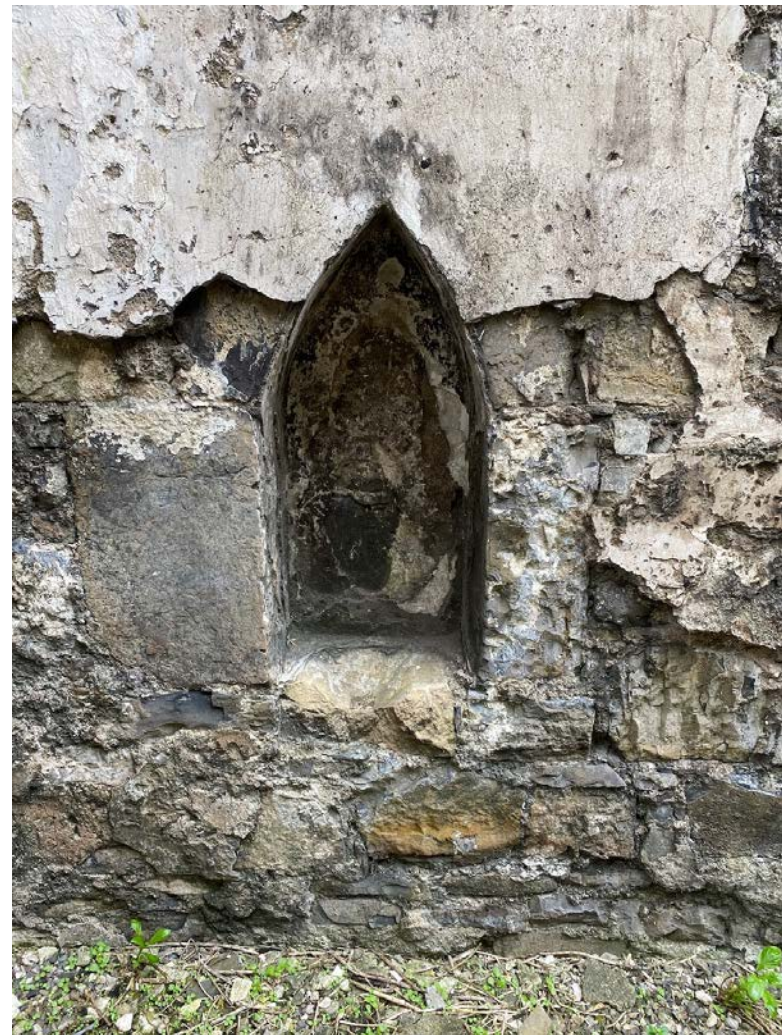
44. Detail of sandstone piscina to side chapel with surviving layers of plaster.

- Care should be taken not to disturb the surviving wall plaster during repair works, and pilot works to consolidate these layers should be progressed.

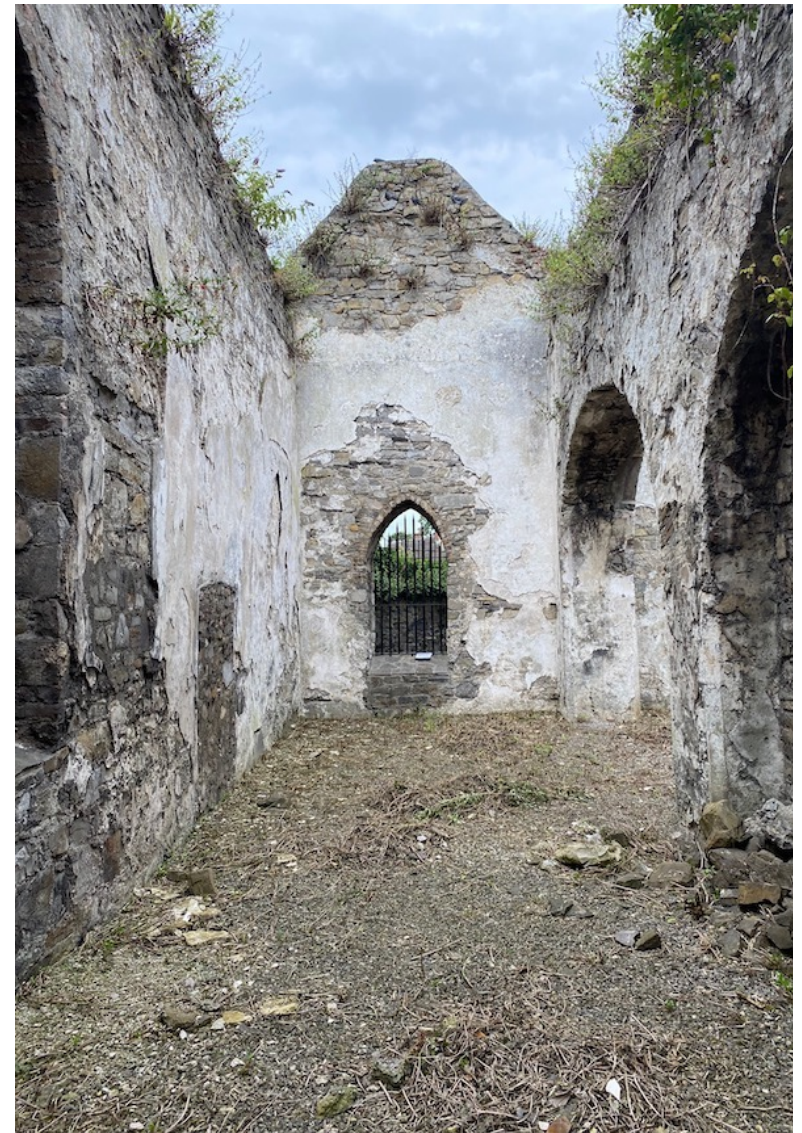
49. View looking west in side chapel. Note fallen plaster on floor.

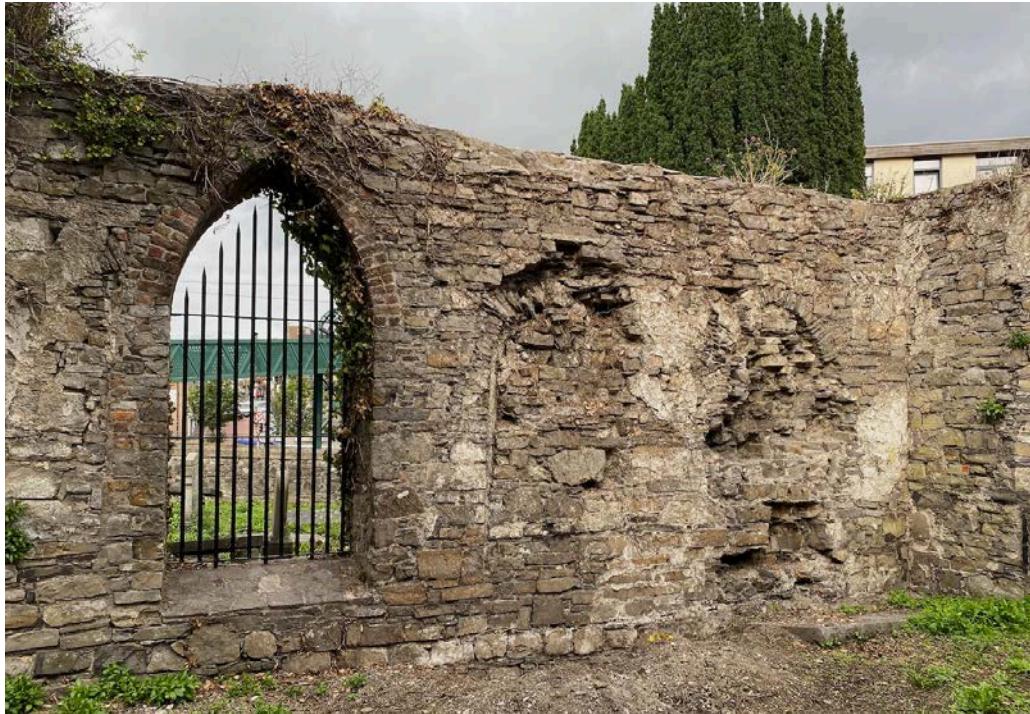
The walls have been capped using hard concrete at eaves level, most of the protruding stone eaves course survives beneath. While no doubt installed with good intentions to weather the walls, it has caused erosion of the softer mortar and stone directly beneath, which in turn has been colonised by shrubs and ivy, accelerating the rate of decay through displacement and mortar loss. This can be observed at the corners with the gables, where larger shrubs have established, and along the tops of the walls generally.

50. View of exposed north chancel wall showing former openings in vulnerable condition.

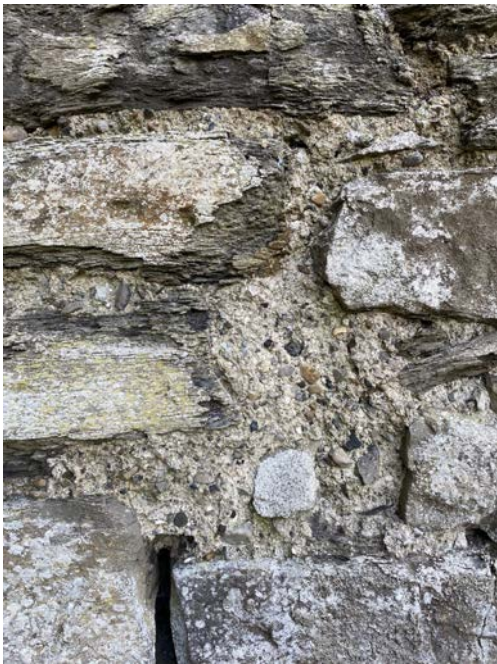
55. Lime mortar and eroding Calp.

Cement pointing of brickwork is a particular problem to the window surrounds. Hard cement has also worked on areas where Calp limestone was used. This limestone is particularly vulnerable to erosion, being prone to decomposition along layers that have impurities such as oxides or shale in the case of the lowest quality stone. Calp was quarried close to Dublin and it is a very common building stone used on many churches and public buildings. However, due to its variable quality, it was most often used on less prominent parts of the buildings or for boundary walls. Often it was

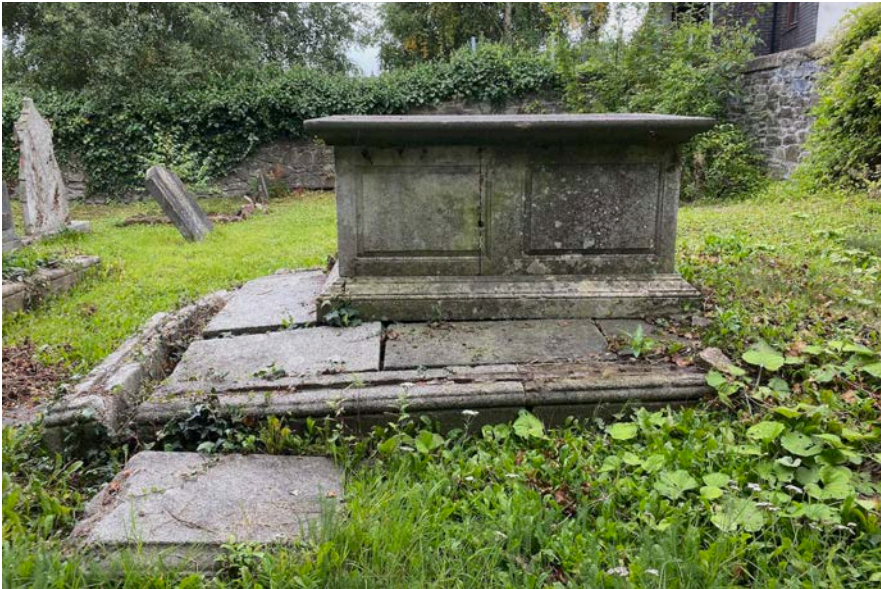
57: View of Baron John Pocklington chest tomb (ref. 42) following ivy removal.

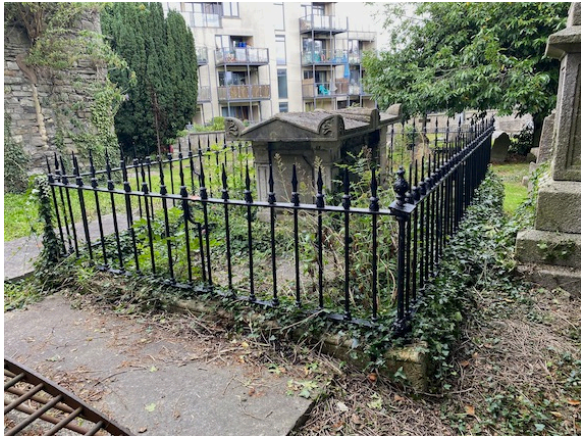
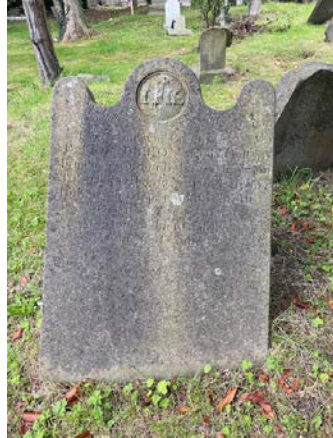
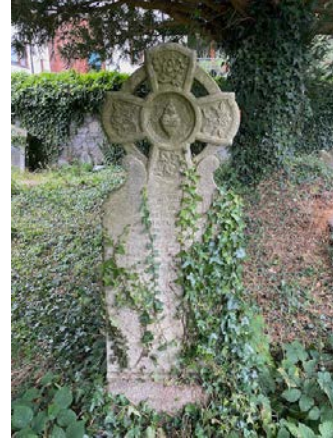
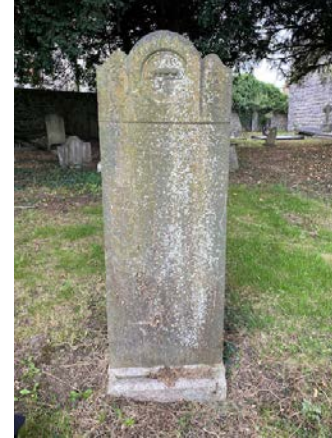
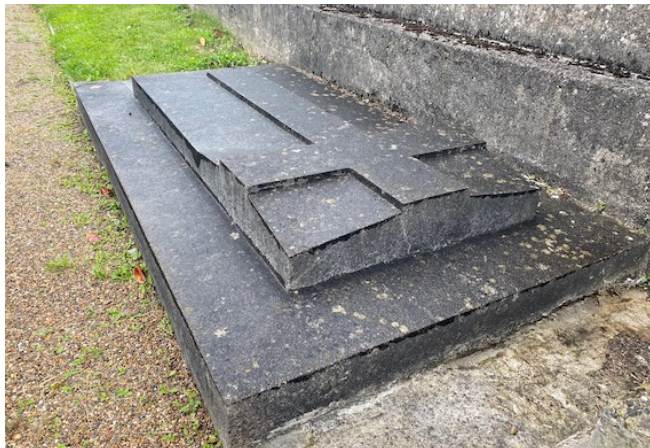
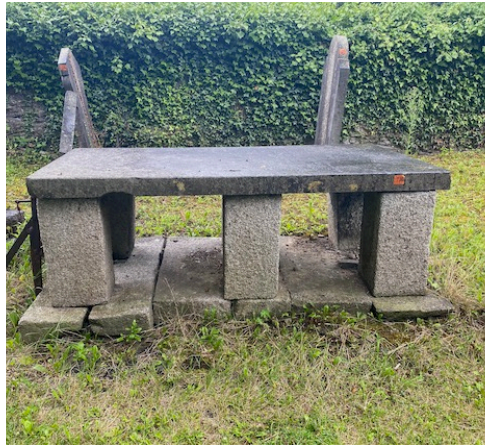
58-65. Detail photos of mortuary monuments including chest tomb, table tombs, headstones, recumbent slabs and their condition.

Headstones are susceptible to settlement and collapse due to changes in ground conditions, tree falls or accidental damage. In areas that appear clear of burials, there may well have been plots marked by headstones that are now broken and lost or which have become buried over time. Others that have settled into a more severe tilt angle may be of structural concern and will require checks for their stability.

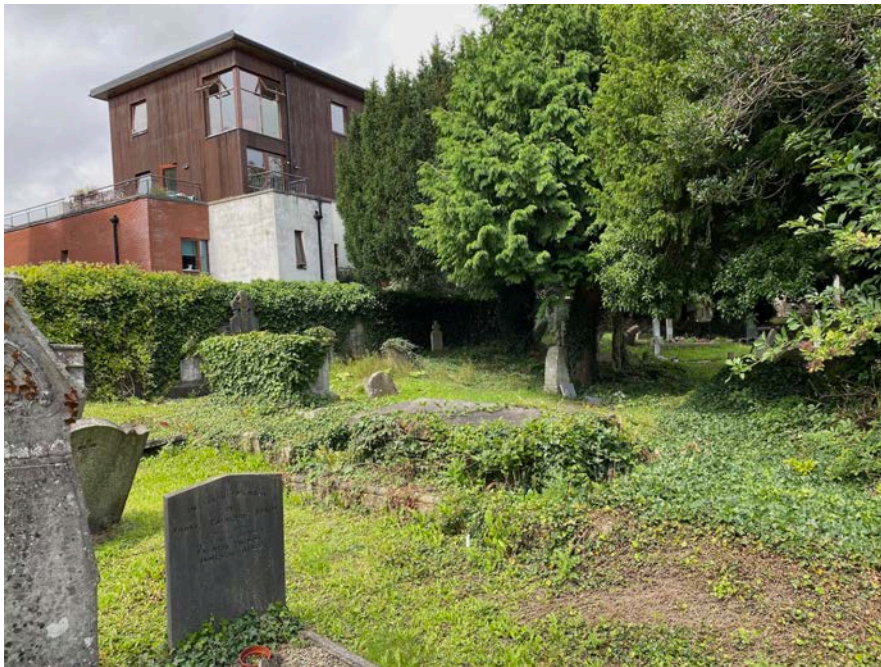
- Encroachment of development and vegetation, especially ivy, has caused the loss of parts of the boundary walls to the graveyard, along with displacement of some of the monuments. Mature trees in the graveyard are also displacing nearby monuments, damaging both their stonework and metalwork.

80. View of ivy encroachment to SW corner and encroaching development.

- Vegetative growth should continue to be monitored to avoid further damage, while new planting could enhance the presentation of the graveyard and improve biodiversity.

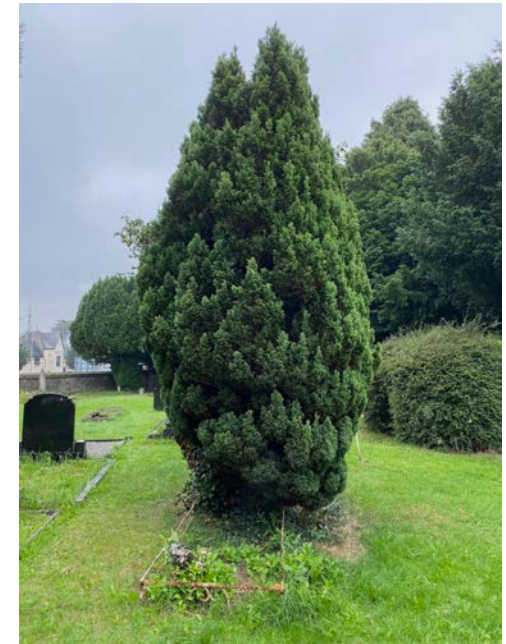
88. Leylandii destroying memorial.

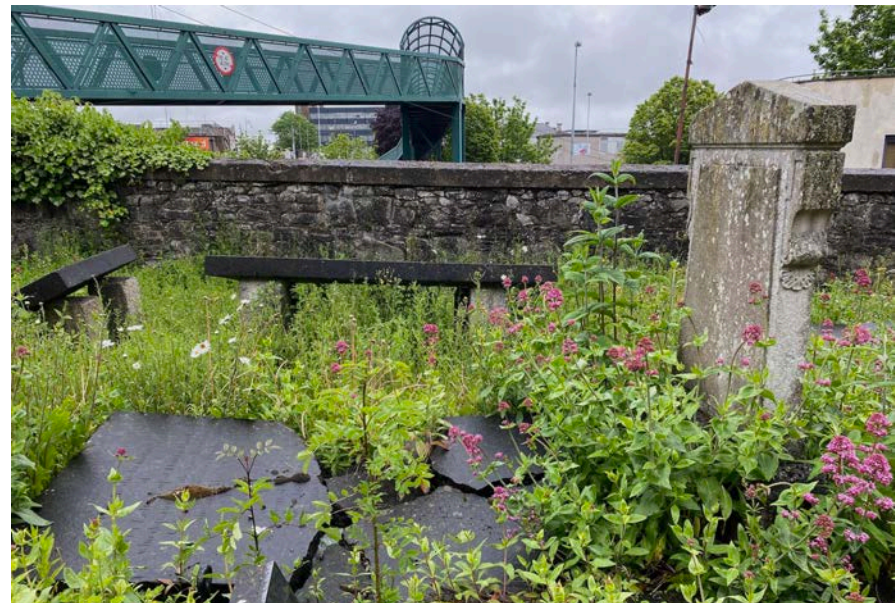
90. Broken recumbent slabs close to entrance porch and bridge in background.

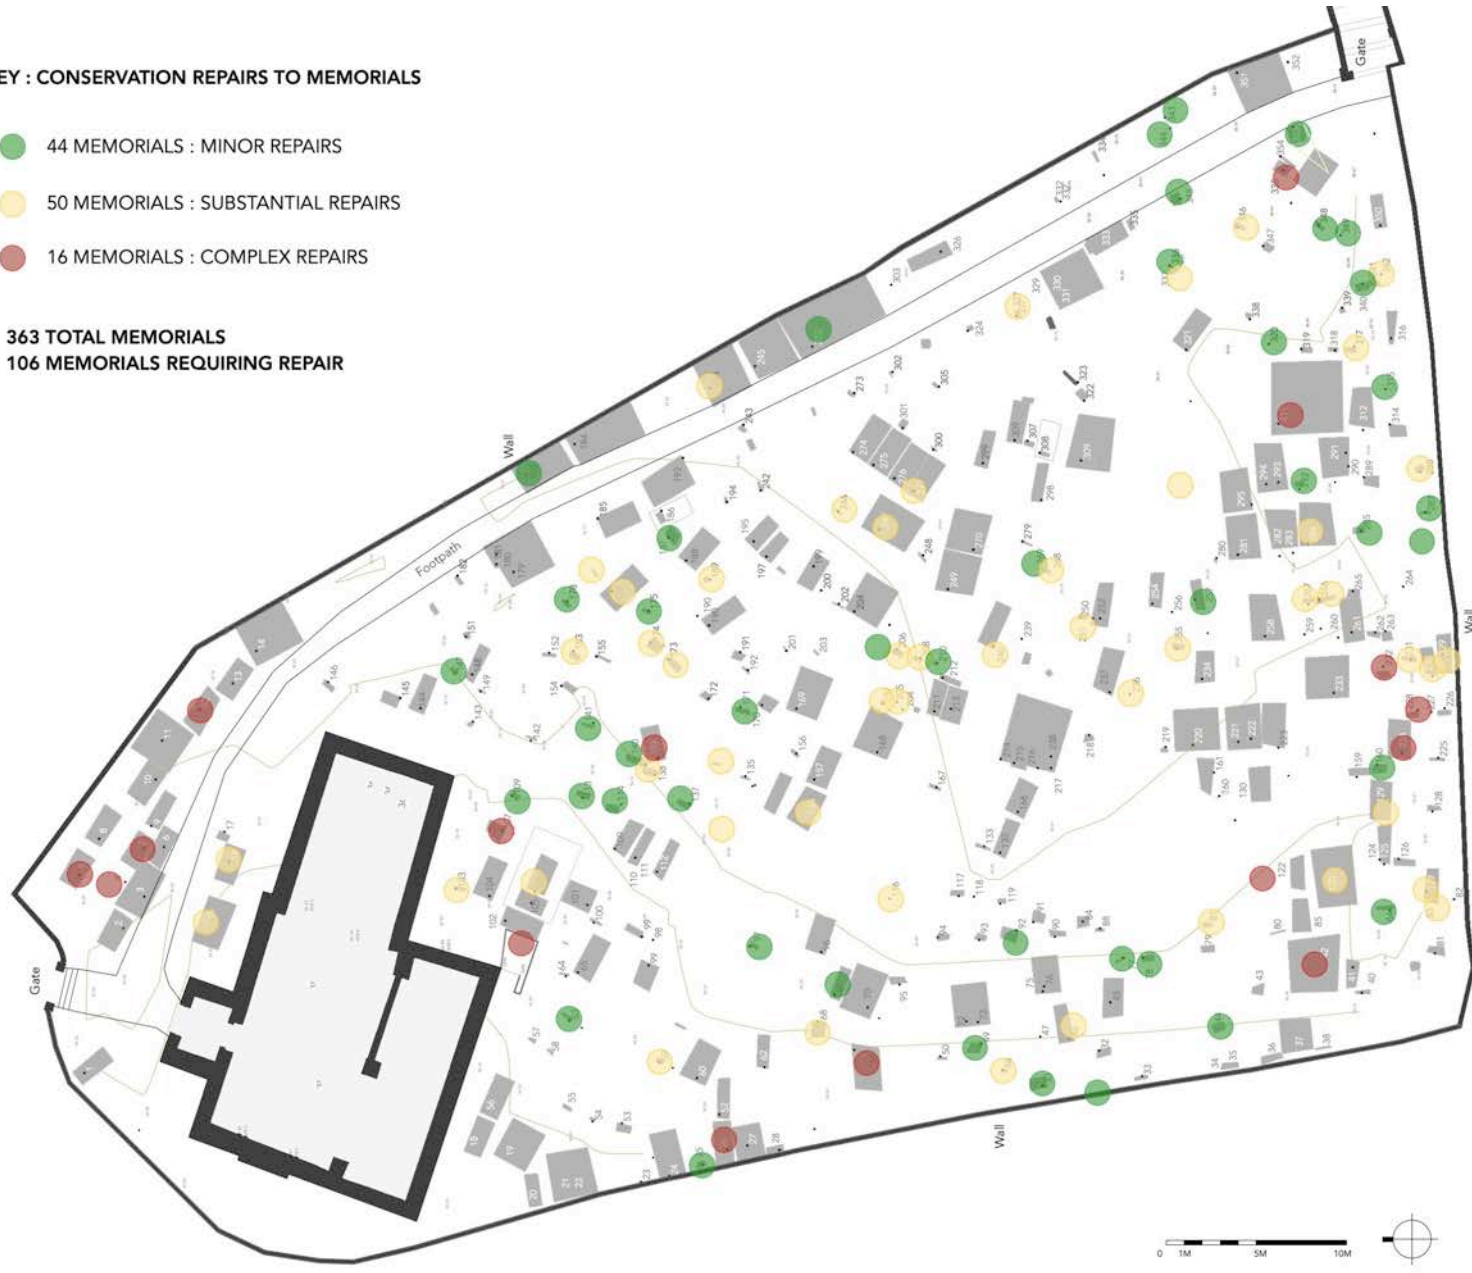
363 TOTAL MEMORIALS
106 MEMORIALS REQUIRING REPAIR

92. Site layout showing traffic light analysis of memorial condition.

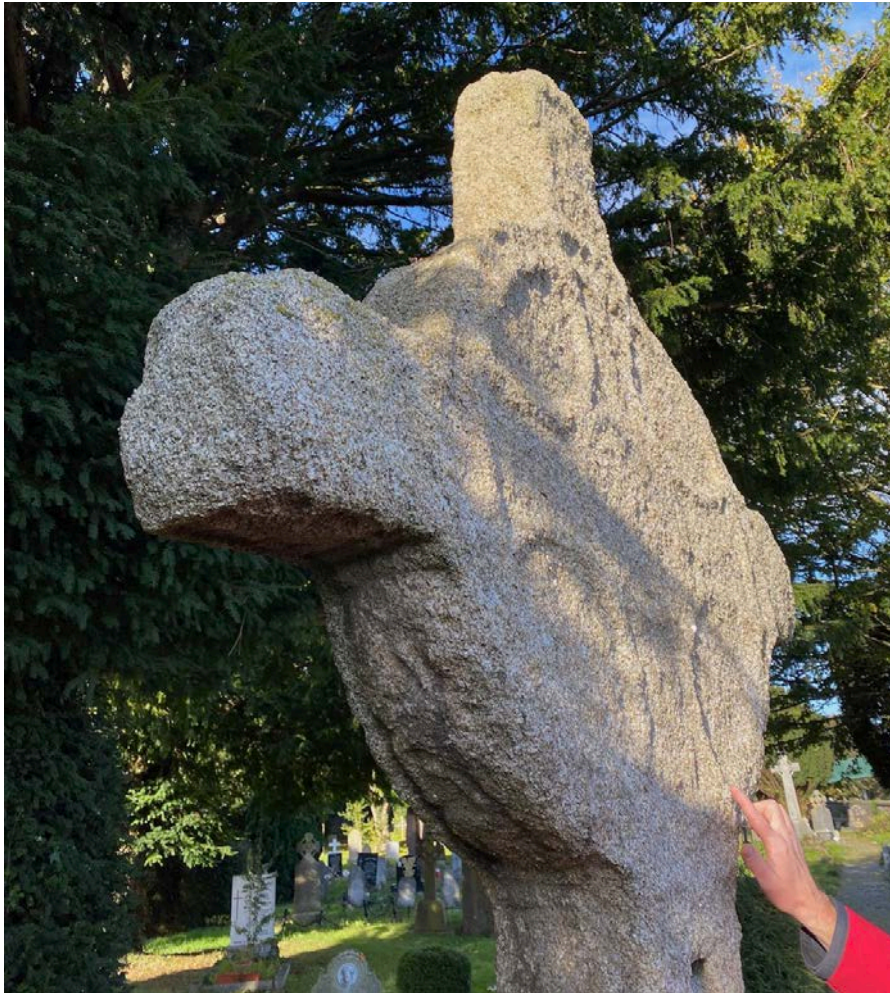
In the longer term the remaining surface detail of the high cross will be lost, the stone will lose dimension and become unstable leading to cracking and collapse. As the cross is top heavy, this might occur sooner than might be anticipated, its tilt angle and irregular bedding contributing to this uncertainty.

93. View of Nethercross showing damage, erosion and faint carvings.

- A structural survey should be undertaken of the Nethercross in 2022 to determine what risks to its stability are present due to its present location and its continued deterioration.
