KILMAINHAM MILL

A CONSERVATION PLAN

APRIL 2002

DUBLIN CITY COUNCIL

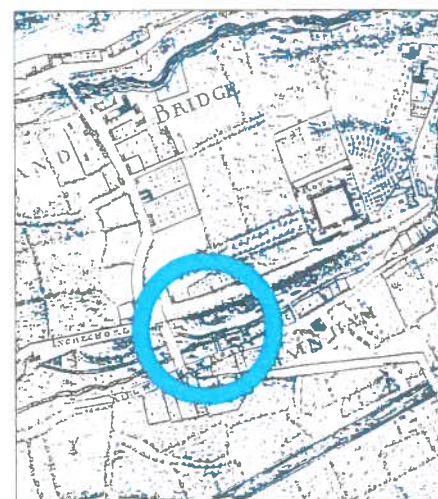
Rocque's Map 1773

Robert Girdler's 1650 map of Kilmainham Parish shows a watermill on the north side of the River Cammock. It is most likely that this is the mill referred to in the Cromwellian catalogue. The fact that John Rocque's map of 1773 does not show a building at this location is hardly significant as it does not show other mills, which are known to have existed at that time, either. The map does however clearly show the bridges across the river at Kilmainham and, the River Cammock splitting into two to provide races serving the mills located along it.

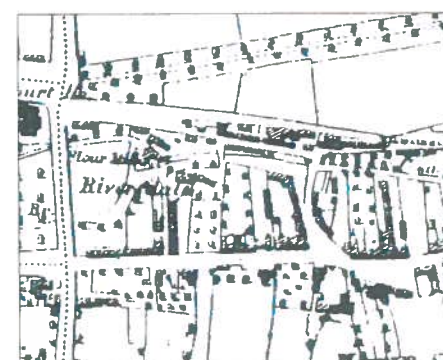
Ordnance Survey Map 1837

The Valuation book records the new complex as comprising 'a five storey mill, a return thereto, and miscellaneous one and two storey buildings'. The dimensions of the main building are given as 49 feet 6 inches by 26 feet and the return as 33 feet by 28 feet 6 inches. These measurements correspond almost exactly with the dimensions of Building 1. The Mill, then, comprised the north part of Building 1A and all of Building 1B; the return comprised the south part of Building 1A.

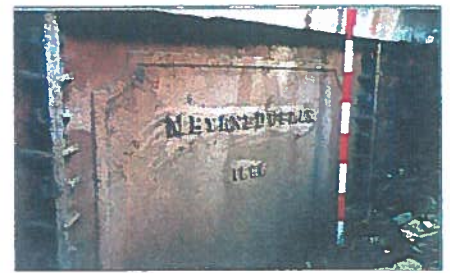
A panel of the cast-iron sectional aquaduct

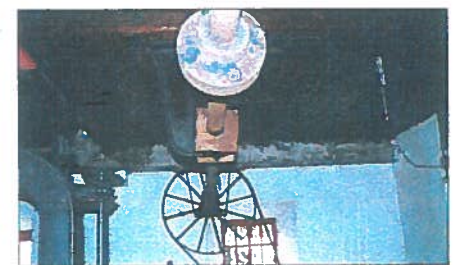
Transmission shaft fixed to underside of floor

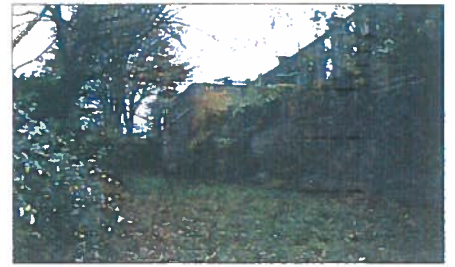
The Mill Race looking west towards Kilmainham Bridge

Although now partially infilled, the original line of the mill race as it flowed from Kilmainham Bridge to the Mill, can still be clearly seen. Prior to the construction of Building 2, the 1843 Ordnance Survey map shows the head race entering Building 1A and its tail race flowing along the south side of Building 1B. The 1863 and 1875 maps also show the head race entering Building 1A but with the tailrace emerging immediately to the east of Building 2. A semi-circular headed, opening in the party wall between Buildings 1A and 2 suggests a possible location for the tail race particularly as its centre line is roughly in line with the rectangular opening on the head race side. As this arch would have been on the external façade of Building 1A before the addition of Building 2, the head race was probably culverted under the floor of Building 2 before discharging into the river. The bank at this point is now faced with concrete and overgrown, so it is impossible to pinpoint exactly where the tail race exited. The 1887 map shows the, then recently installed, cast iron aquaduct linking the head race and the south gable of Building 1A where the new water wheel was located.

Surviving external physical evidence accords with the map records and confirmatory remnants of the original sluice gates can still be seen to the west of Building 4.

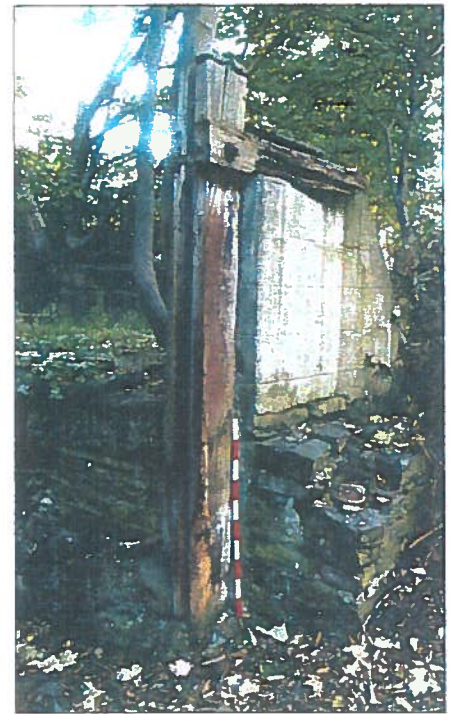
Surviving remnants of sluice gates

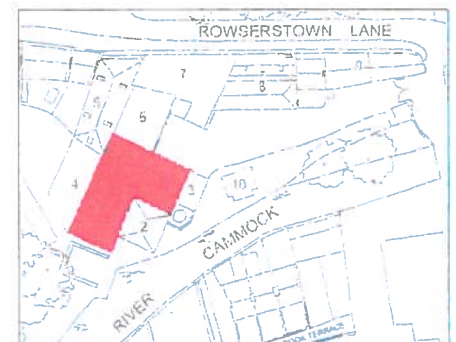
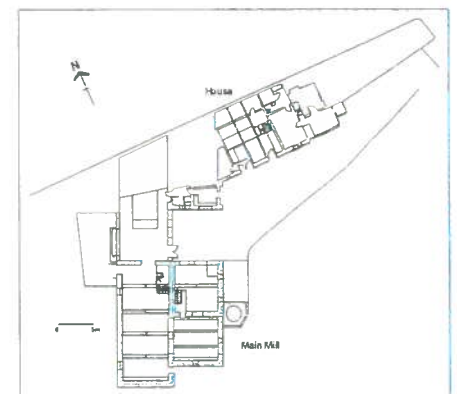
Main Mill - Existing ground floor plan

The main structural walls are of rubble limestone with roughly dressed limestone quoins and brick dressings to openings. The head and sill heights of most second and third floor openings have been altered with inset brick arches and rubble infill, apparently contemporaneous with the insertion of the new internal structural system in 1886. External walls are generally structurally sound although some bulging is evident on the north elevation where a number of larger openings have been formed by the insertion of steel lintels and yellow brick dressings. The south elevation of Building 1B leans noticeably inwards towards the top. The natural slate roof, with suppressed hips, is in poor condition. A substantial, rectangular profile, asbestos gutter drains the roof to the west elevation of the building, returning a short distance on the north side where it discharges into a , large diameter, asbestos downpipe. Gutters are entirely missing from all other elevations. Windows are generally cast-iron or timber side-hung, outward-opening, casements with horizontal glazing bars. A large, slightly tapering, square chimney, constructed in brick with a projecting brick cornice at its top, emerges through the roof in the north-east corner of the building and a firebreak wall, surmounted with a small campanile, separates Building 1A from 1B.

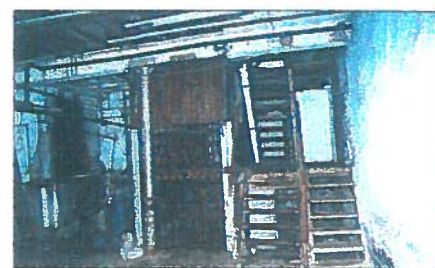
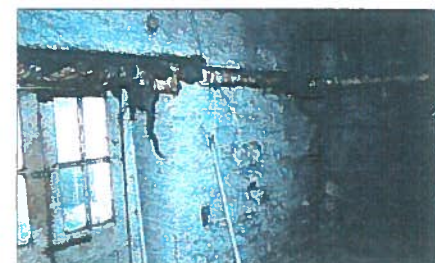
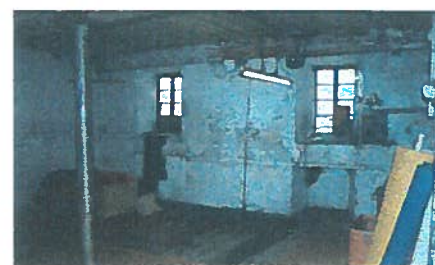
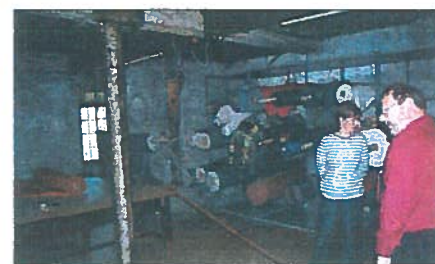
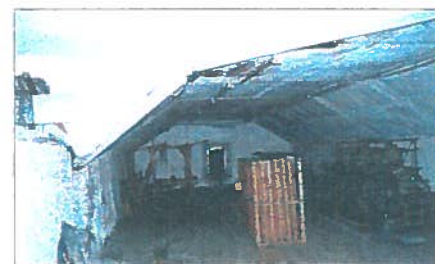
BUILDING 2 - Two storey building infilling internal angle of Building 1, built circa 1868 - Significance rating B

This building is contiguous with and interconnects at ground and first floor levels with Building 1.

Walls are of rubble limestone with roughly dressed quoins and brick dressings to openings similar to Building 1. Most openings have been altered with inset brick arches and rubble infill, apparently contemporaneously with the insertion of the new internal structural system in 1886. The natural slate roof is hipped in the form of a pyramid, a square flat at the apex may mark the position of a, now missing, ventilator. The roof is in poor condition. Gutters and downpipes are missing from both exposed elevations and lead tapered gutters at abutments with Building 1 are in very poor condition.

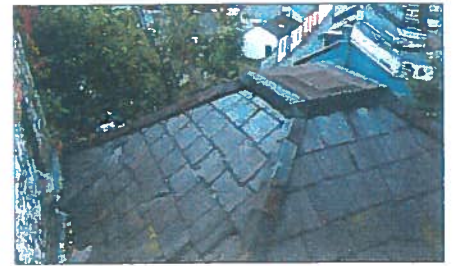
Building 2, roof

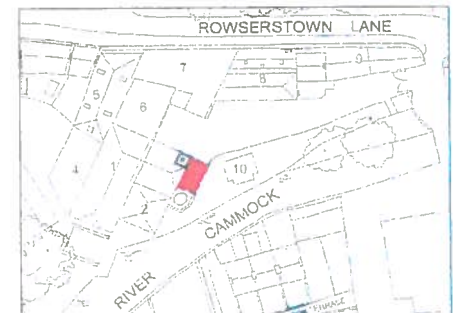
BUILDING 3 - Boiler room, built late twentieth century -
Significance rating E.

A single-storey boiler room with smooth-rendered walls and flat concrete roof.

Policy 18.3.1 *Building 3 and boiler should be removed.*

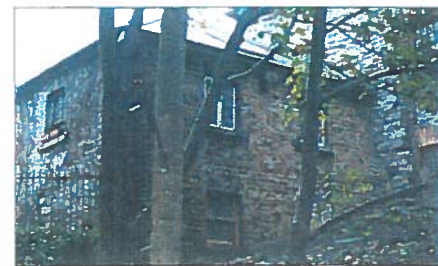
This building is of later construction than Block 1 but is possibly contemporaneous with the 1886 remodelling. The north elevation opens at second floor level to Rowserstown Lane. Walls are of brick, except the lower sections of the south wall which are of rubble limestone and, most probably, represent the northern edge of the original mill race. Some window openings are now blocked and some original, six-over-three pane, sash windows survive on the west elevation. Later sash and casement windows are also evident on the south elevation. The natural slate roof is hipped and in poor condition.

Building 5, south and west elevations

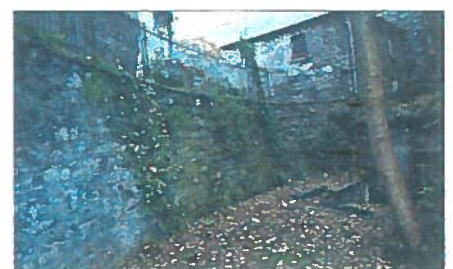
Mill race looking west

rear boundary to Mill Terrace) extends from Kilmainham Bridge, to the west, and curves to abut Building 5 in the east. The dates of construction and modification are not known however the structure to the west is predominantly of rough mass concrete suggesting a late-nineteenth or early-twentieth century date while that to the eastern end is largely of rubble stone construction, suggesting an earlier date. Some alterations to the line of the masonry wall are apparent behind Mill House, Kilmainham House and the two adjoining two-storey red brick properties. While the original intention is not clear, the 1838-47 Ordnance Survey map indicates an area separate from the mill race at this location. Also, at this point, the wall is capped by a stone coping into which is set a simple wrought-iron panelled fence including a gate which presumably linked Mill House with the mill.

Policy 21.1 *Rubble stone walling should be consolidated and re-pointed where necessary.*

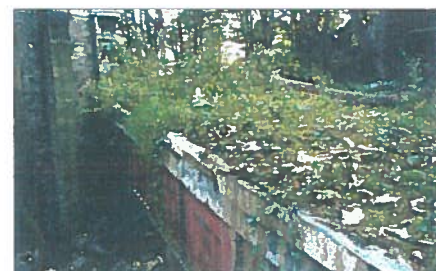
The cast iron trough, or aqueduct, was introduced in 1886 to permit a water wheel to be located on the south gable of Building 1. It would appear that the intention was to maximise delivery of power to the pulley drives which turned the mill stones. In the 1950s, the trough was truncated and sealed to form a water tank to provide water for the, now mechanised, finishing processes.

Aqueduct

The trough is contemporaneous with the 1886 internal reconfiguration of the Mill and bears the same manufacturer's mark to that on the columns within the building. The trough has more recently been infilled but remains in its original position.

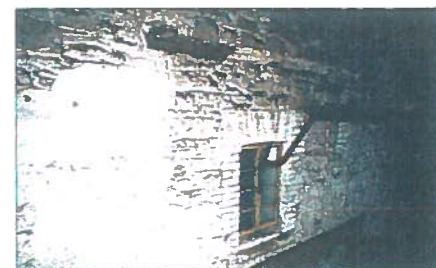
Blocked up opening on west wall of Building 1 inside Building 4

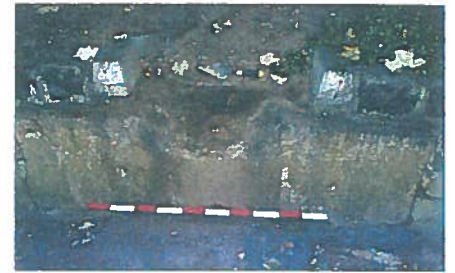
The, more recent, mill wheel has also been removed and is, reputedly, now located in Kilbeggan. However, remnants of the wheel mechanism remain, including fragments of the (partially buried) gearing system, bearings and other mechanical components. Evidence of the timber and cast-iron sluice mechanisms also remain, albeit in an advanced state of decay.

Axle housing

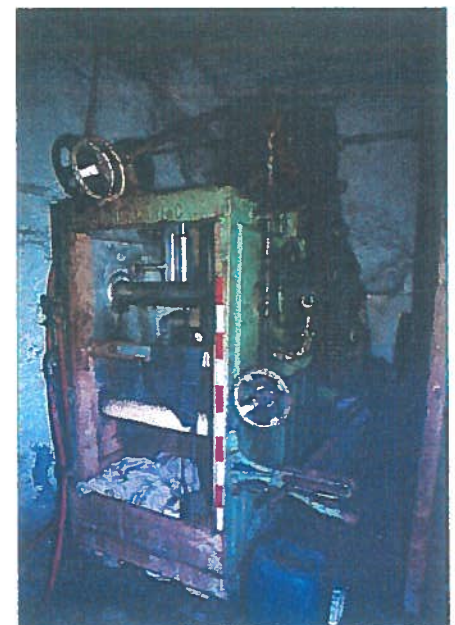
Milling box

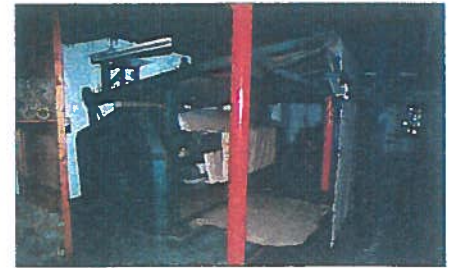
Brushing machine, Building 1

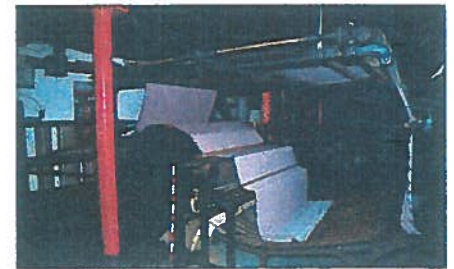
Steam brushing machine, Building 1

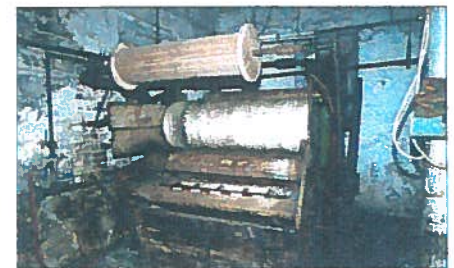
Scouring dolly, Building 1A

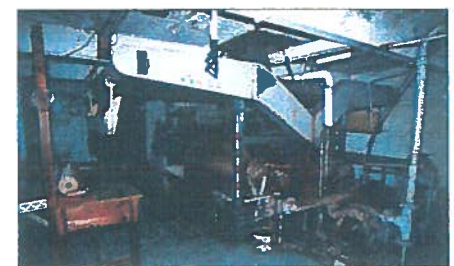
Decatizing machine

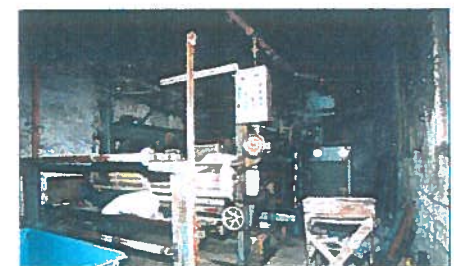
Walls are of concrete blockwork and the monopitch roof is covered with corrugated asbestos sheeting. The building was constructed to house a tentering machine.

Tentering machine, Building 4
