2022 Assessment - Designation of Clontarf Boat Slipway as an EU Identified Bathing Water

**DESIGNATED BATHING AREA
RISK ASSESSMENT REPORT**

Location: Clontarf slipway
Date: 18th November 2022
Assessor: Ronnie Horan

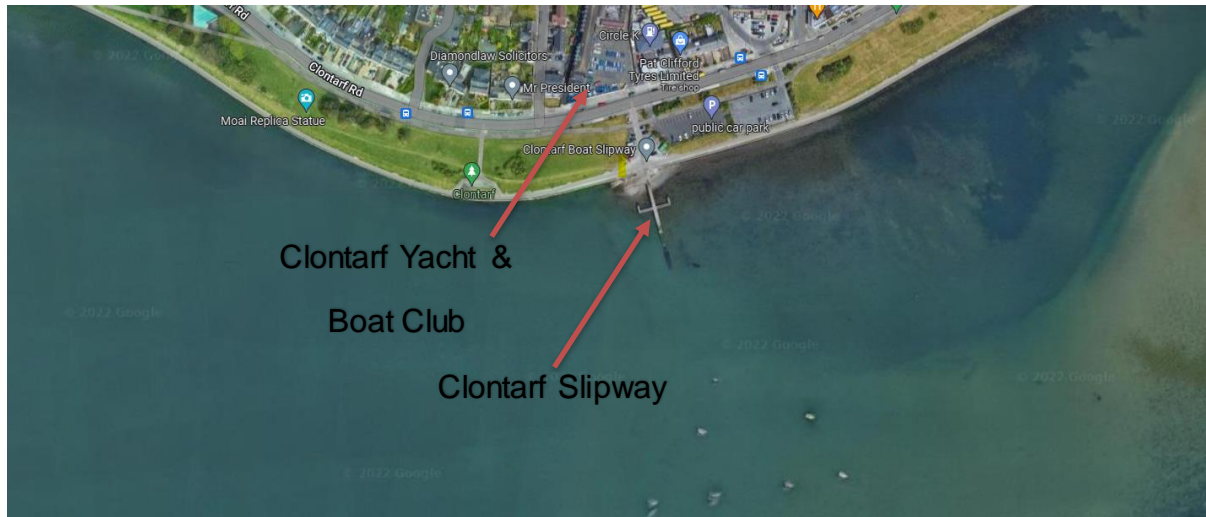
Figure 1 Clontarf Boat Slipway (www.google.ie/maps)

The Clontarf Boat Slipway is located off the Clontarf Road (R807) immediately opposite the Clontarf Yacht and Boat Club (see Figure 1 below). The location can be accessed by various modes of transport including bike, foot, car and bus. A public pay and display (zone blue) carpark is situated immediately East of the slipway.

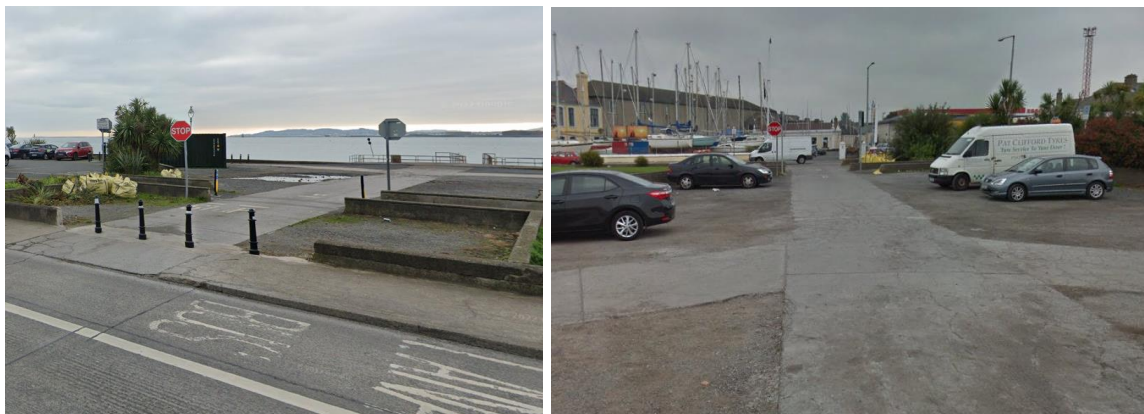
Figure 2 Boat Access to Slipway from Clontarf Road (South),

There is a separate entrance to the slipway for the transport of boats to and from the water (pictured below). This entrance is primarily utilised by the Clontarf Yacht and Boat Club.

Figure 3 Boat Access from Slipway to Clontarf Road (North) (www.google.ie/maps)

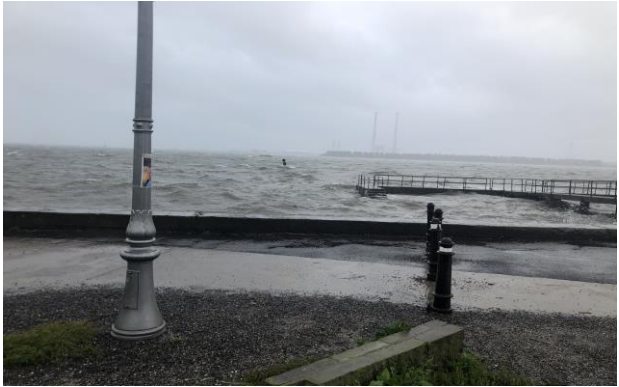
The area is not currently a DBA. The slipway which runs parallel to the seawall is the main launching area for small sailing dinghies coming across the R807 from the club as well as for the club motorised rescue craft (see photos 4&5). The jetty extends seawards beyond the slipway and is used to transfer rescue crews to their boats and to transfer sailing crews to the larger sailing cruisers that are moored offshore (photos 6, 7, 8 & 9). It is noted that the access ramp can be covered at high tide (photos 1& 2).

#	Date/Location	Content
1	Clontarf jetty high tide.

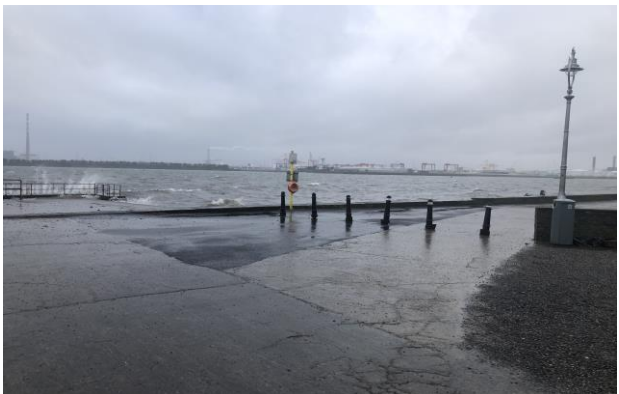
2	Clontarf jetty pedestrian access and RB1 high tide.

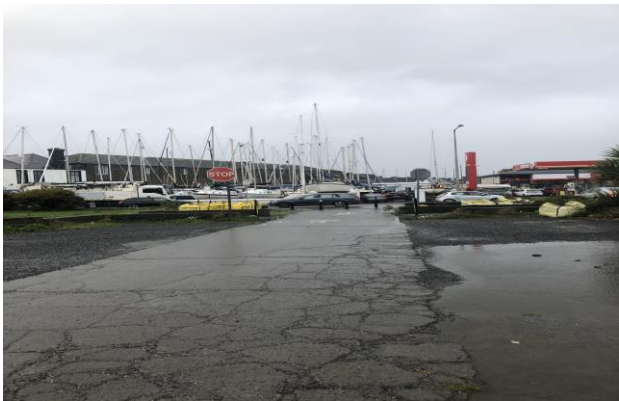
3	Clontarf jetty pedestrian and boat access from Boat club across Clontarf Road (R807). Removable bollards in place to control vehicle access.

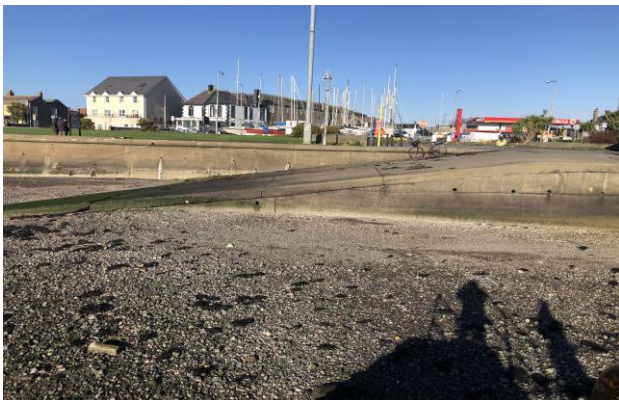
4	Clontarf main slipway for boat launching.

WSW 025	Warning; crocodiles, alligators or caimans	N/A	N/A	N/A
<p>4.5.4. Recommendations:</p> <p>1. Erect sign WSW002 'Warning slipway' and WSW016 'Warning boating area' and WSW023 'Large Breaking Waves' at top of slipway.</p>

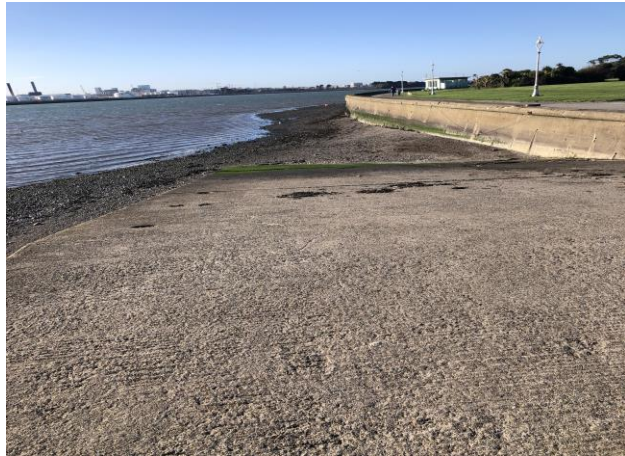
5 Clontarf main slipway 2.

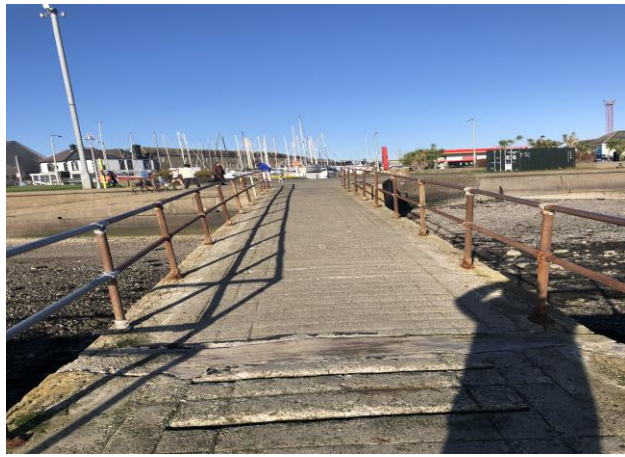
6 Clontarf pedestrian access to main boat ramp.

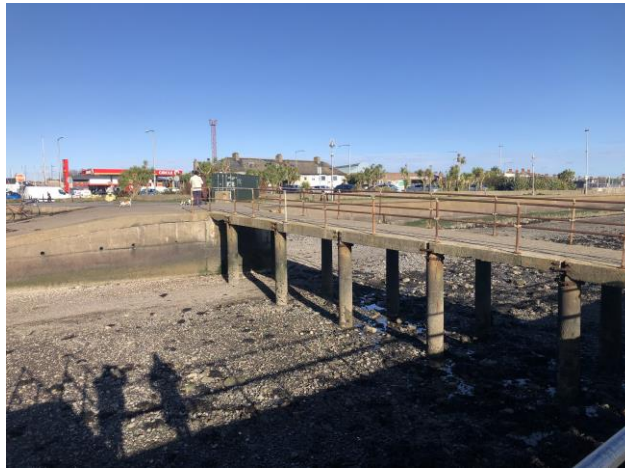
7 Clontarf pedestrian access to main boat access ramp 2.

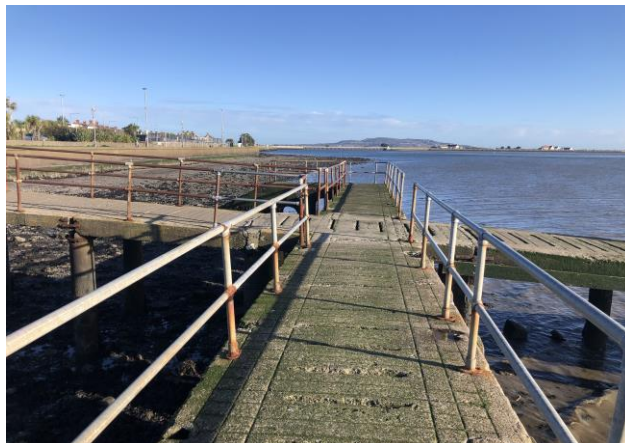
8 Clontarf pedestrian access to boat access ramp 3.
