Preliminary archaeological excavation report

**St Anne's House (formerly Thornhill)  
St Anne's Park  
Raheny  
Dublin 5**

**Licence ref. 22E0688X ext**

13<sup>th</sup> November 2023

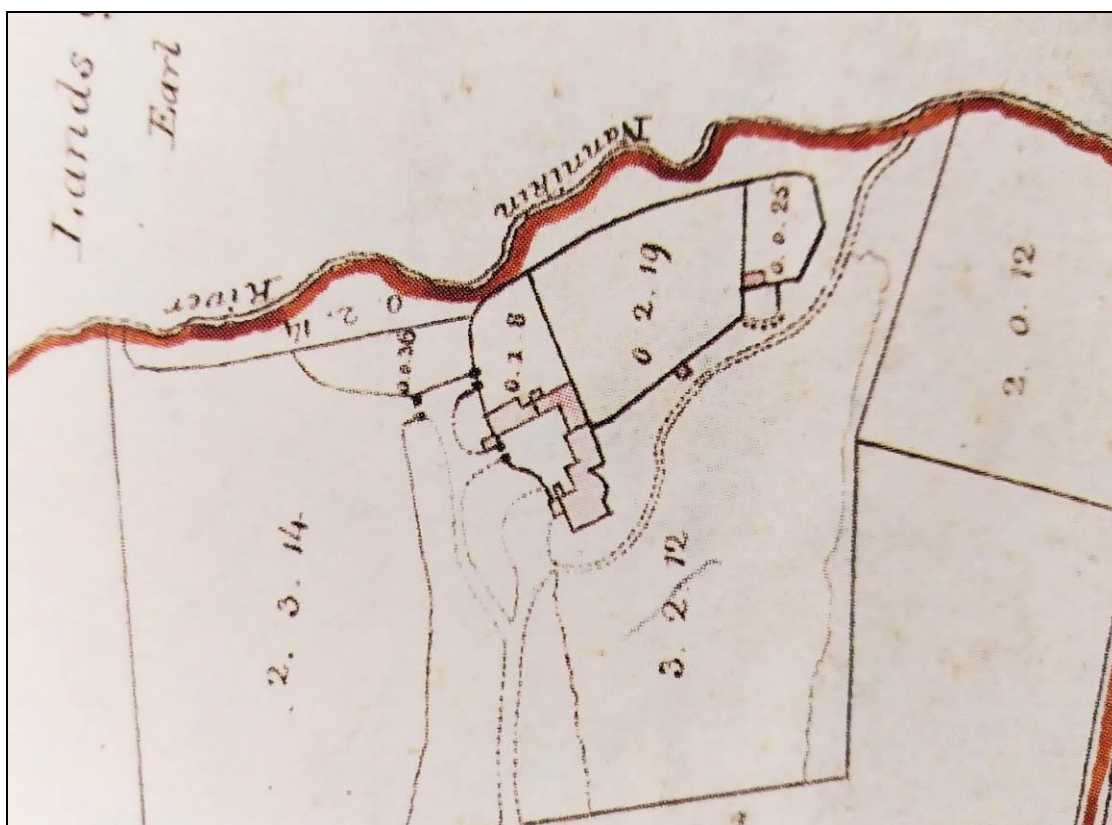
Figure 4 Extract from Brassington and Gale's Map of Thornhill House and Estate c.1832 (Dublin City Council)

An estate map by Brassington and Gale from 1835 shows Thornhill House, the surrounding walled garden and the access routes (Figure 4). The first detailed survey of the area was the 6-inch Ordnance Survey; carried out in 1836 and published in 1843. The revision of this map in 1868 shows St Anne's mansion (St Ann's) after its' expansion from the more modest, yet still substantial house that was depicted by Brassington and Gale.

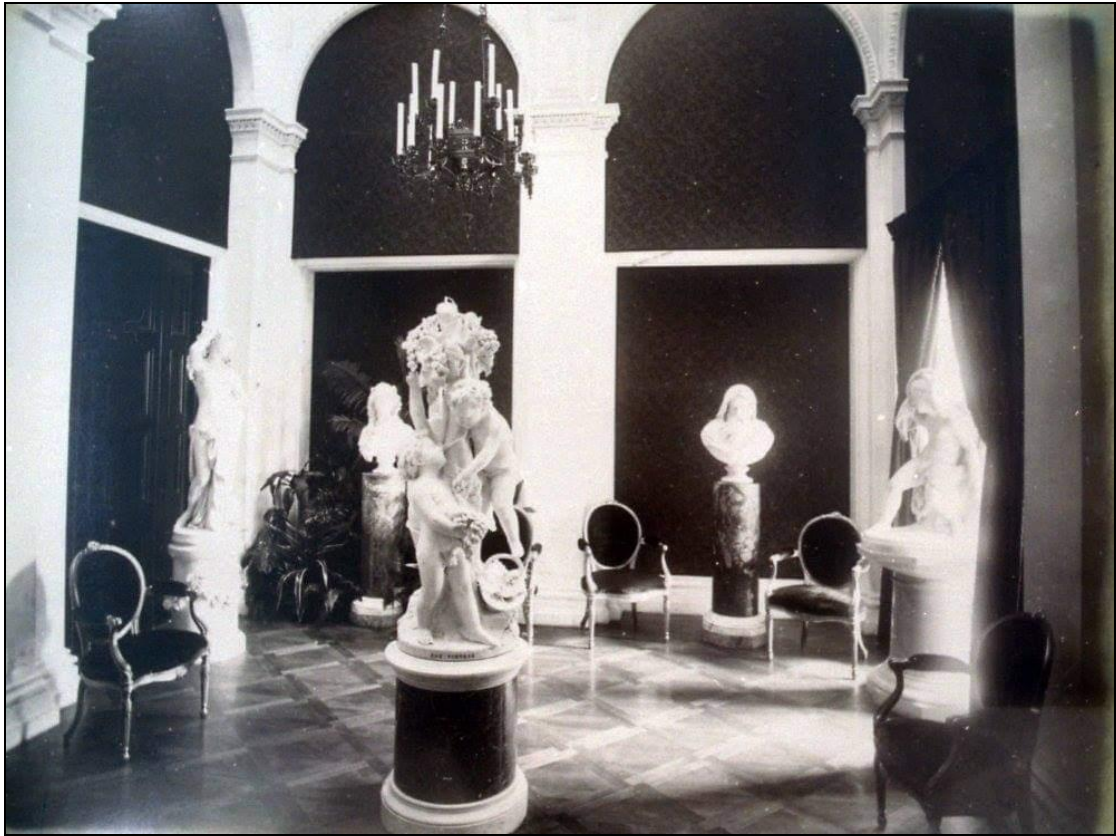
Plate 6 Interior of Statue Room, c.1876 (Plunkett Collection)

The Statue Room (Plate 6), was located within the south wing of the former mansion and the extent of this room within the excavation measured 4.4m north-south and 3.9m east-west, representing approximately 80% of the total sq.m<sup>2</sup> area of the room. A subsurface horizon C.36 extended across the internal space serving as the sub-floor level of the statue room, comprising compact mortar rich brown clay with frequent stone inclusions throughout and this was a uniform 0.3m below the former floor level of the room.
