**St Anne's House (formerly Thornhill)  
Blackbush or Heronstown  
St Anne's Park  
Raheny  
Dublin 5**

**Licence ref. 22E0688 ext  
Preliminary archaeological excavation report**

20<sup>th</sup> November 2024

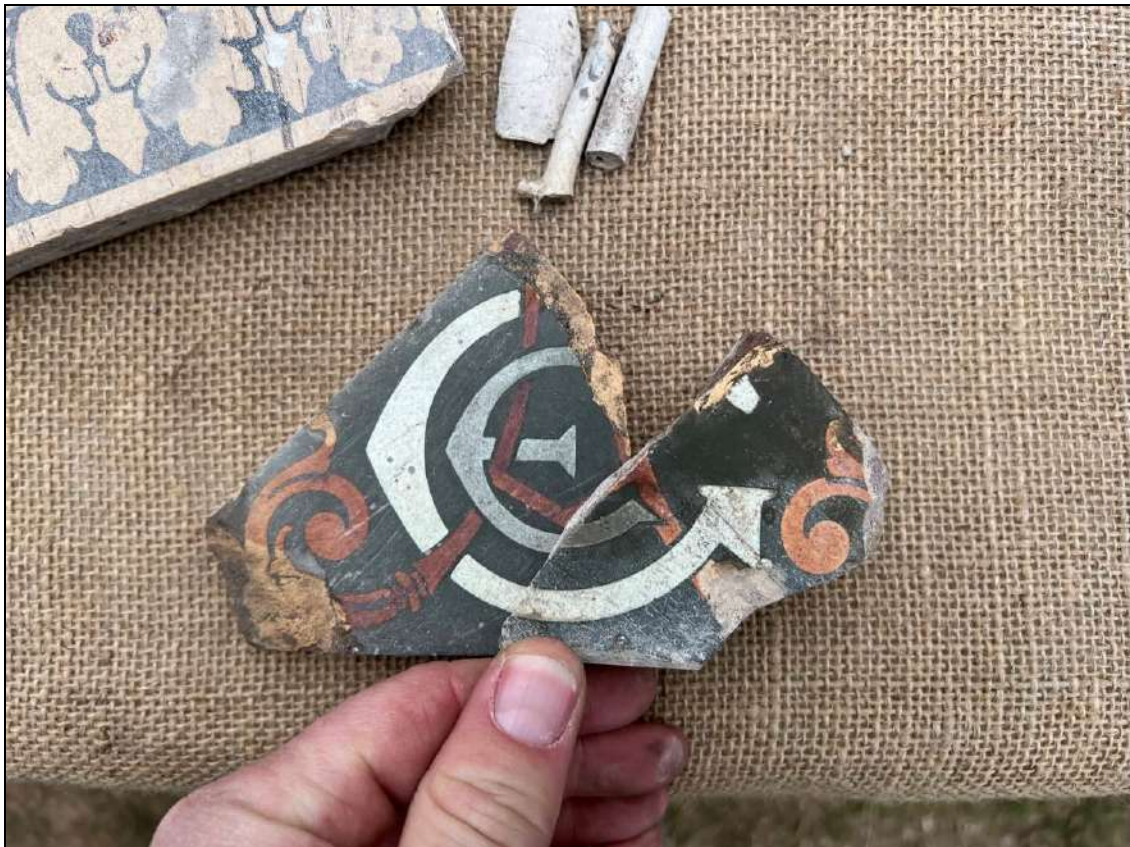
Plate 12

Composite of two fragments of monogrammed AEG tiles

Postulating from the symmetrical nature of the building, the porch would have originally accommodated several tile panels and if one assumes a symmetrical layout to these panels the southern panel would have a twin to the north, which might yet survive wholly or in part, to be excavated next year. By extension, the remains of the remains of the two northern panels possibly represent central parts of the pattern, extending across the centre of the porch to the southern panel, with most of the remaining central panels being sadly absent at the time of the excavation. The centre of the porch had clearly suffered a direct hit from the wrecking ball, but the excavation of that impact crater uncovered the partial remains of three monogrammed encaustic tiles. These triangular tiles, bearing the initials AEG, for Arthur Edward Guinness (Plate 12), presumably formed part of the central panels of the porch, either as corners to those panels or as a central device/focal point within them. All of the uncovered porch tiles bore the name of 'The Campbell Brick & Tile Company' of Stoke-on-Trent, with the latter's compass points trademark, dating the manufacture of these tiles to the period of 1875-1882.

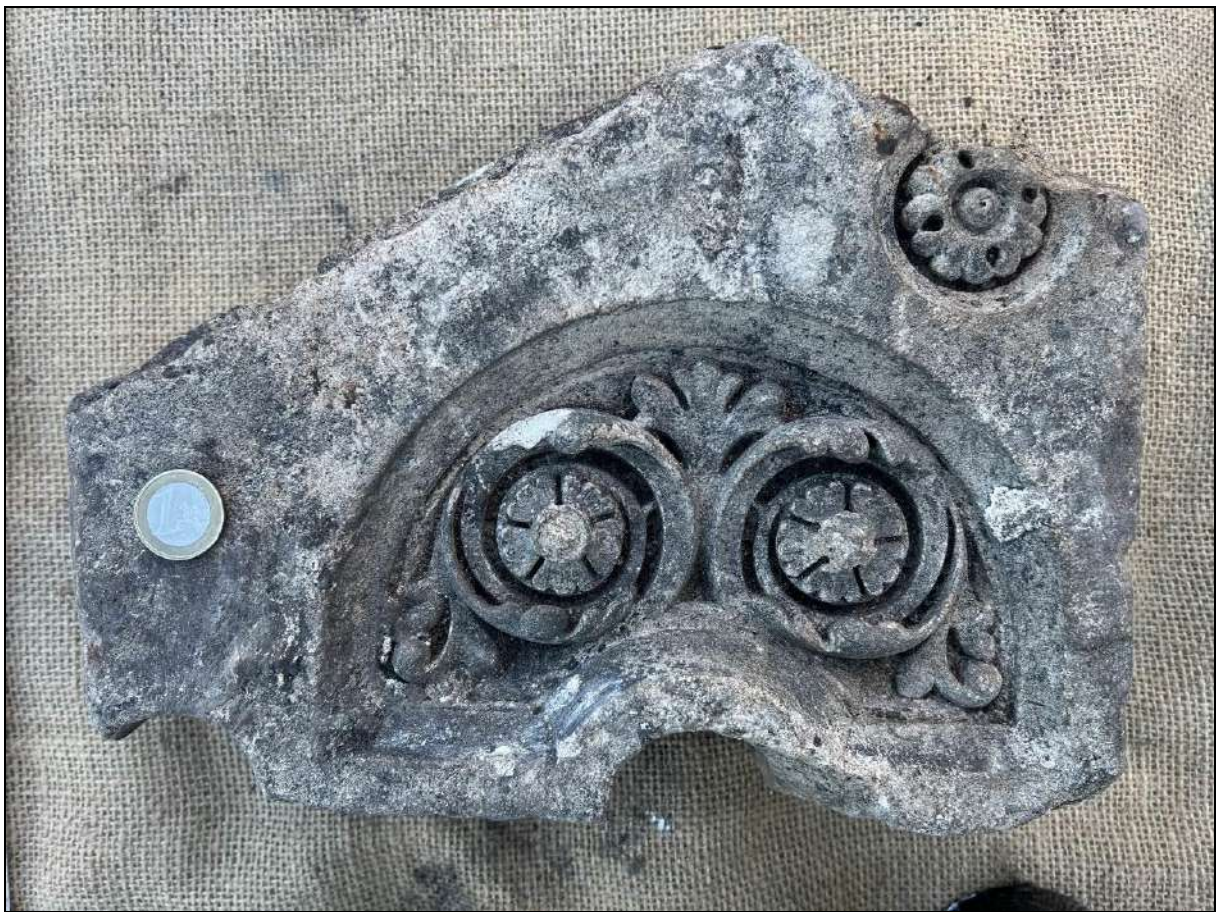
Plate 13

Fragment of ornate internal doorcase

The main hall would have been accessed from the porch, via a decorative cut stone doorcase of which only a fragment remained (Plate 13) with an arrangement of pillars and internal windows either side of that door separating the porch from the main hall. Only the most western 1.5m of the main hall was present in the trench, with the remaining c.28m *in situ* to the east, under the baulk, unexcavated at the time of writing. Even with such a small percentage of such a large room available to excavate, there were enough features which
