Arboricultural Assessment Report

Finglas Village Improvement Scheme

September 2022

PROJECT REFERENCE: Finglas Village Improvement Scheme

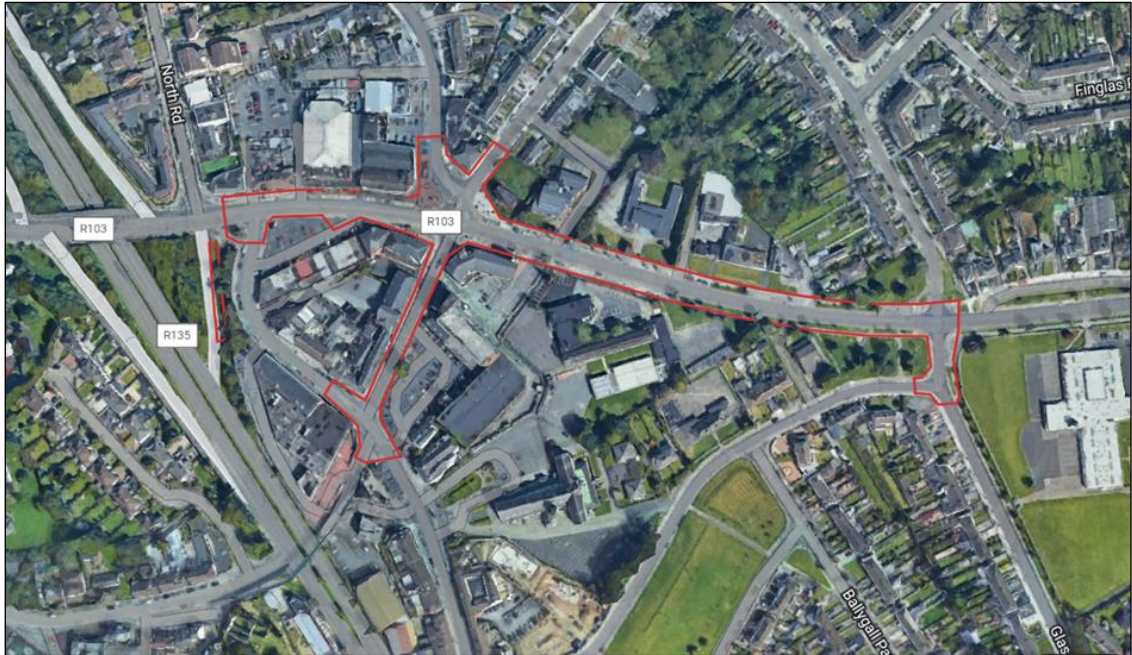
Figure 1: Aerial image of the site and its immediate surroundings. The approximate boundary of the tree survey extent is outlined in red. Image (Google Earth, 2020).

- 2.2.1. The tree survey targeted the trees established within the redline boundary on the tree survey extent drawings (drawing no: FVIS_ARUP-ZZ-ZZ-DR-CH-0002-02) provided by ARUP. The tree numbering begins on T1774 in the west of the village next to the down ramp on to the Finglas Bypass. The tree numbering continues east through the village on the northern side of Seamus Ennis Road and returns to the centre of the village on the southern edge of the road. The final two trees (T1824 & 1825) are established in a raised planter on Jamestown Road.

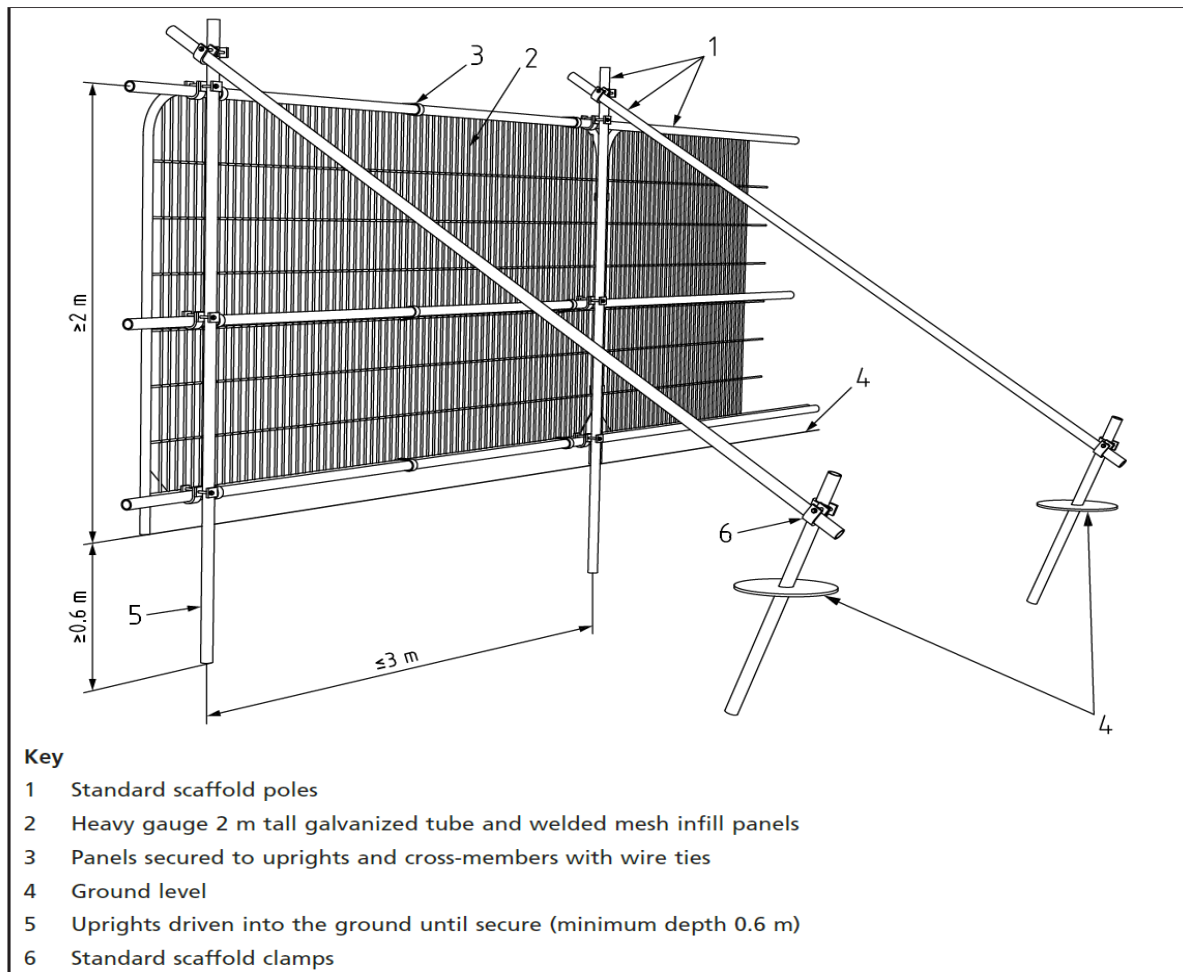
British Standard BS 5837: TREE PROTECTIVE FENCING

- The tree protection fencing will remain in place for the duration of the construction phase and should not be removed without approval from the retained consulting arborist.
