Dublin Bay Bathing Waters

Report by the Bathing Water Task Force

June 2023

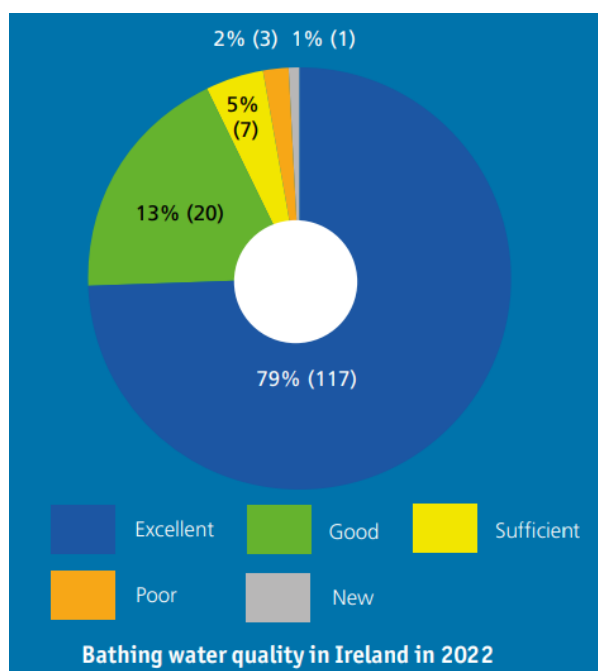
Figure 4: Source: EPA ‘Water Quality in Ireland: 2022 Report’ – Changes in bathing water classifications between 2021 and 2022

Classification	Number of bathing waters in 2021	Number of bathing waters in 2022
Excellent	115	117
Good	19	20
Sufficient	10	7
Poor	2	3
New/Changes	2	1
Total	148	148

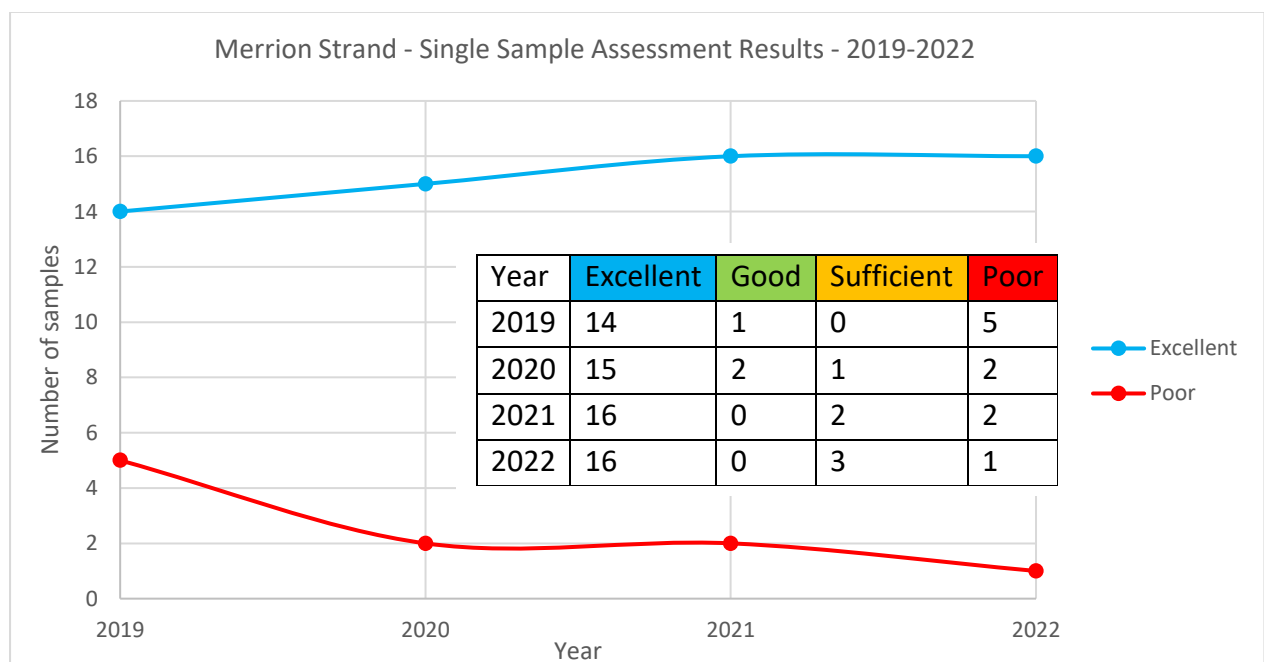
Figure 8 – Source EPA – designated bathing area classification bands.

The specific water quality profile at Merrion Strand since 2019 is shown in Figure 8 below. This graph displays a slow but steady improvement in water quality over the last four years. Ceasing the decline in water quality in a relatively short time frame is a significant achievement and indicates that the BWTF activities, as set out in Chapter 7, are having a positive impact.

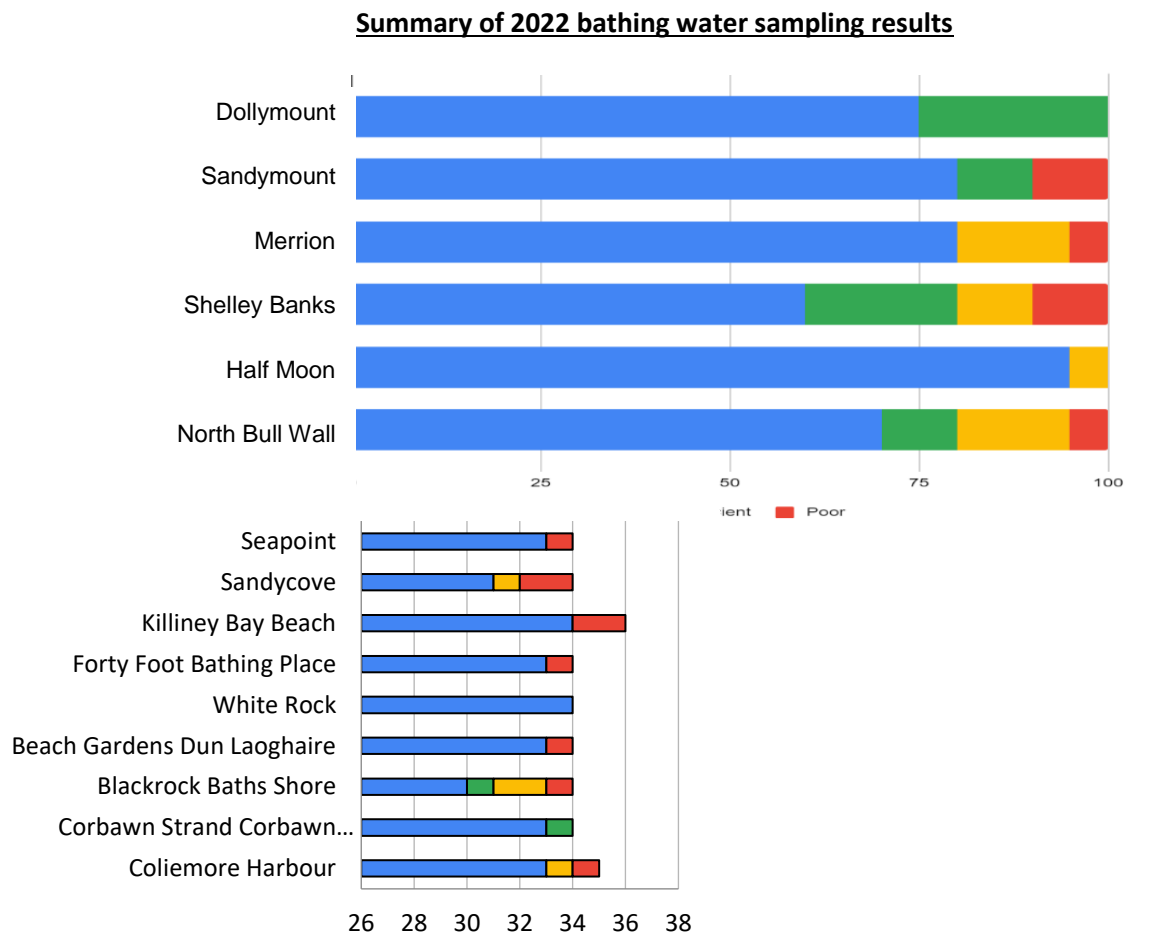
Figure 9 – Source: DLR & DCC

The following graphs show the Dublin Bay sampling undertaken at the various bathing areas along Dublin Bay and the apportionment of water quality classifications as determined by the Central Laboratory.

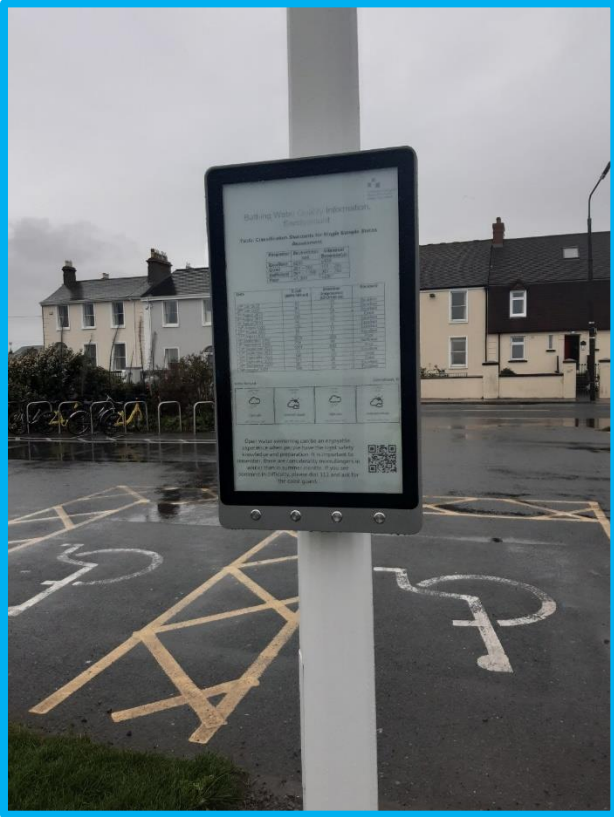
Image: Sustainable self-powered information signage trial ongoing at Sandymount Beach

7.12.3.	<p>On-site communications:</p> <p>To further improve the dissemination of information to the public, DCC initiated a pilot during the bathing season, trialling two self-powering digital screens at Sandymount and Dollymount Strands. The screens are self-sustainable and powered by renewable energy generated by a turbine and solar panel fitted on the installation. They utilise e-ink technology (similar to a kindle) and are updated remotely by DCC staff (see photograph 1 below). Statutory information including bathing water results and warnings are published on the screens and supplemented by water safety campaigns, weather forecasts and tides. The pilot has been extended for a further 6 months with minor adjustments to establish the feasibility of their operation during winter months.</p> <p>Further digital screens have been installed at busy bathing locations in the DLR area, including at Seapoint, DLR Baths, Sandycove and Killiney Beach. Those particular screens are mains powered and can be updated remotely with new data making them an ideal communication tool to inform the public about recent bathing water results, weather forecasts, tide times or important safety tips for swimmers.</p>	Trail commenced in Q1 2022 and remains under trial status.

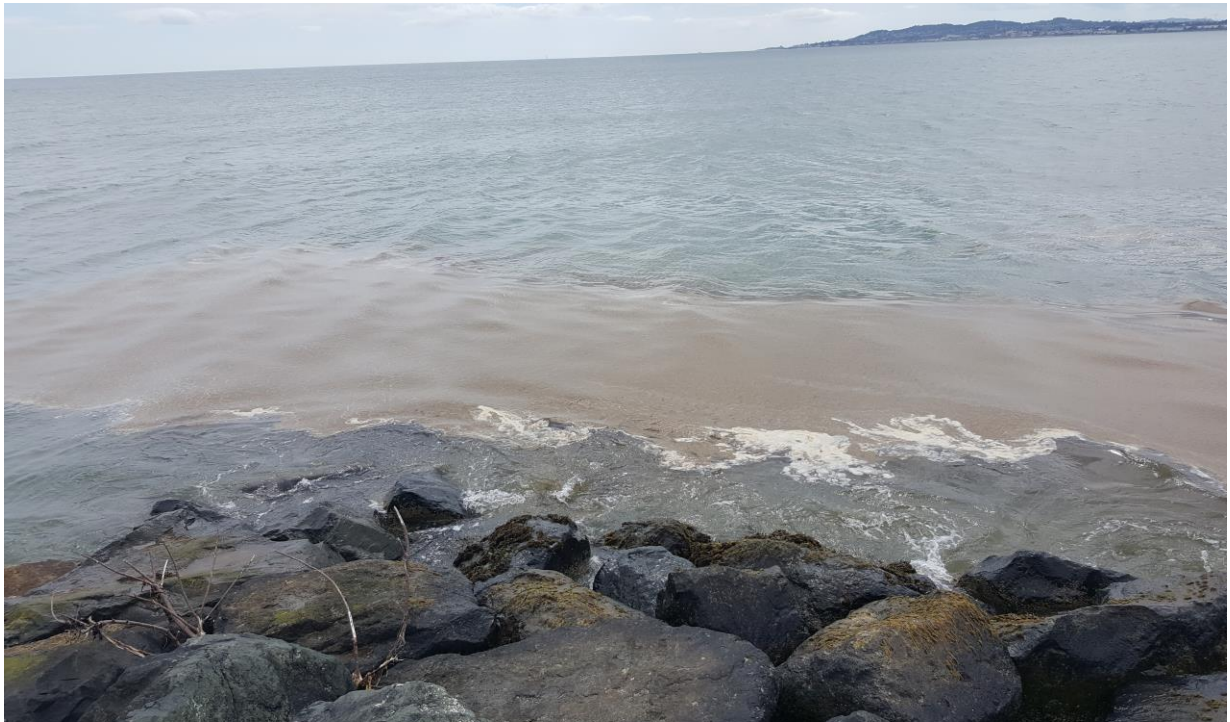
Shelly Banks – Brown ectocarpus washing ashore in the seawater, (Sept. 2019)

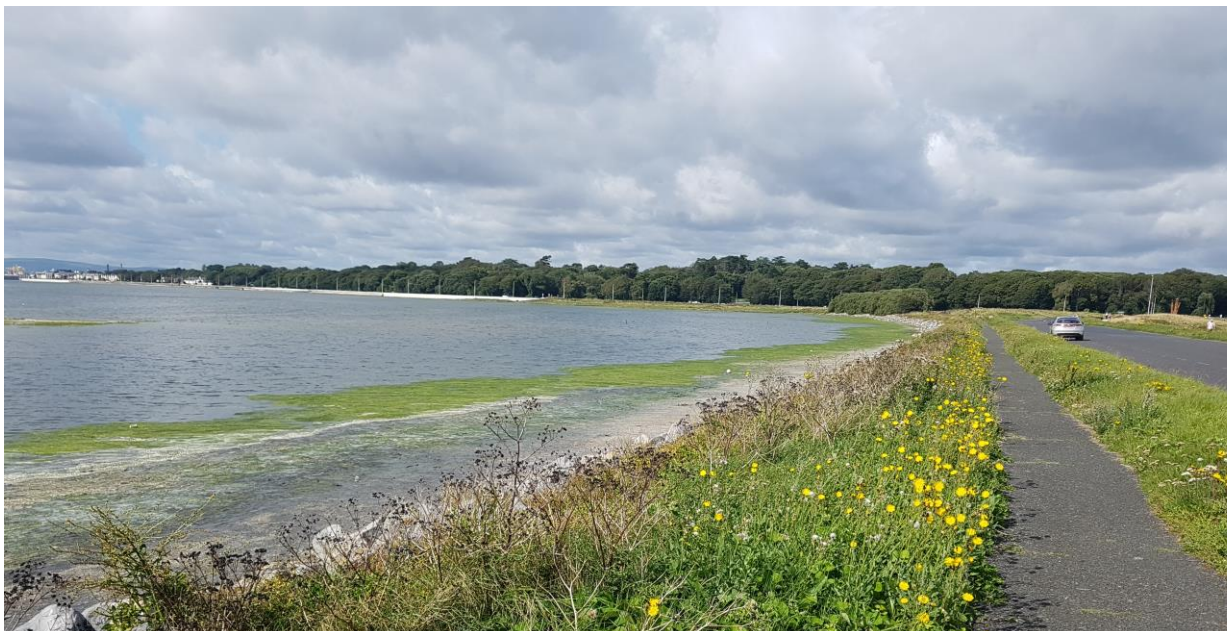
Causeway Road, Bull Island – Green ectocarpus floating on high tide waters, (Sept. 2019)

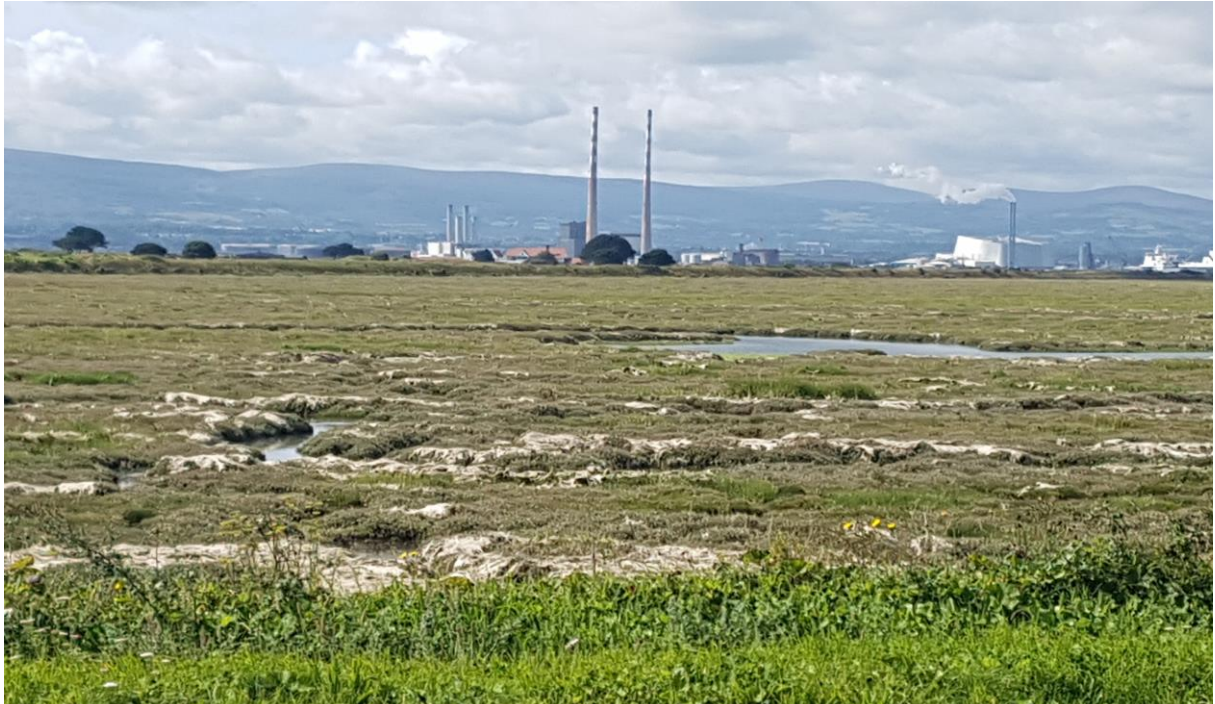
Bull Island – (Light brown) Dried ectocarpus resting on top of the marshes once high tide waters recede, (Sept. 2019).

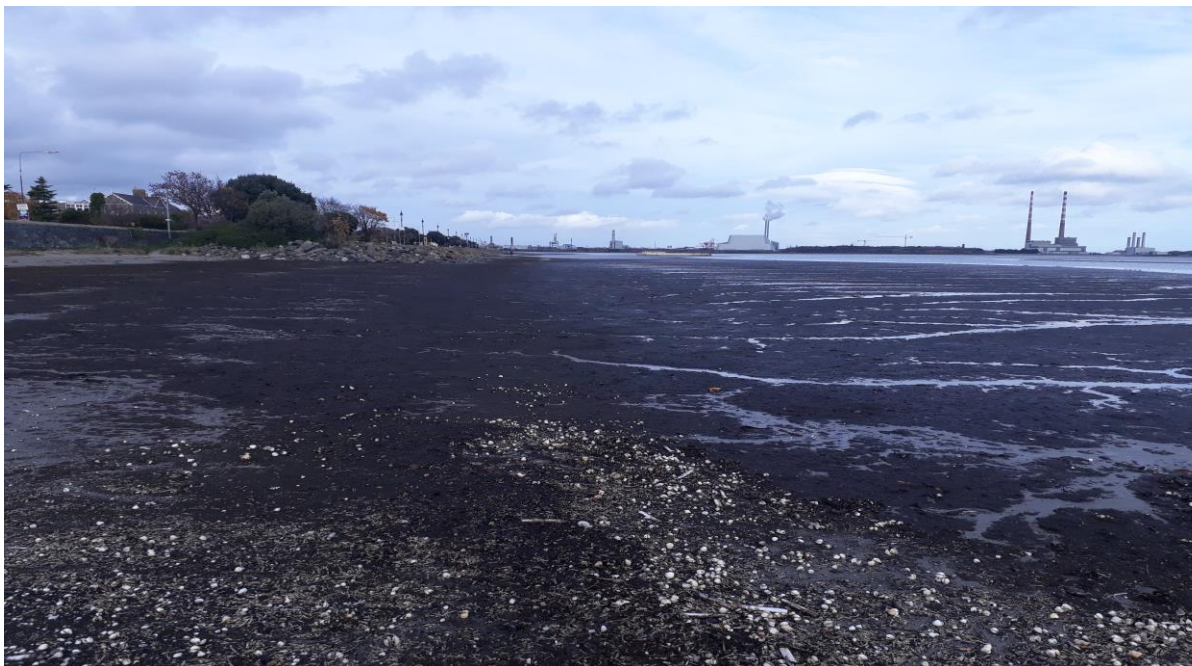
Merrion Strand – (Dark brown) recently washed up ectocarpus on the beach once tidal waters recede, (Sept. 2018).

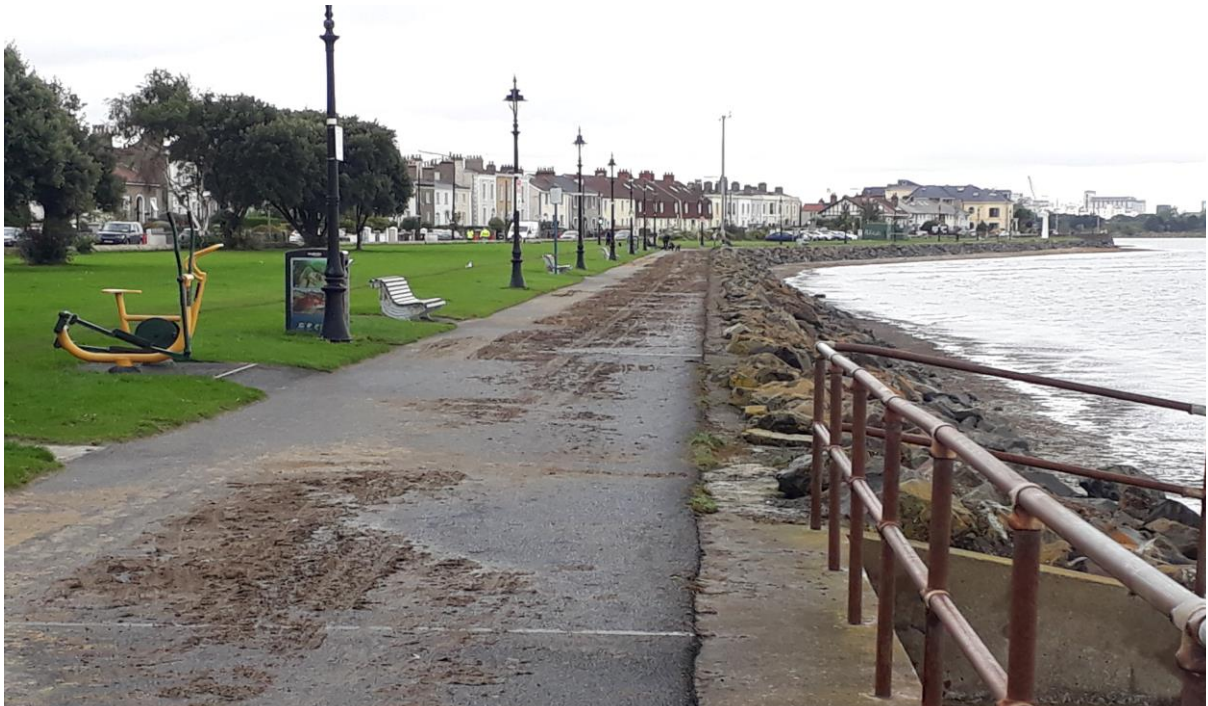
Sandymount Promenade – Ectocarpus washed onto the rocks footpaths during a combination of heavy rainfall and high tides, (Oct. 2019).

Furthermore, we are aware that after the recent heavy rainfall, combined with high tides, decaying ectocarpus can be washed up on the various footpaths or promenades adjacent to the coastline. Our Waste Management Department does tend to these incidents so as to make pedestrian footways safe and ensuring minimal relocation of this natural material from its environment.

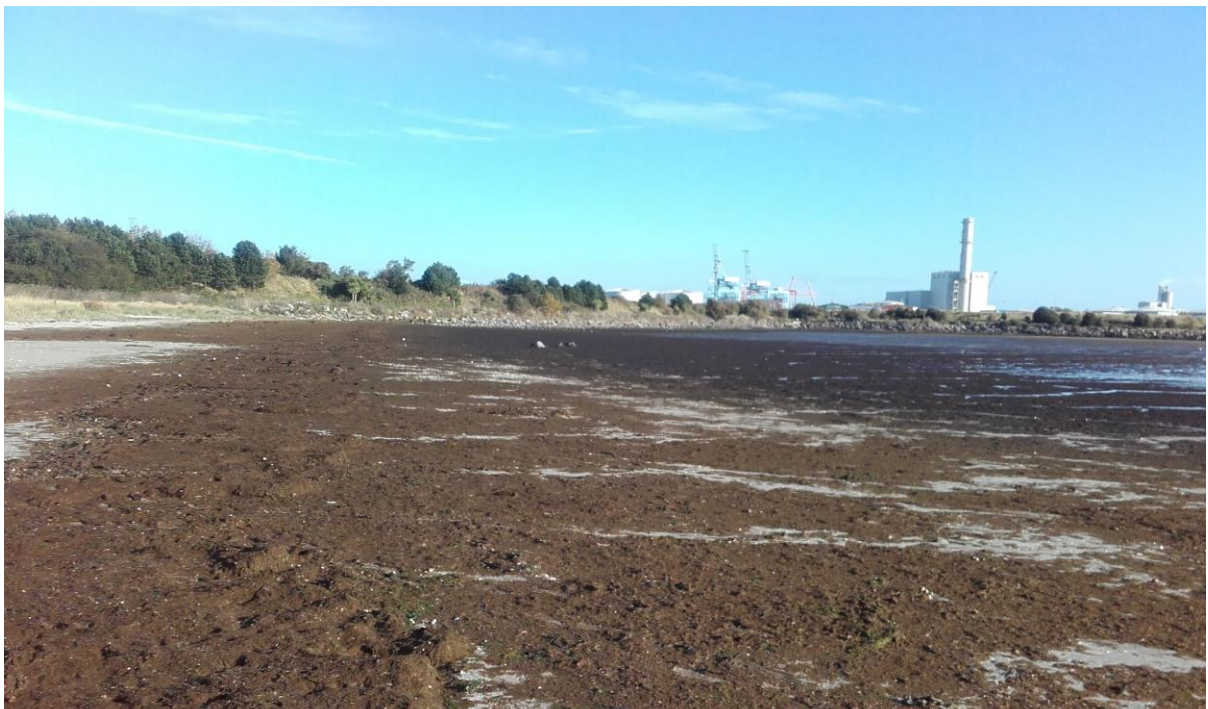
Sandymount Beach – Ectocarpus at various stages of decay, (Oct. 2016).
