Independent Tree Surveys Ltd

Tree Survey Report
Dodder Rapid Deployment Scheme
Anglesea Road
Dublin

May 2023

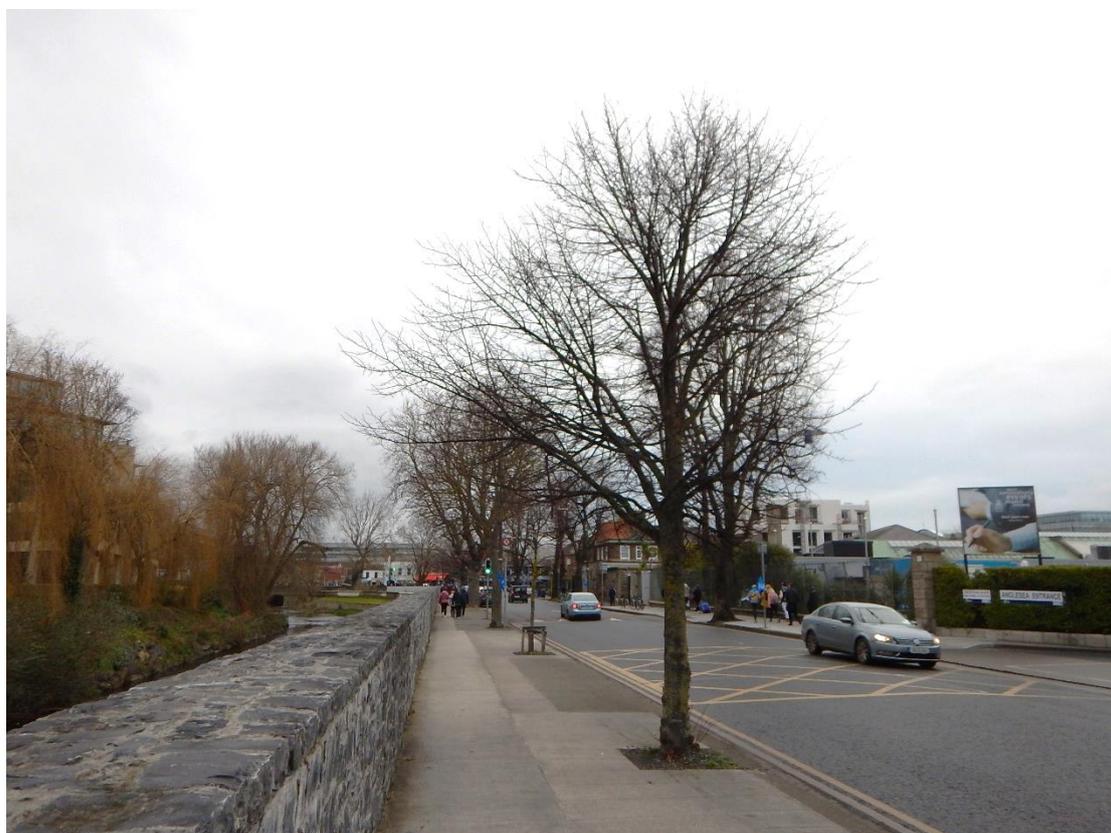
Five street trees planted into footpath, including one large mature London Plane, one Maple and three semi-mature Lime trees. The trees are in mostly fair or good condition. The four younger trees will require some light pruning works to crown lift the lower branching to provide the 2.5m clearance required. This will only require the selective pruning of small branching and should not have any significant negative impact on the trees.

1. Five street trees along Anglesea Road, viewed from the south

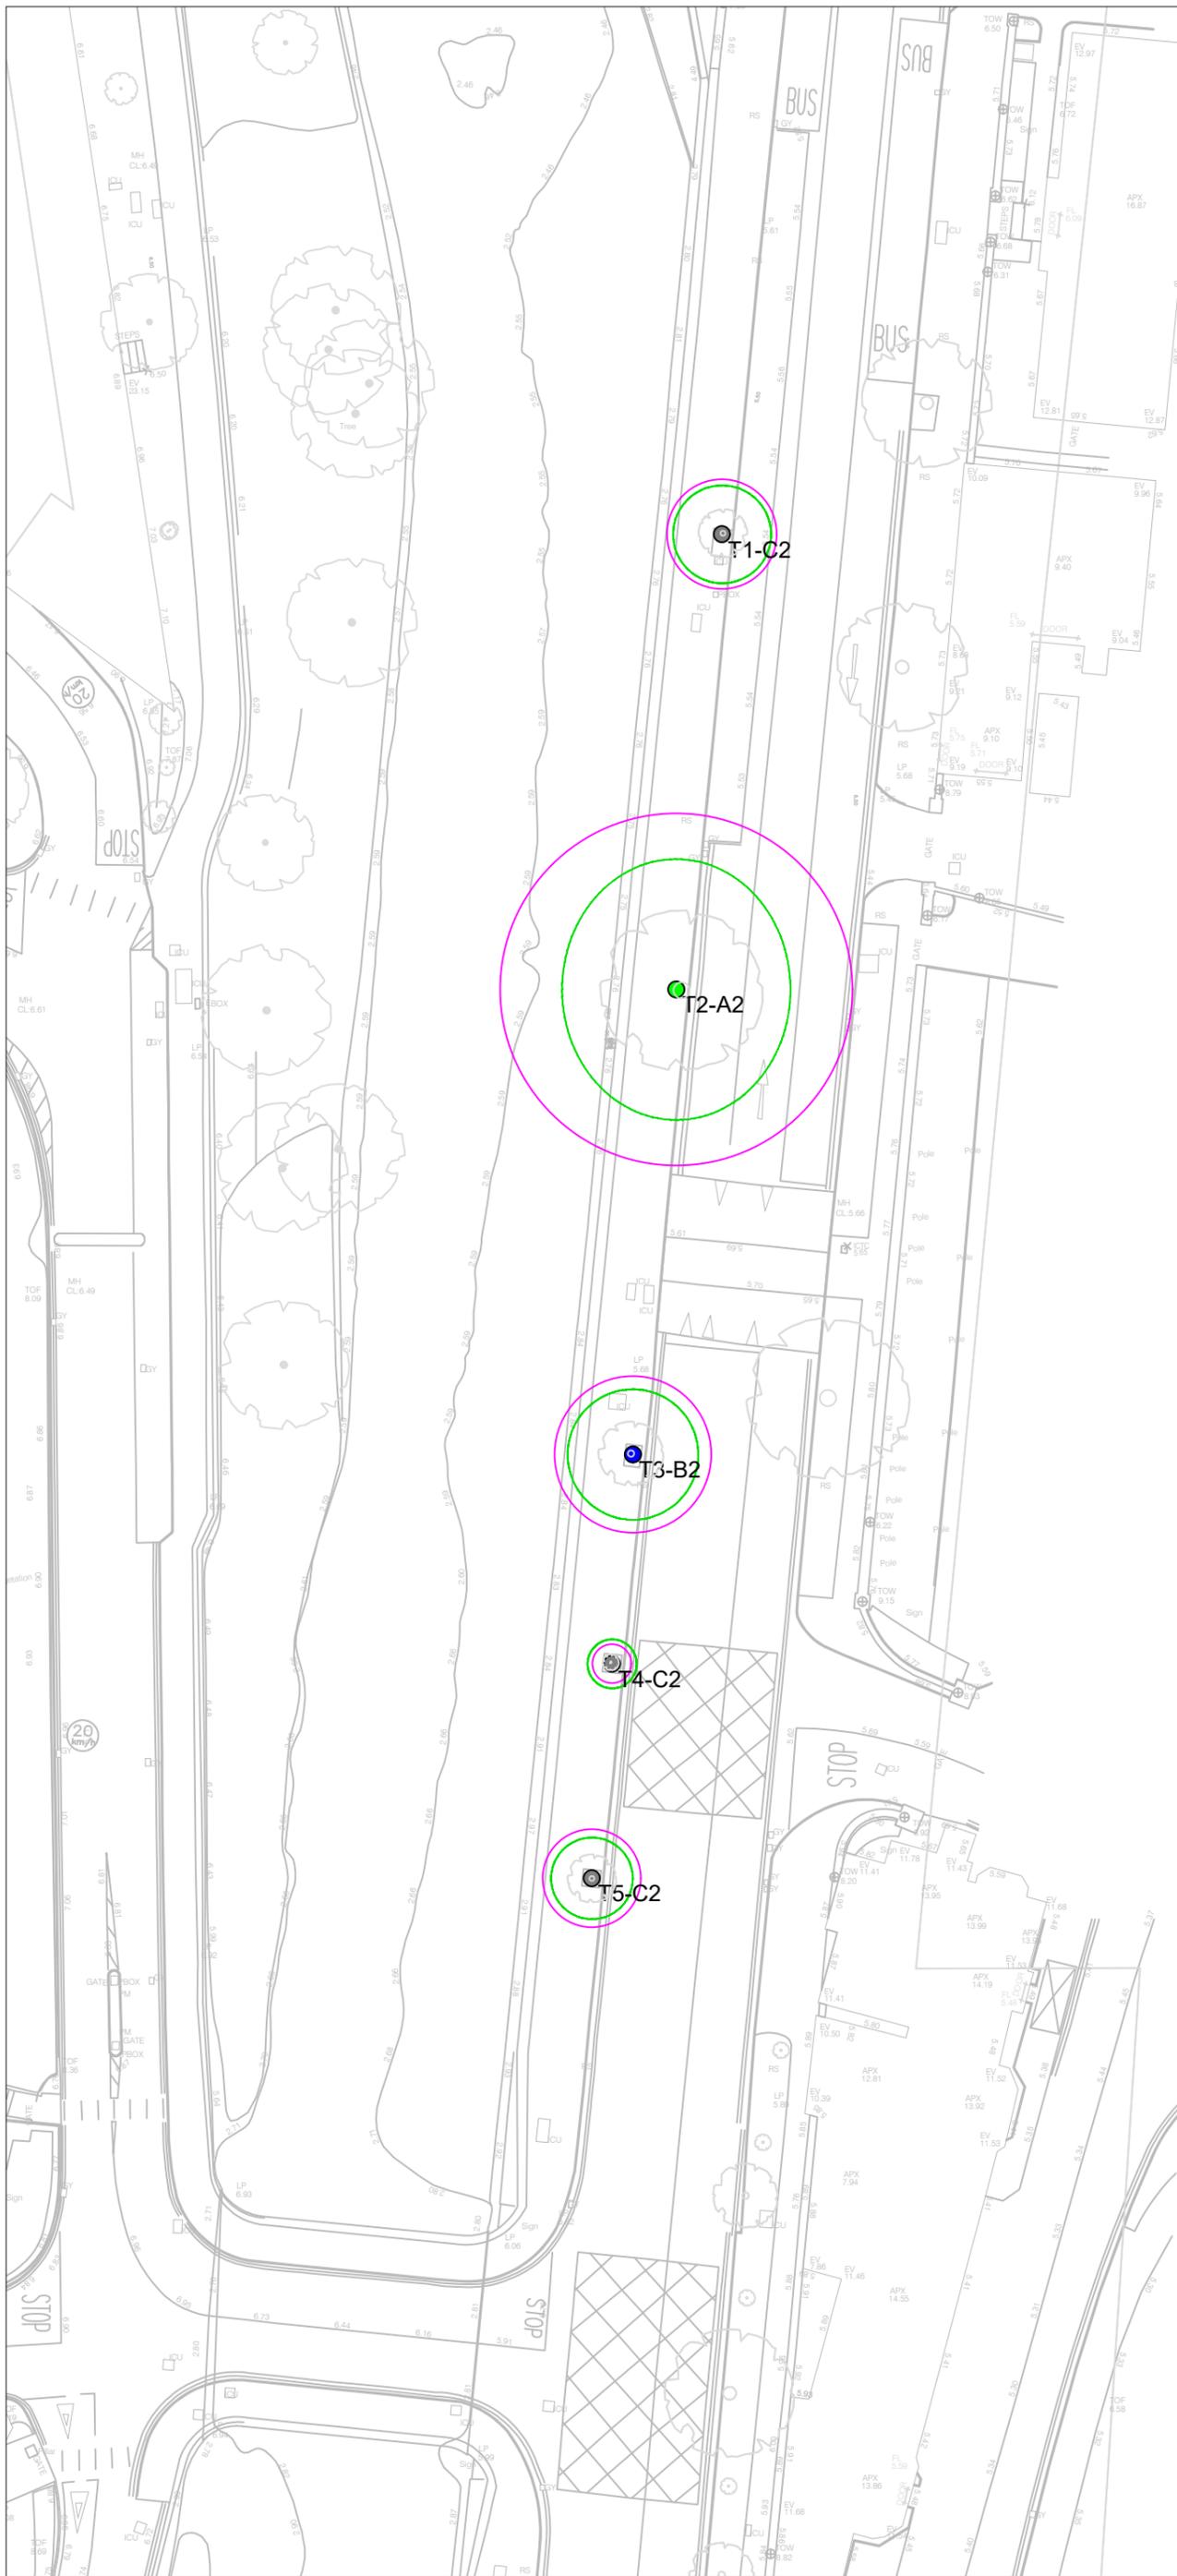
Drawing Number: 23007_TS_Sheet 2 Anglesea Road

The Root Protection Area (RPA) is the minimum area around individual trees to be protected from disturbance during construction works; RPA is recorded as a radius in metres measured from the tree stem and is shown on the tree survey/constraints drawing as a circle with the tree stem in the centre.

The trees were assessed during a site visit in February 2023; the field data for the trees is contained in the accompanying Tree Survey Schedule in the appendices. Indicative tree location, BS5837 category, RPA and approximate crown shape are shown on the Tree Survey/Constraints Drawings 23007_TS sheet 2.

Drawing Title: Tree Survey/Constraints Plan
